Sri Lankan Geotechnical Society

Prefailure deformation of unstable slope observed by tilt sensors

(2) – Case studies

L. Wang, I. Seko Chuo Kaihatsu Corporation

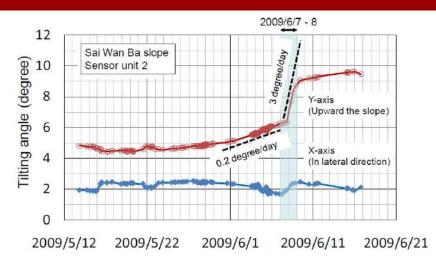
Time histories of tilting angle obtained by Sensor unit 2.

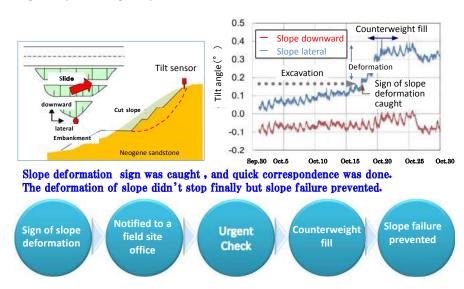
Disaster prevention of the slope failure during national highway cutting slope construction in Tohoku district.

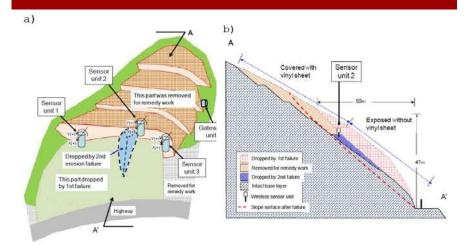
a) Sketch of failed slope along road and arrangement of deployed sensor unit; and b) cross-section of the slope including the second failure part.

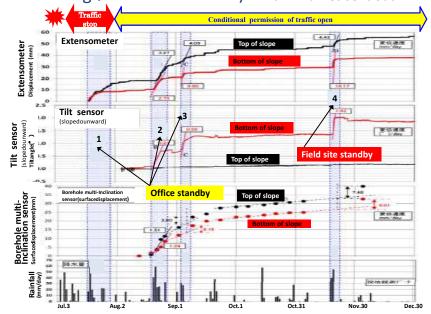
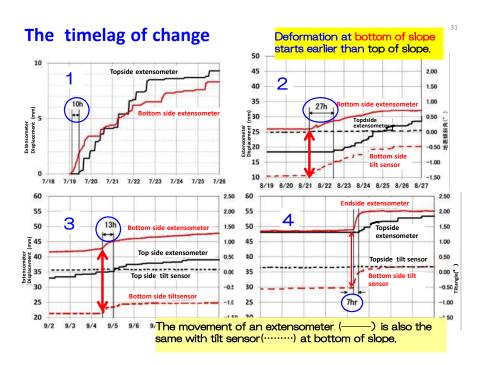
Monitoring (Jul. ~ Dec.in2011) Alarm 4times sent out

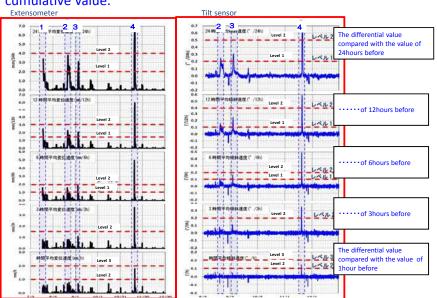
It is easier to understand the situation differential value than cumulative value.
