Rectification of Landslides in Sri Lankan Road Network - Lessons Learnt

Presenter :- Prof. S. A. S. Kulathilaka
University of Moratuwa
Sri Lanka

Presenter :- S. O. A. D. M. Lakruwan
NBRO

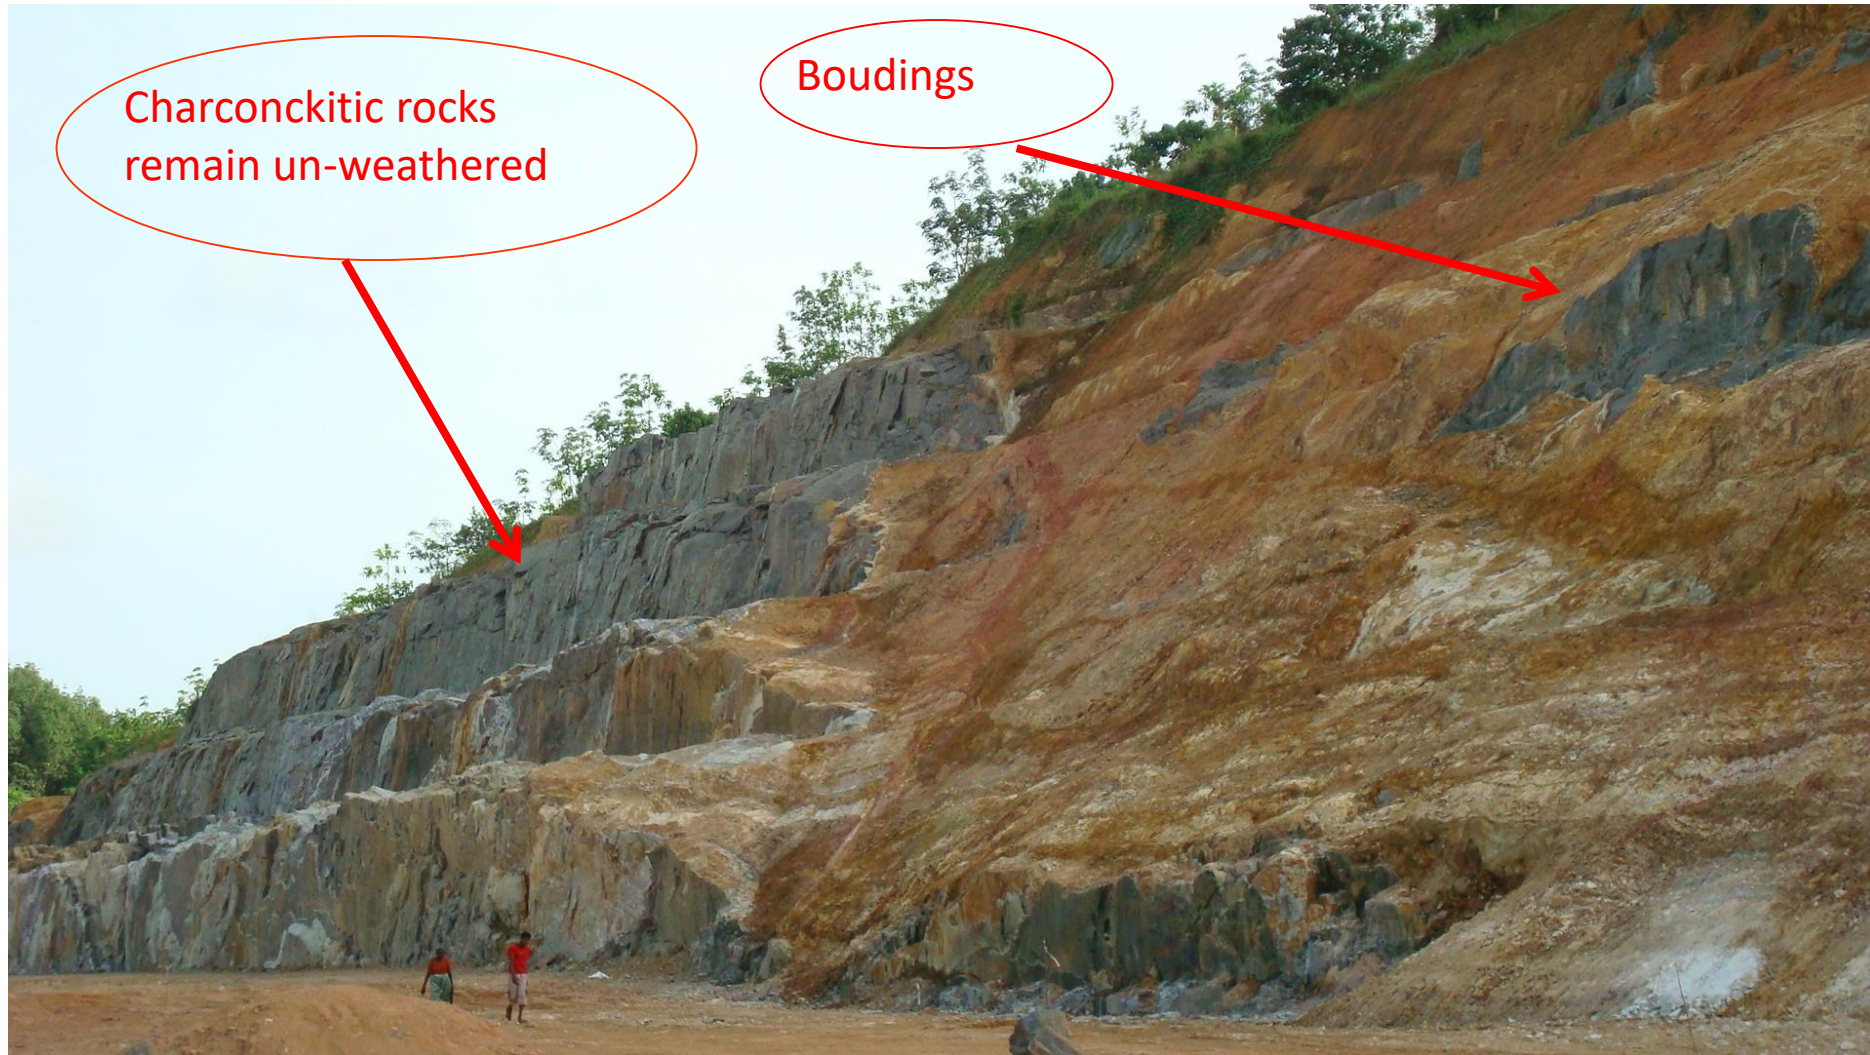
Current Knowledge – *Geological Background*

- ❖ Charconckitic Rocks that have high resistance to weathering Remains un-weathered – known as Boudings

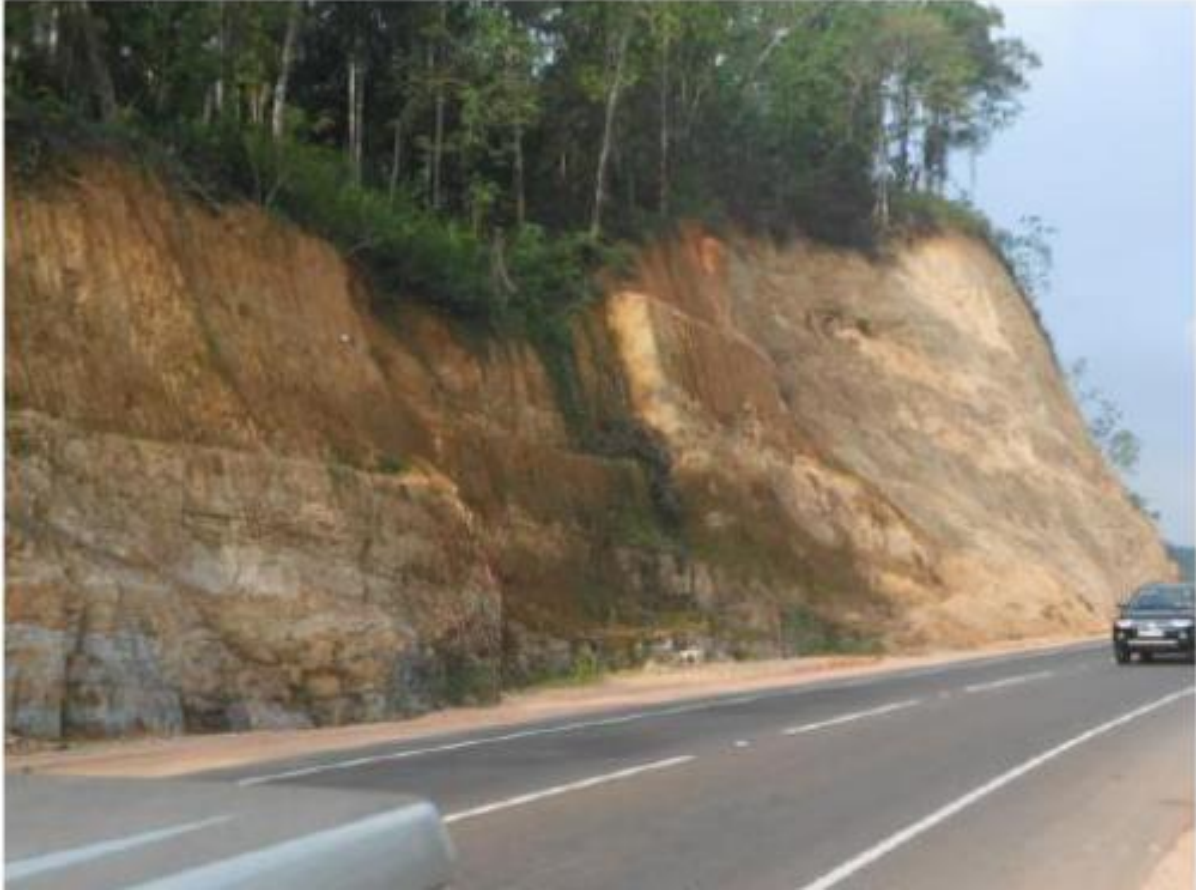
Kegalle Bypass Road

Immediately after cutting 24-3-2014

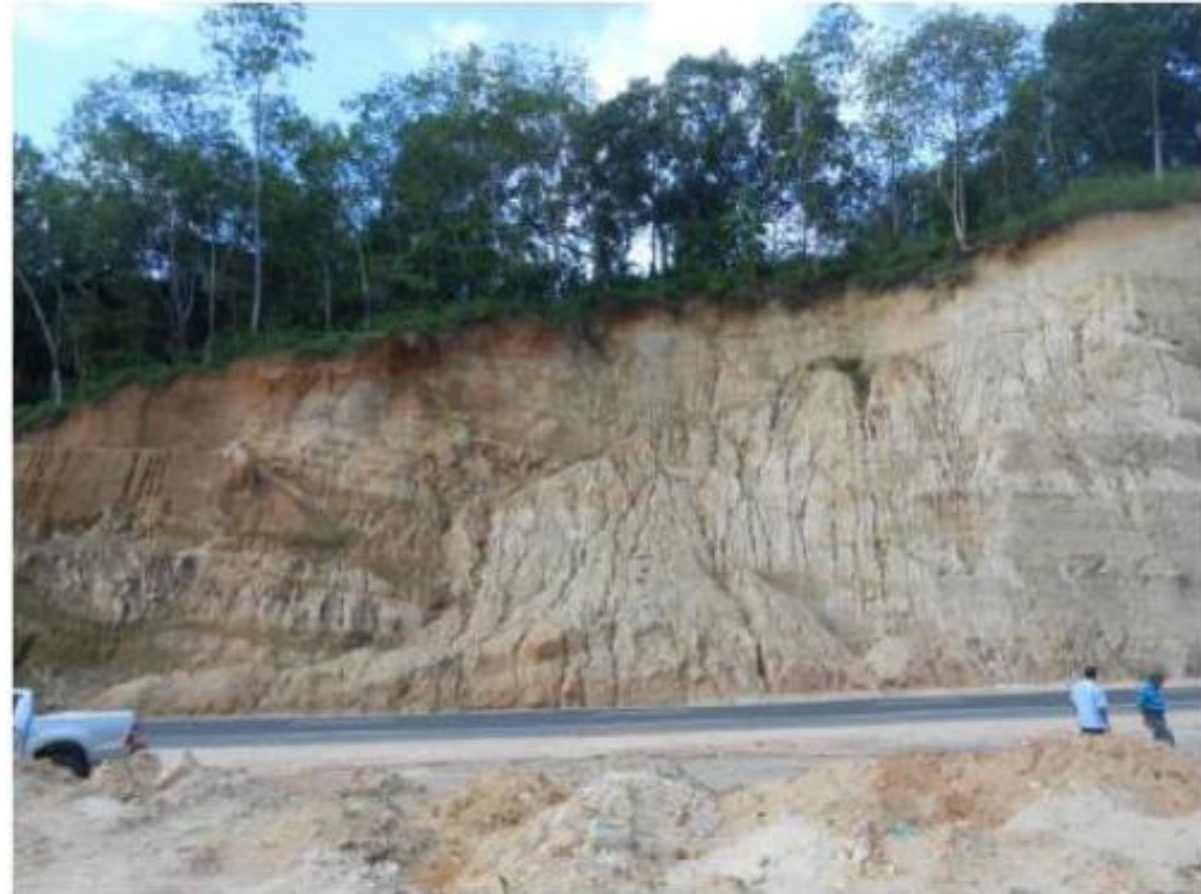
Two months later, after the rain 14-5-2014

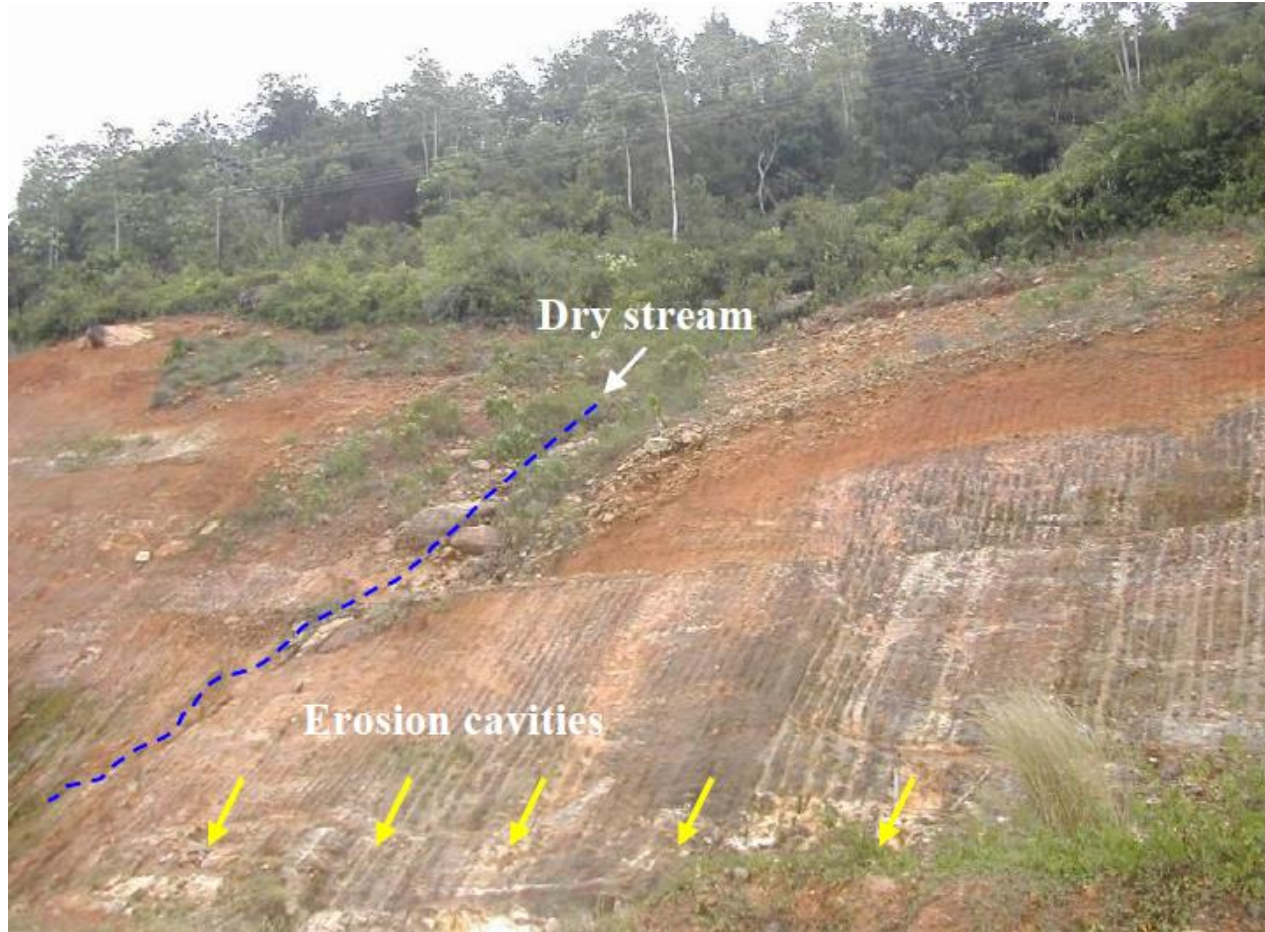
STDP Galle – Matara Section

Slope during a dry period of weather

Slope was cut but drainage measures were not implemented

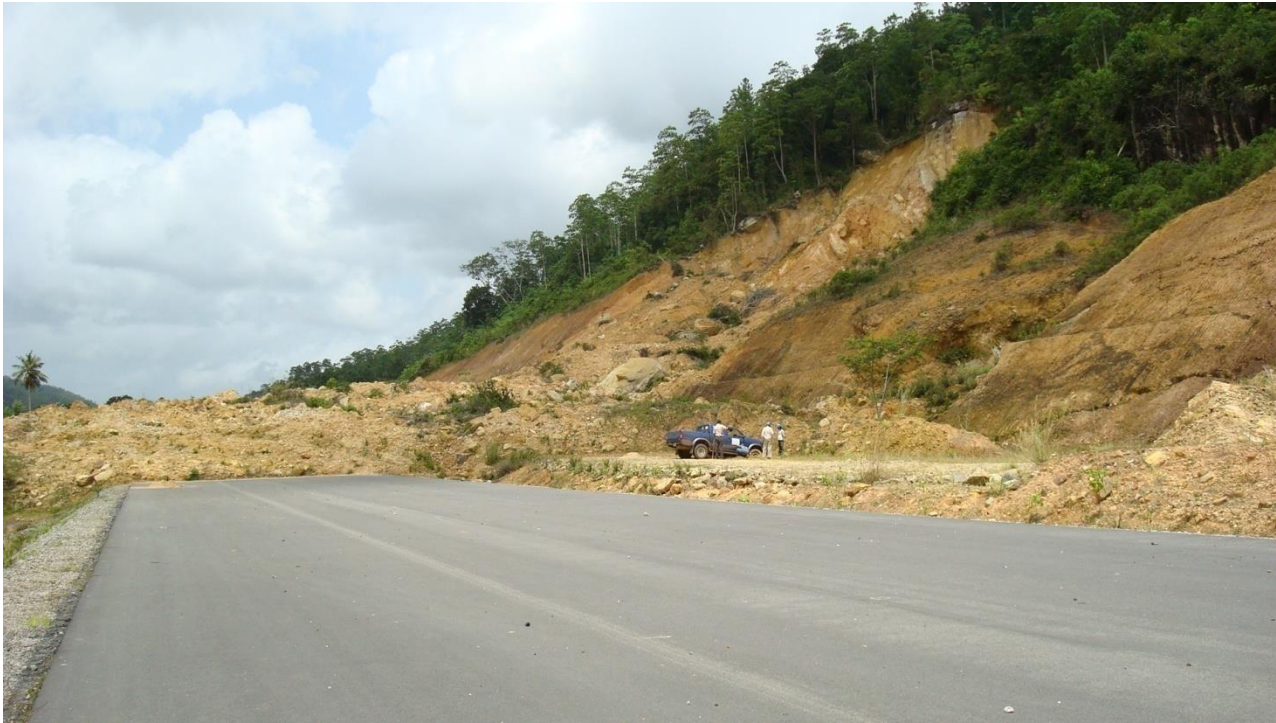
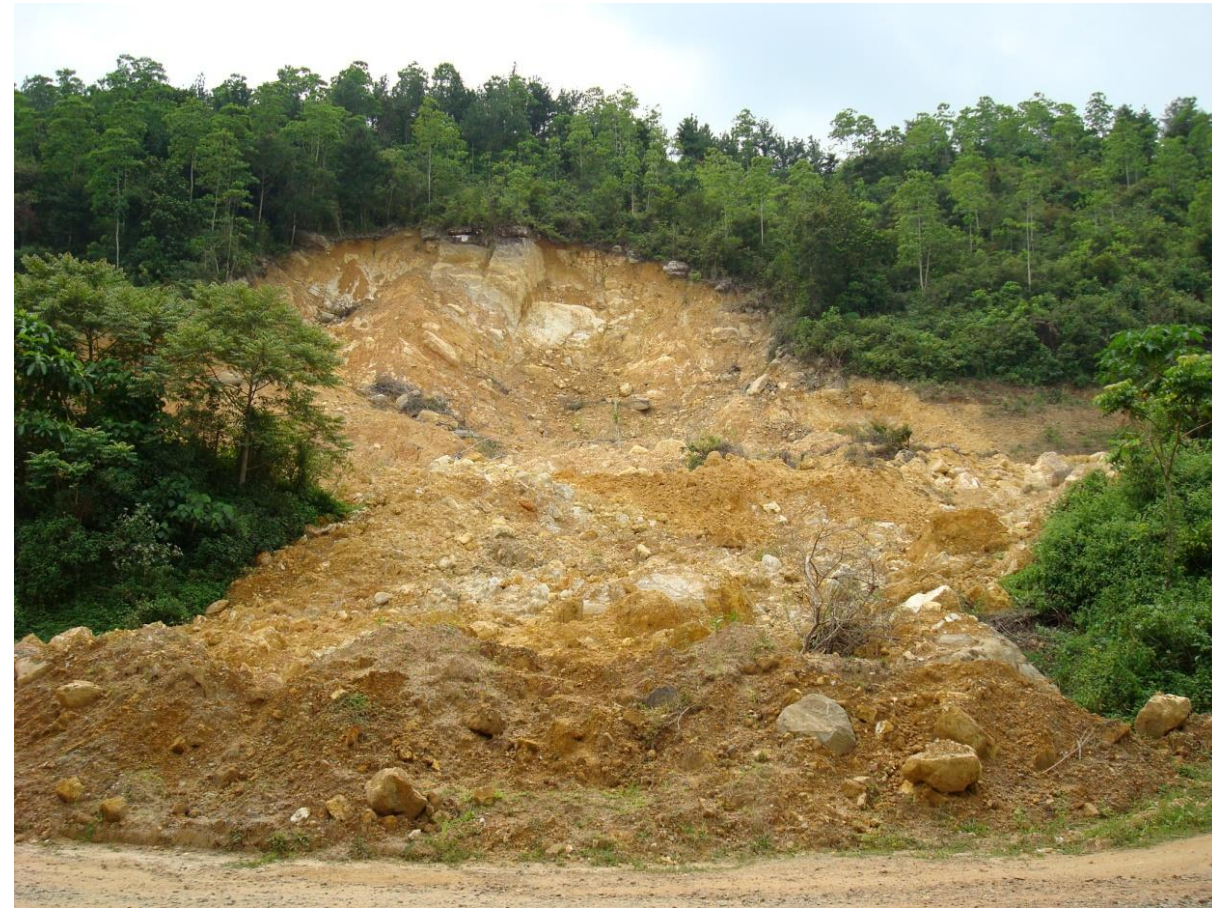
STDP Galle – Matara Section

Ended up as a catastrophic failure

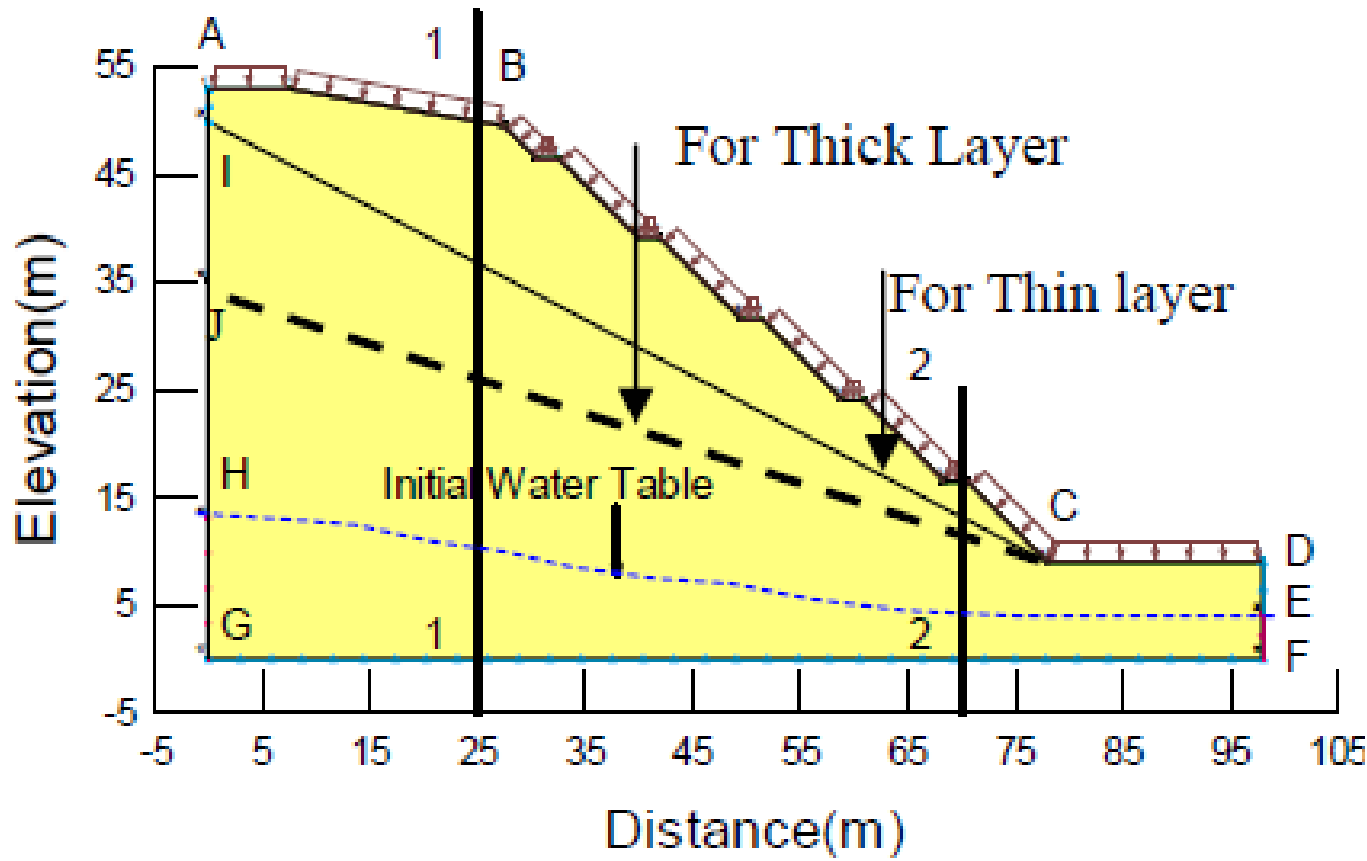
- ❖ A transient seepage analysis was done with SEEP/W software for a hypothetical slope rainfall intensities of 5mm/hr and 20mm/hr.

Boundary Conditions

AB, BC, CD = I_r (Rainfall intensity)

AH, DE, FG = $Q = 0 \text{ m}^3/\text{s}$ (No flow Boundary)

EF, GH = h_t (Total head at sides)

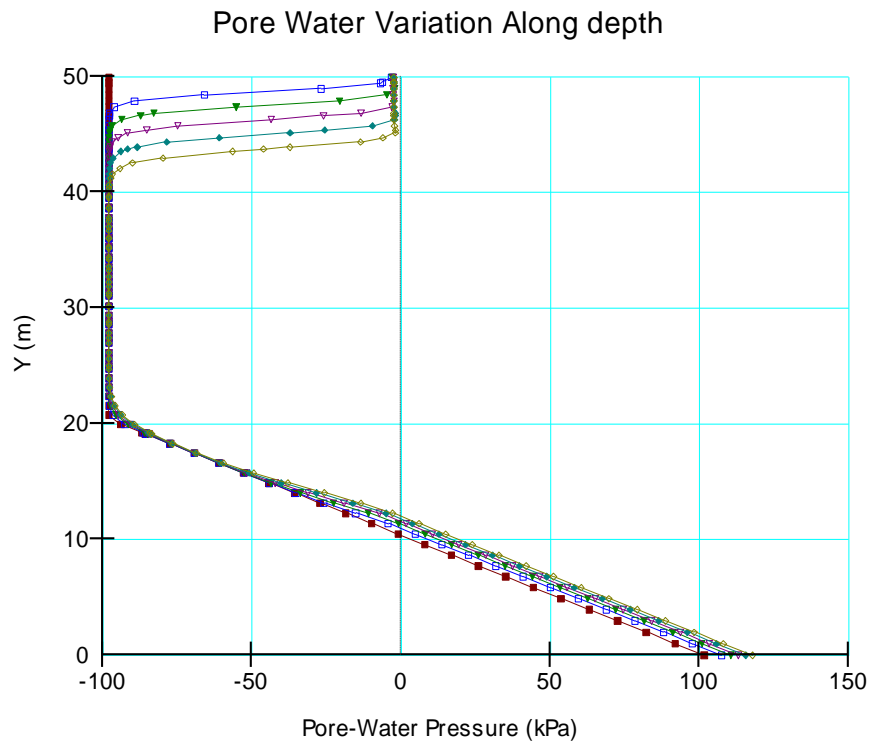
Section 1-1

- ❖ Resultant variation of pore-pressure for 5mm/hr rainfall in a uniform slope.

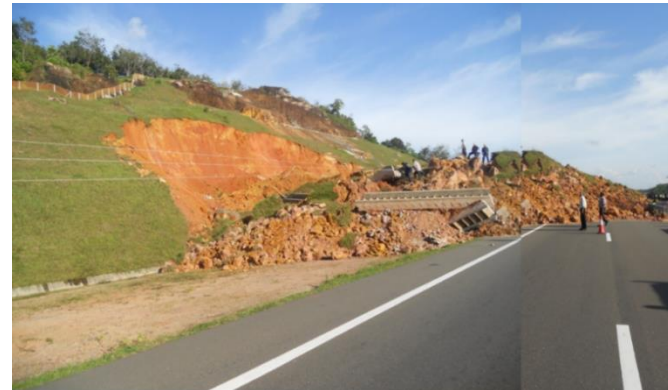
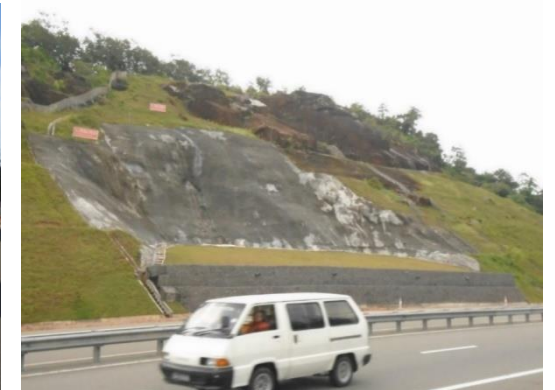
Welipenna Mitigation Measures

- ❖ Mitigation of Welipenna landslide on Southern Expressway is a very good example for landslide mitigation by combination of different measures.
- ❖ Drainage improvement, ground modification, reinforcement & toe retuning structure are used for stabilization.
- ❖ Most importantly, top down approach was followed in soil nailing. Horizontal drains are installed after grouting the soil nails to prevent cement grout coming to the horizontal drains & blocking them.

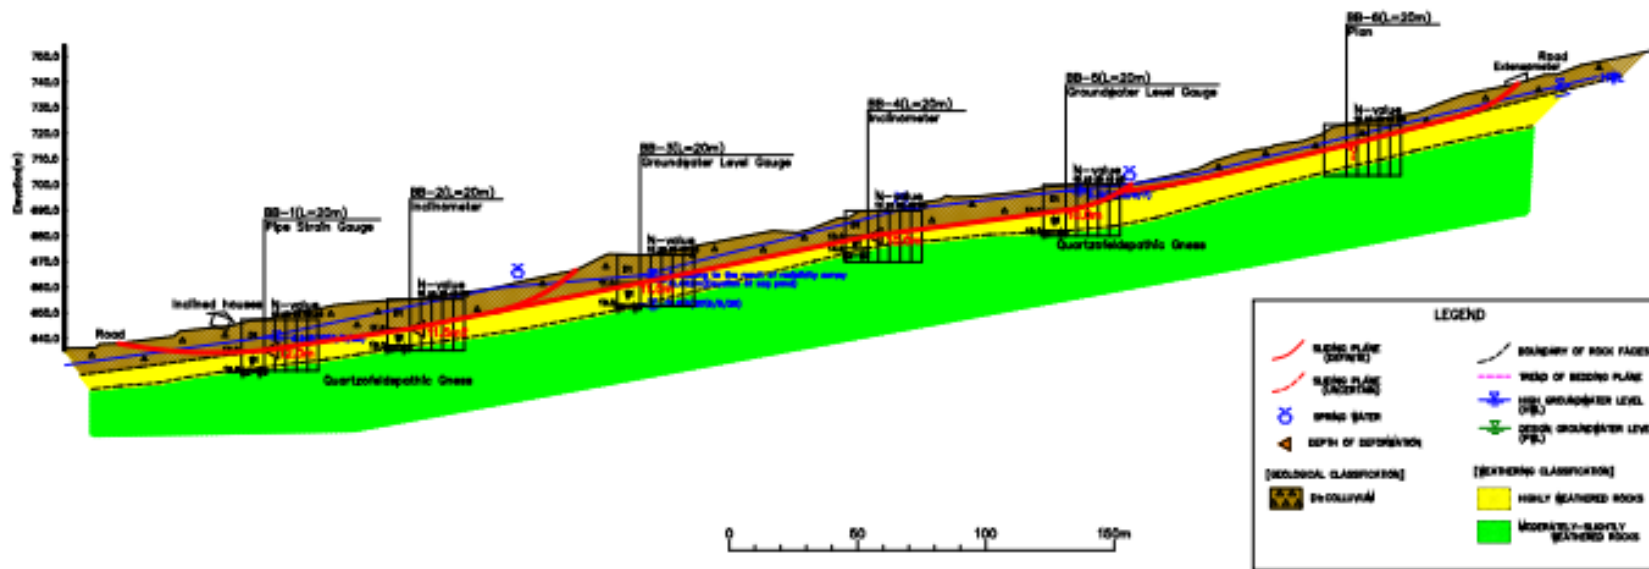
Subsoil Profile

- ❖ Landslide of long extent in colluvial soil was stabilized with surface drains and sub surface drains in radial directions at different locations (elevations)

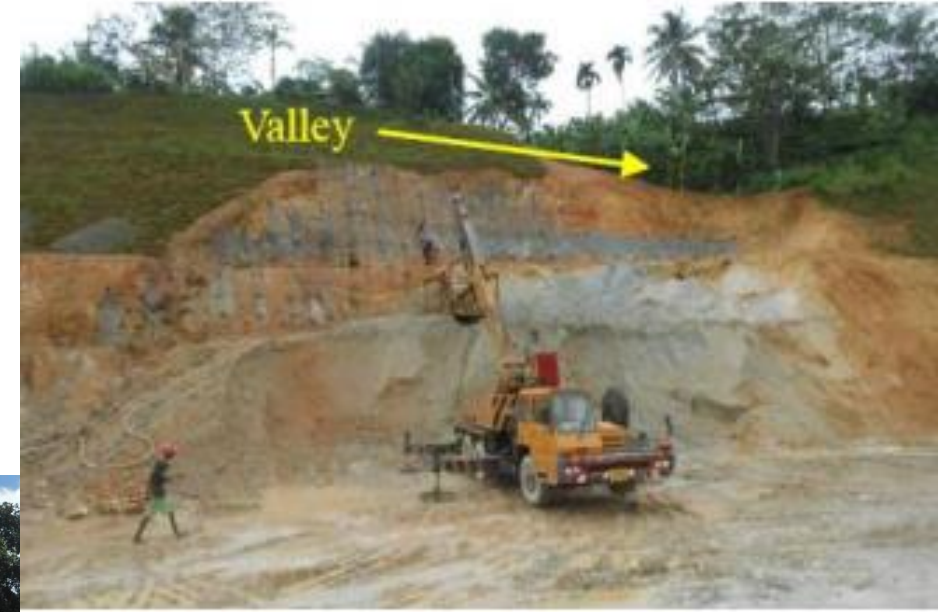
Landslide in STDP

- ❖ Stabilized with basin drain, cascade drains, subsurface drains and soil Nailing

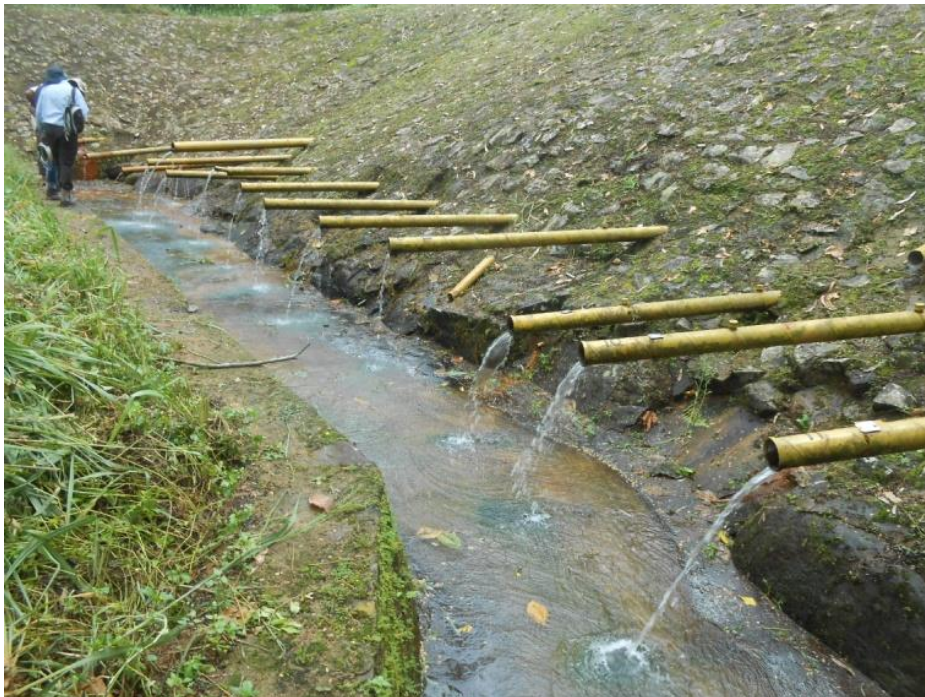
Watawala Landslide (1994)

- ❖ Stabilized with surface and sub directional drains following the failure surface

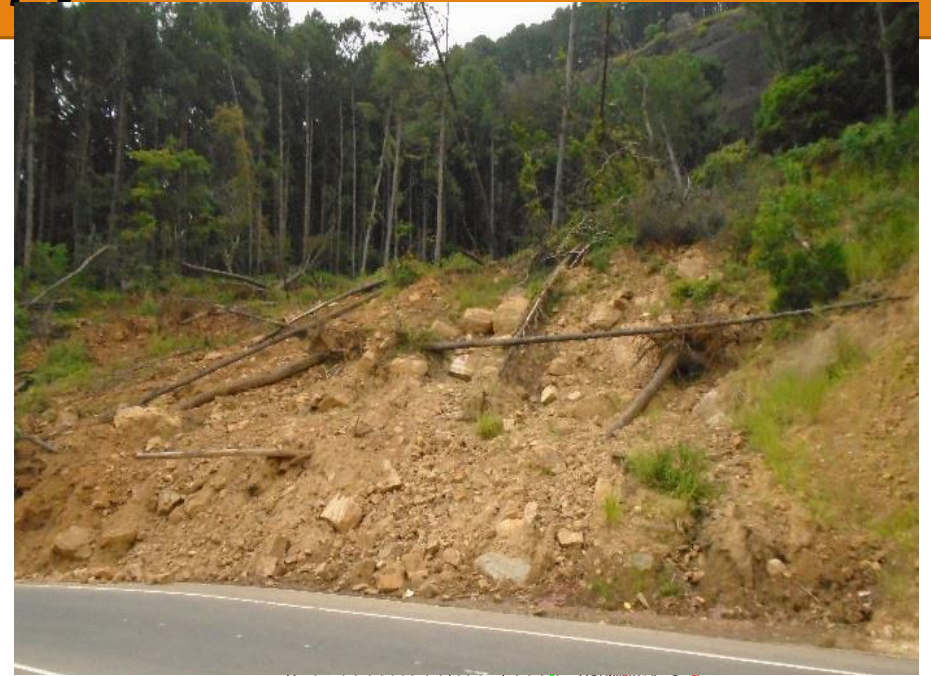
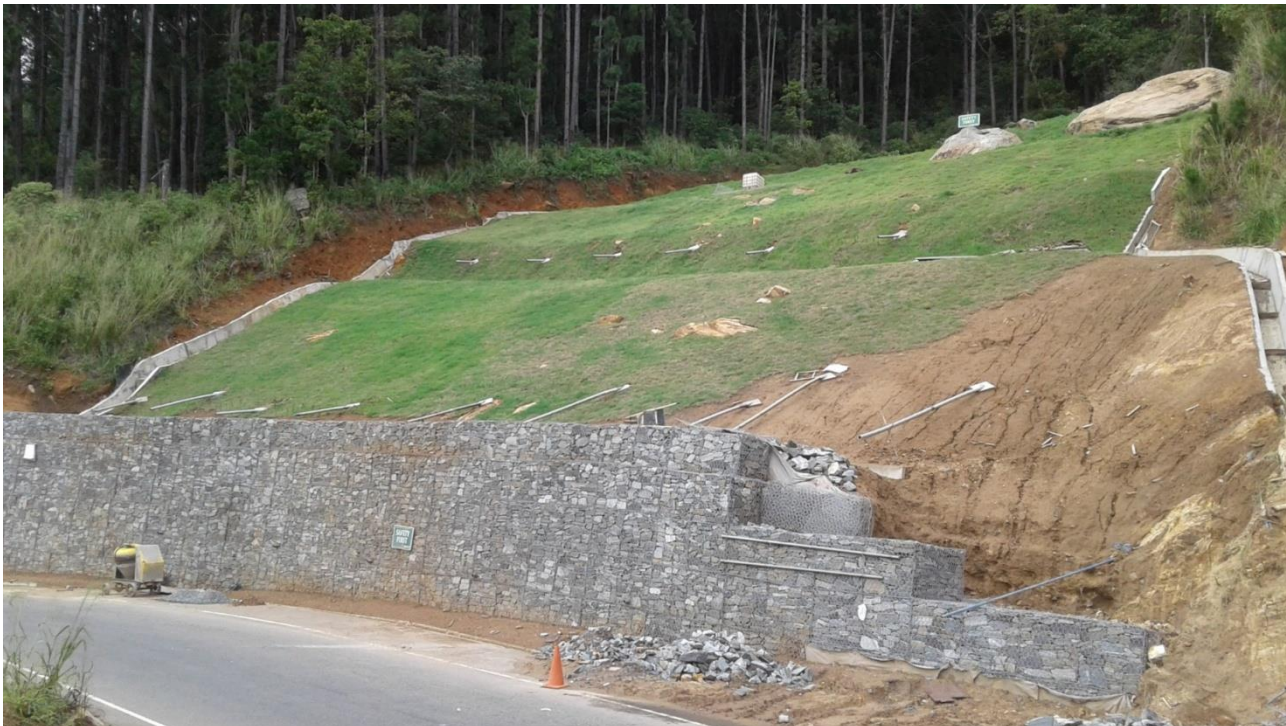
Landslide at Kandy-Mahiyangana Road

- ❖ Improved by construction of a toe retaining structure –gabion wall, making a gentle slope profile, provision of surface drains, provision of sub surface drains

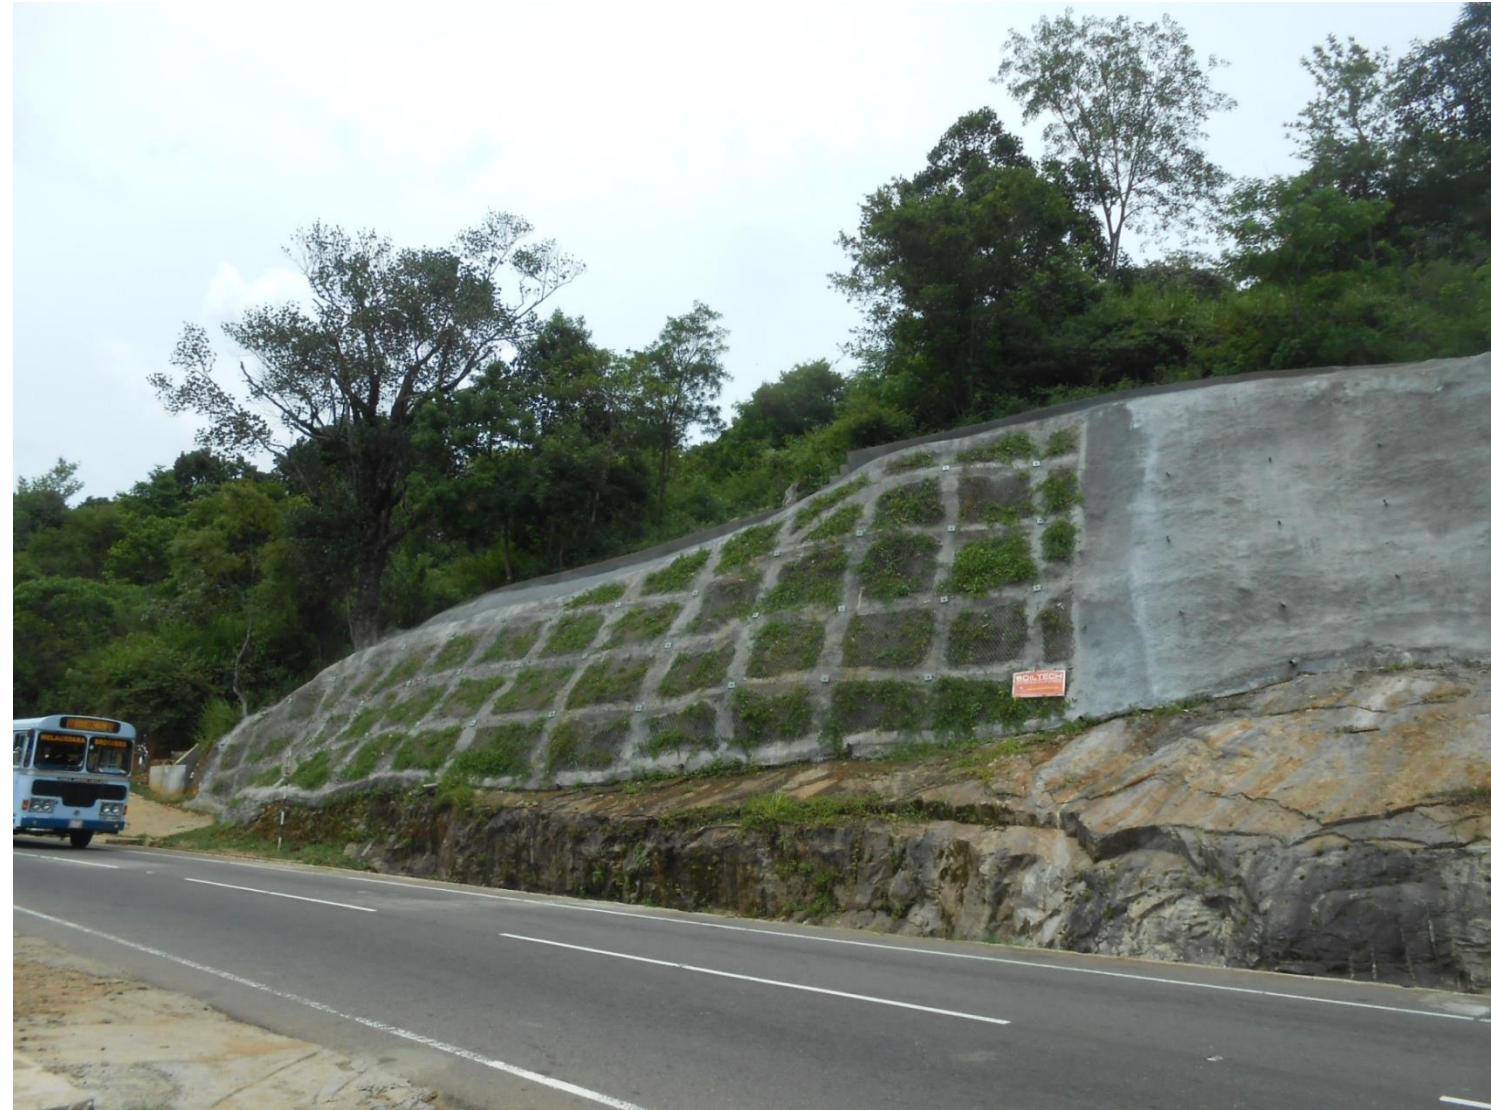
Landslide at Kandy-Mahiyangana Road

- ❖ Portion of the slope covered with shotcrete and the nail heads are connected by beams on the other part. In between the beams will be covered with hydro seeding

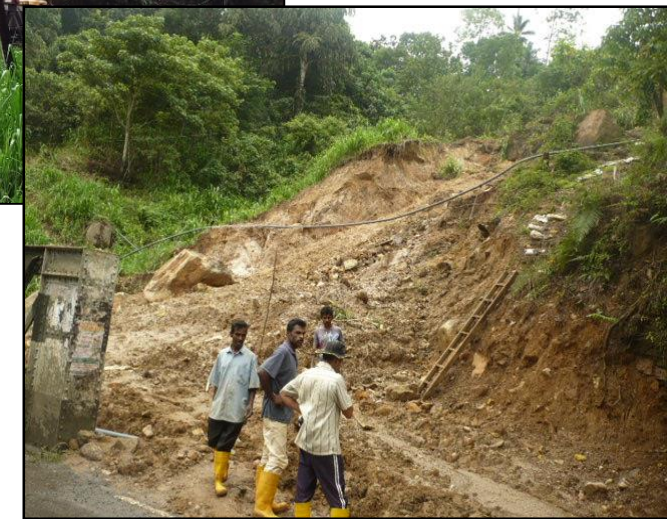
Just after the Failure

- ❖ The ancient landslide at bridge no. 48/2, near Ginigathhena area at Avissawella-Nuwara Eliya road was reactivated by some minor excavation at toe for widening of the bridge and, the failure propagated to upper slope.

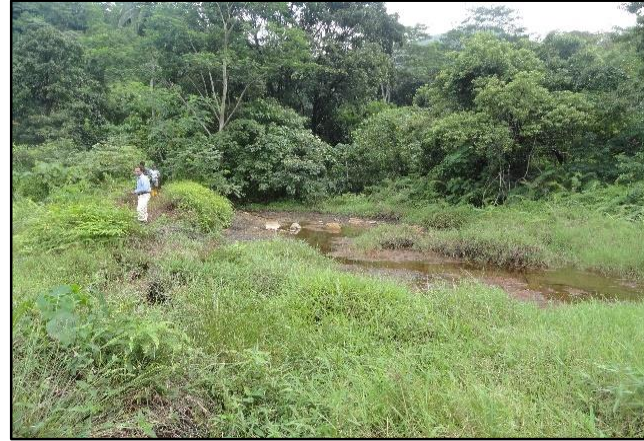
Waterlogged Marshy Area at Top

- ❖ Immediately above the activated landslide, there is a flat, water logged marshy area which can be identified as a major cause for the high ground water table prevailing in the area.
- ❖ Two major streams are flowing into this marshy area from the upper slope and finally come together to flow as one stream through the landslide area. Seepages and high yielding springs are observed in the unstable mass.

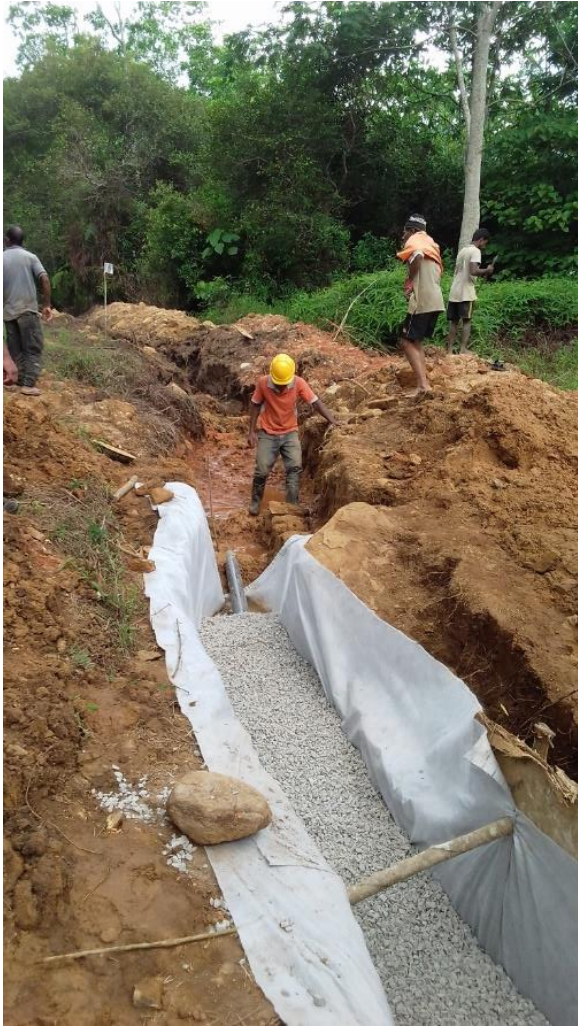
Construction of Trench Drains

- ❖ **Surface drainage improvement** was done to minimize rainwater infiltration with *Cutoff drains, Trench drains, berm drains* and *vegetation* on the excavated slope.
- ❖ **Subsurface drainage improvement** was done to dissipate pore pressures inside the landslide body by *Sub horizontal gravity drains* installed at 5 m spacing on every berm.

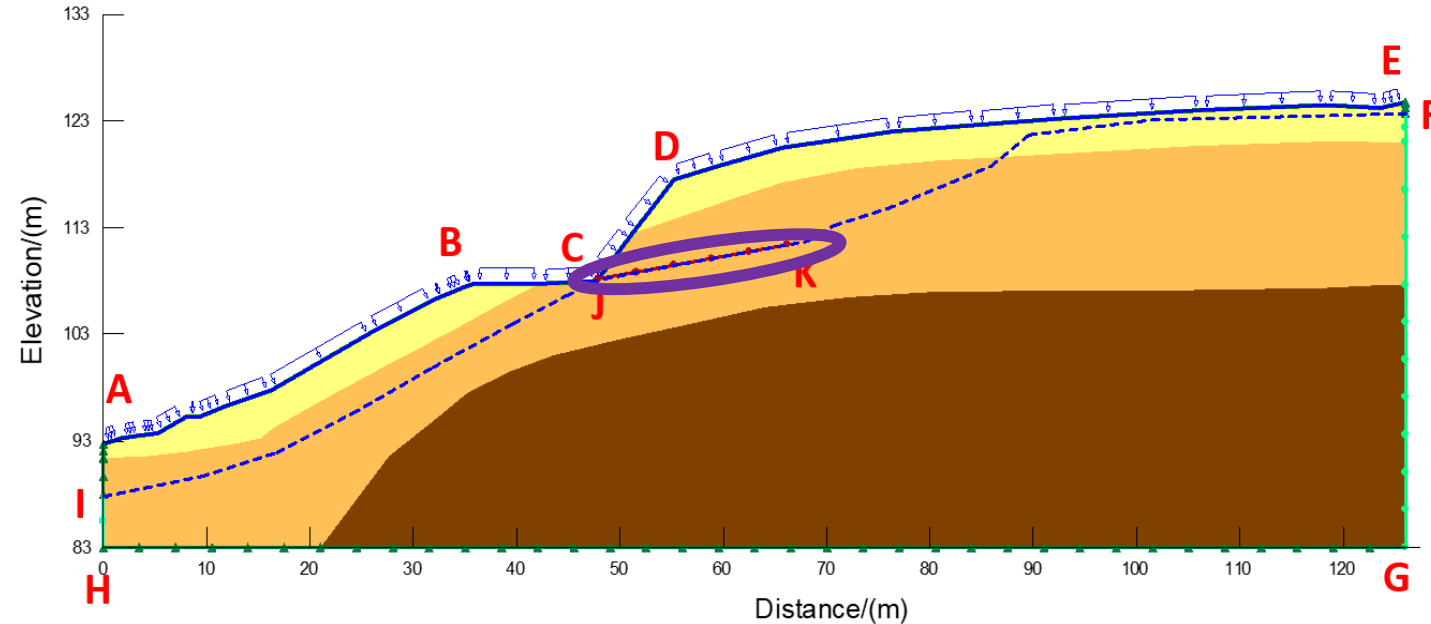
- ❖ A-B-C-D-E → Rainfall as Unit Flux
- ❖ E-F,A-I → No flow as zero Total Flux
- ❖ F-G,I-H → Total heads as Heads
- ❖ G-H → No flow as zero Total Flux
- ❖ J-K → Zero pressure
- ❖ Perforated pipes of sub horizontal gravity drains which were installed at some horizontal spacing was idealized to plain strain condition by zero pressure boundary condition applied to lines with no thickness.

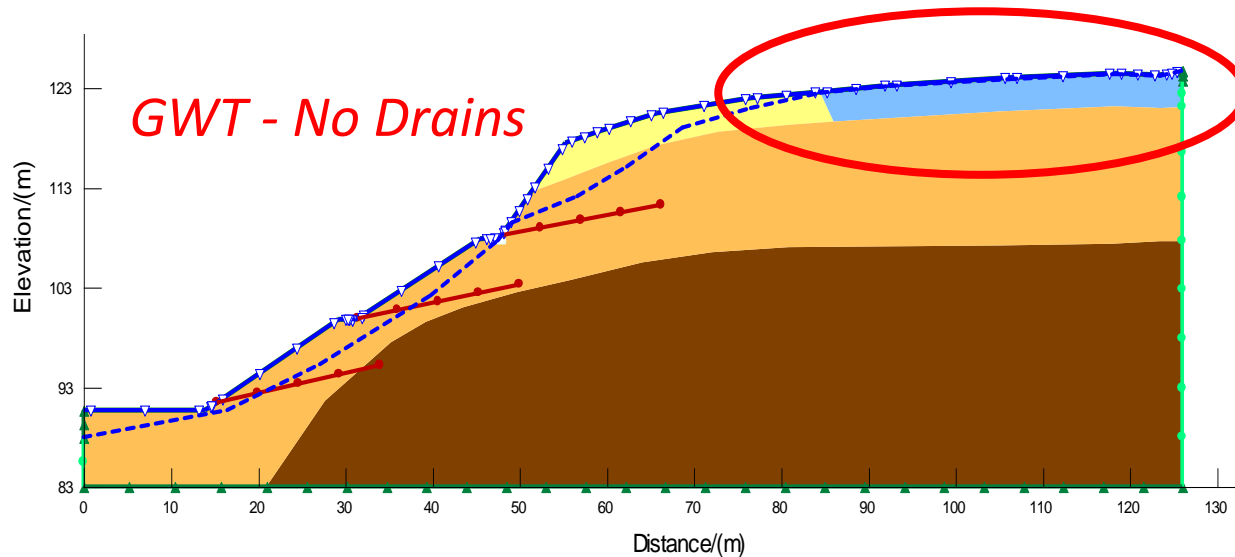
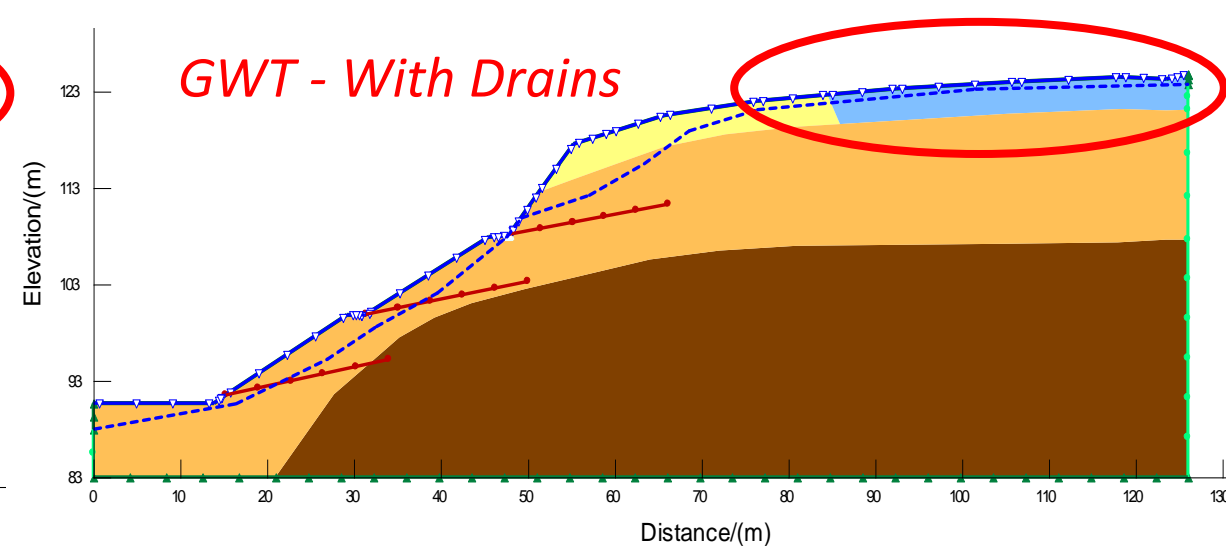
- ❖ Following alternative conditions were considered in the analysis.
 - ✓ No drainage improvement → “No Drains”
 - ✓ Surface drainage improvement → “Surface Drains”
 - ✓ Both surface and subsurface drainage improvement → “Surface & Subsurface Drains”
- ❖ Water table from investigation was taken as initial GWT.
- ❖ GWT lowering at marshy area via trench drains were modeled by lowering the initial GWT at crest area for improved drainage analysis.
