**PROCEEDINGS OF THE  
SRI LANKAN GEOTECHNICAL SOCIETY  
SEMINAR ON**

**EXPERIENCES IN TECHNIQUES OF FOUNDATION  
TREATMENT AND GROUND IMPROVEMENT**

**SEMINAR ON**  
**Experiences in Techniques of Foundation Treatment and Ground Improvement**

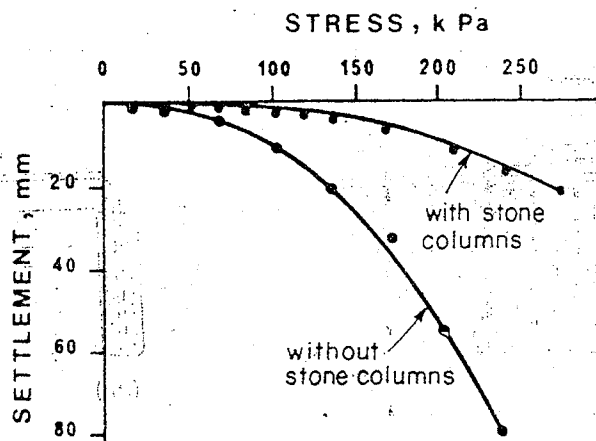
Figure 10: Effectiveness of Stone Columns - Engelhardt et al 1974

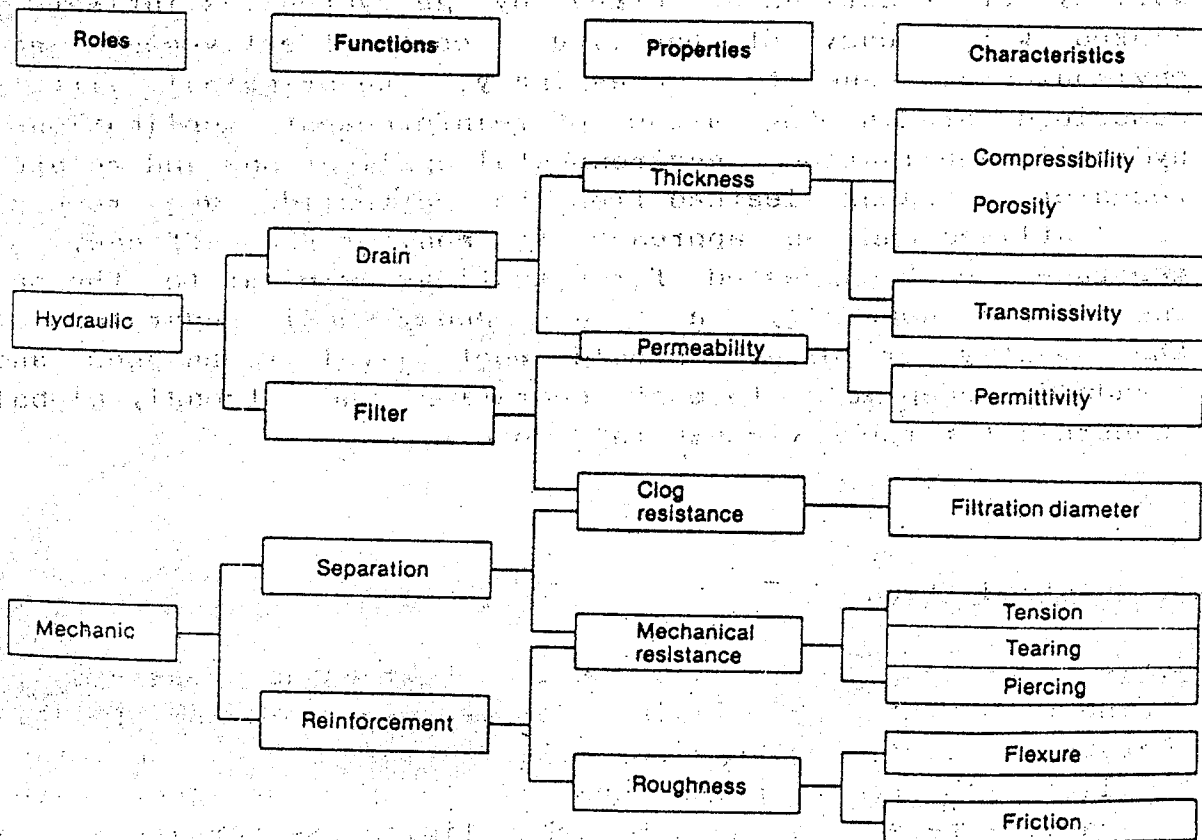
Fig. 1 : Role of properties/characteristics as related to function (after Gicot and Perfetti, 1982)

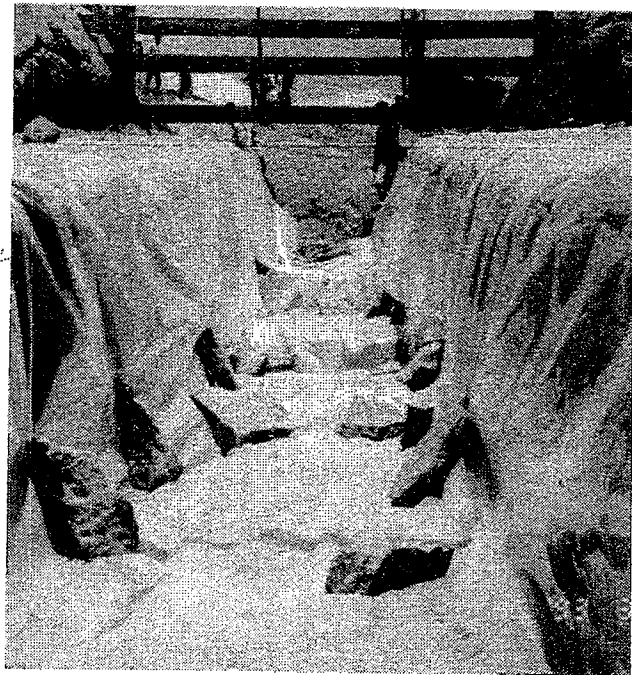
Fig 10 : Sealing of boundary shear surface and construction of trench drain using geosynthetics as an interim control measures.
