**EFFECT OF RECTIFICATION MEASURES IN
KAHAGOLLA LANDSIDE –COMPARISON OF
MONITORING AND ANALYTICAL DATA**

University of Moratuwa

Thesis/Dissertation submitted in partial fulfillment of the requirements for the degree
of Master of Engineering in Geotechnical Engineering

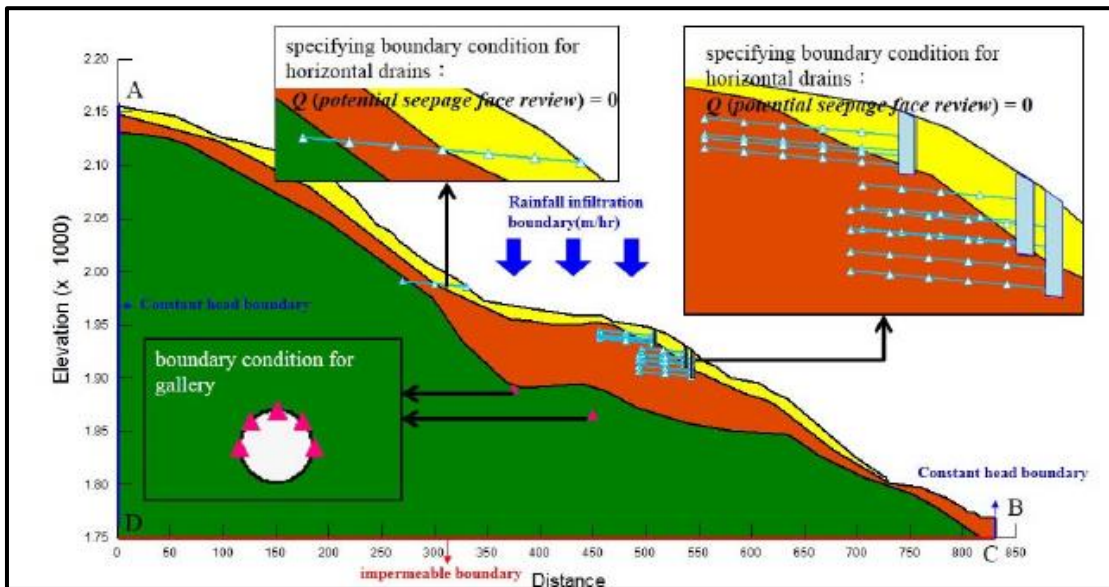
Figure 2.8 : Boundary Conditions Applied to Model to Represent the Rectification Measures

However, this boundary condition removes the water from the system at the applied location. Therefore, applying of boundary conditions available in some software are a bit suspicious when it compares with actual site conditions, which would rather persuade the user to model with a different technique or strategy. Above figure 2.8 represents the boundary conditions applied for a model of rectified landslide in Taiwan.

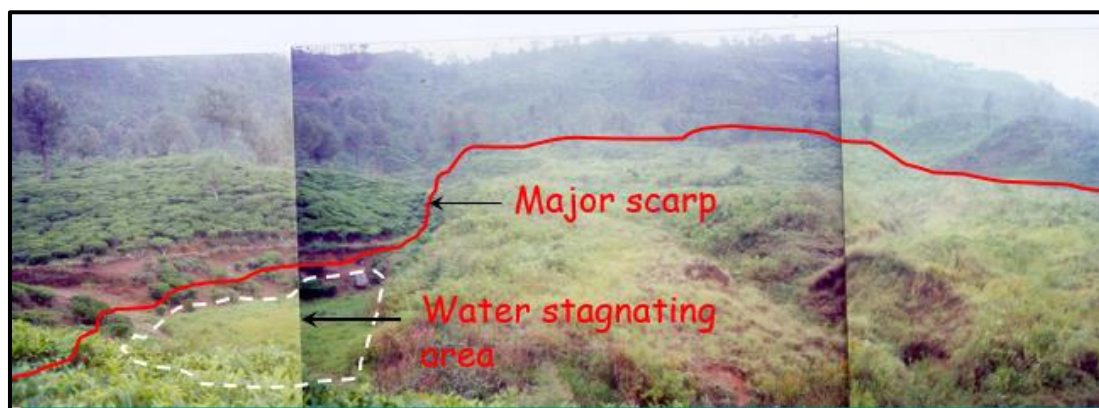
Figure 3.1: Unstable Features of Old Landslide

Thereafter, the affected slope crept at different locations in wet seasons. It was observed that these creep movements appearing towards north- west direction, because of debris deposited from a past landslide was accumulated in this area. The tea estate was destabilized and destroyed with appearing of tension cracks, scars, lumps indicating clear signs of many slip surfaces around the area as shown in figure 3.1.

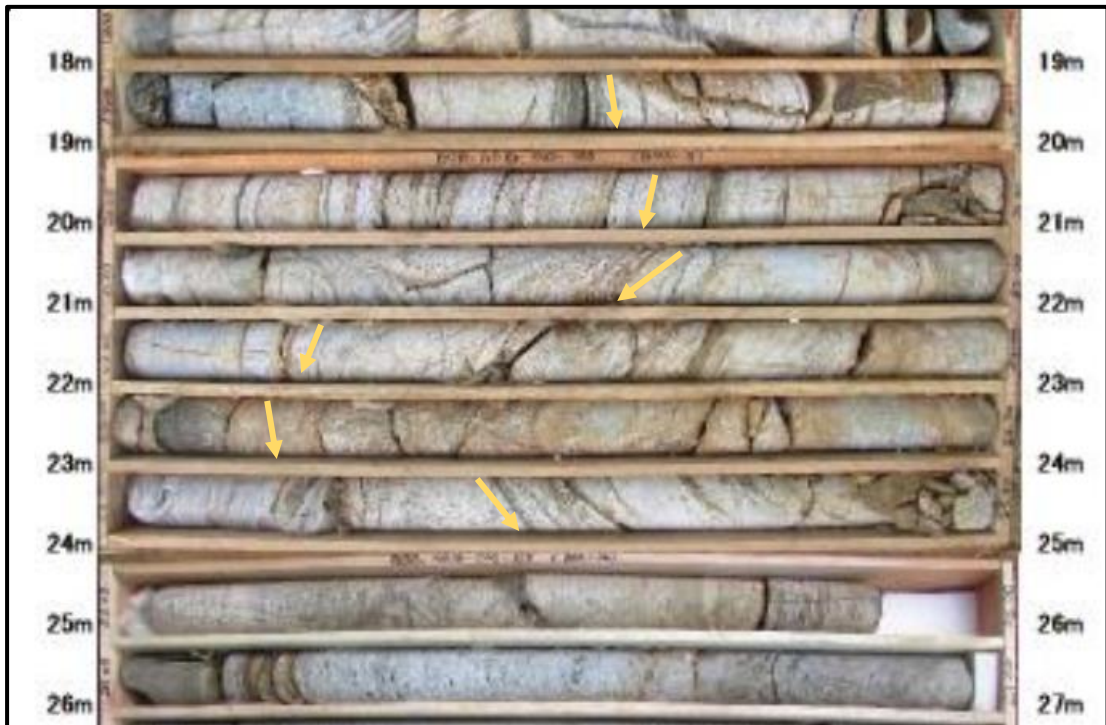
Figure 3.5: Folds in the core samples collected from bore hole no.5

variations in the geological structure with minor folding. The figure 3.5 illustrates such minor folding found within borehole no.5.

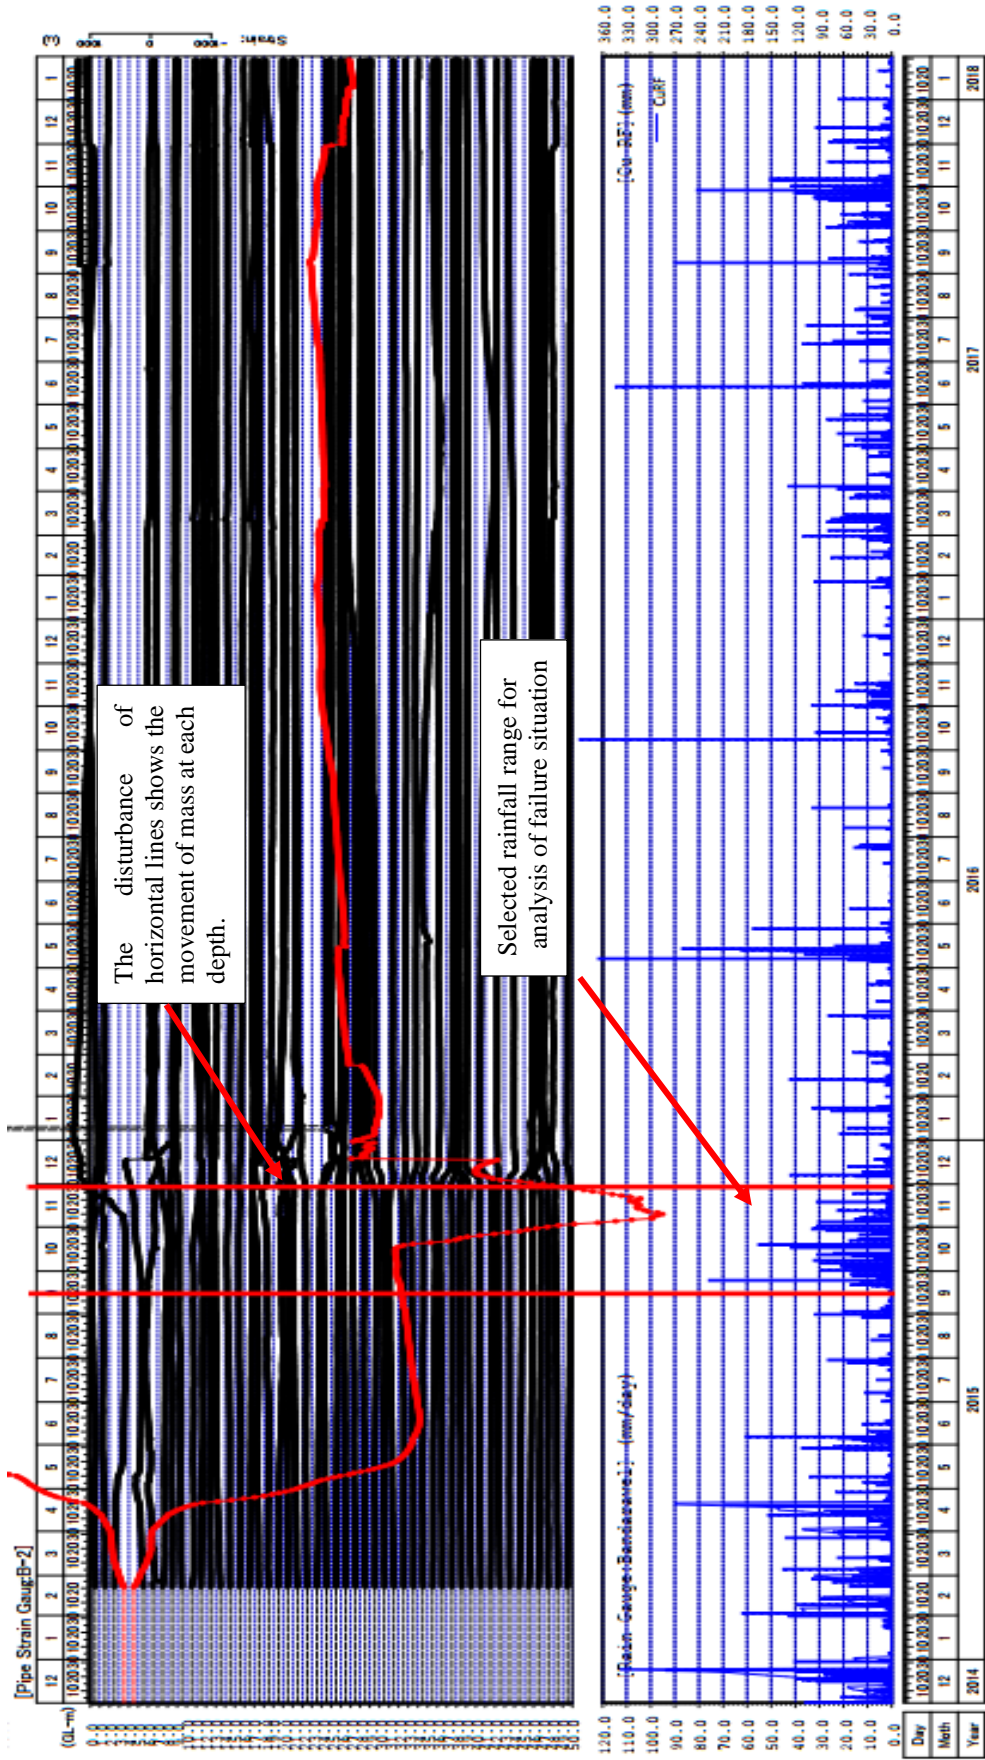
Figure 3.9 :Displacement recorded in Pipe strain gauge at B2 (Planveivin figure 3.3)

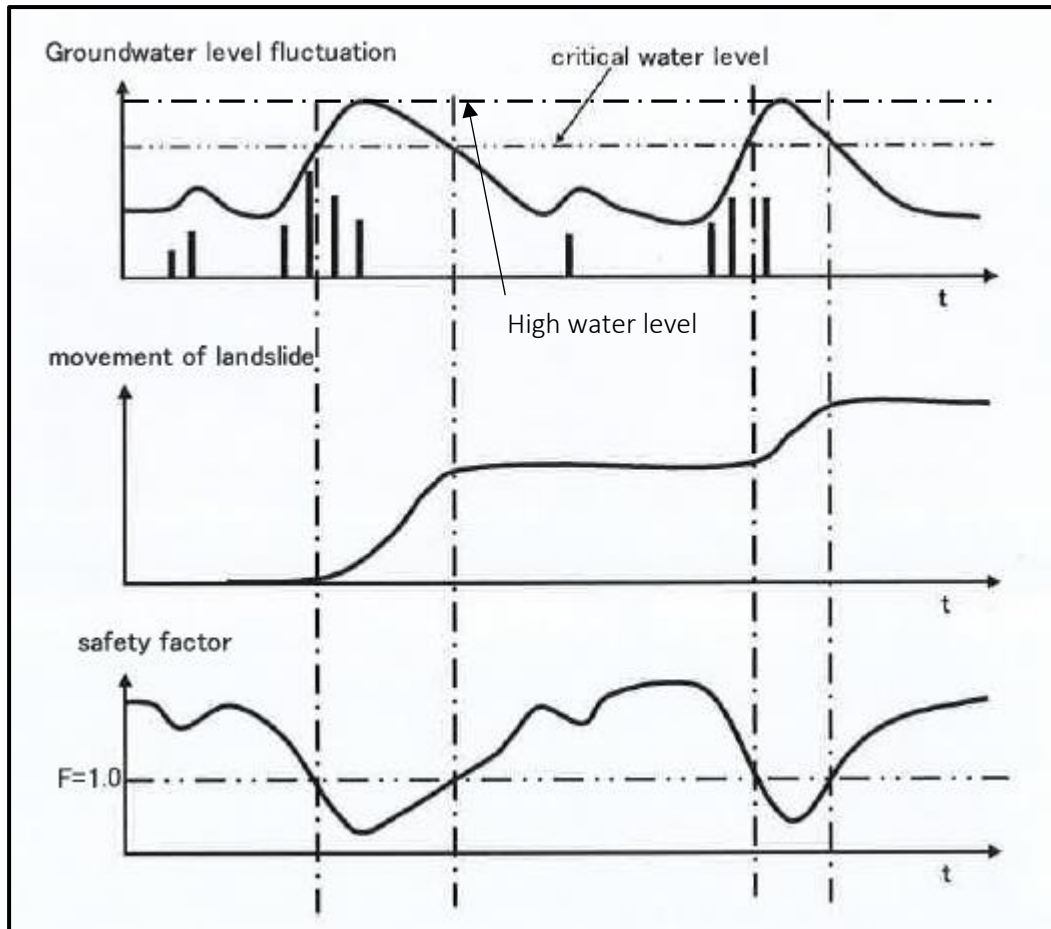
Figure 4.1: Changes of the ground water level affect the movements of mass and change the factor of safety (Source: Oriental Consultants, 2016)

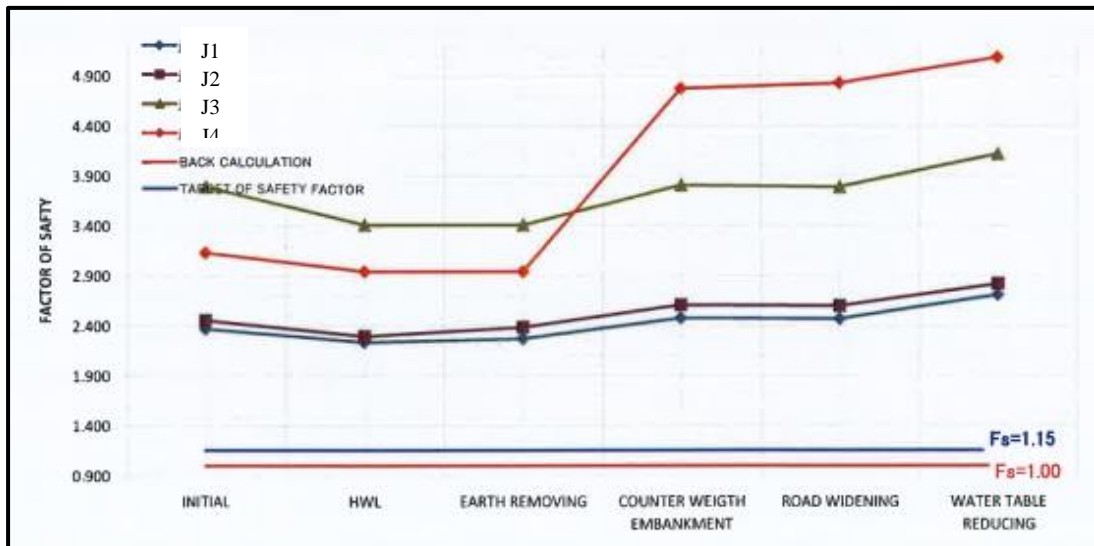
Figure 4.2: Factor of safety values obtained for each stage, each slip surface for block sampling (Source: Oriental Consultants, 2016)

showed values more than 1, indicating results obtained from the analysis are not consistent with the data obtained from landslide deformation monitoring. Figure 4.2 illustrates the obtained unrealistic factor of safety values for corresponding high shear strength values and for all slip surfaces.

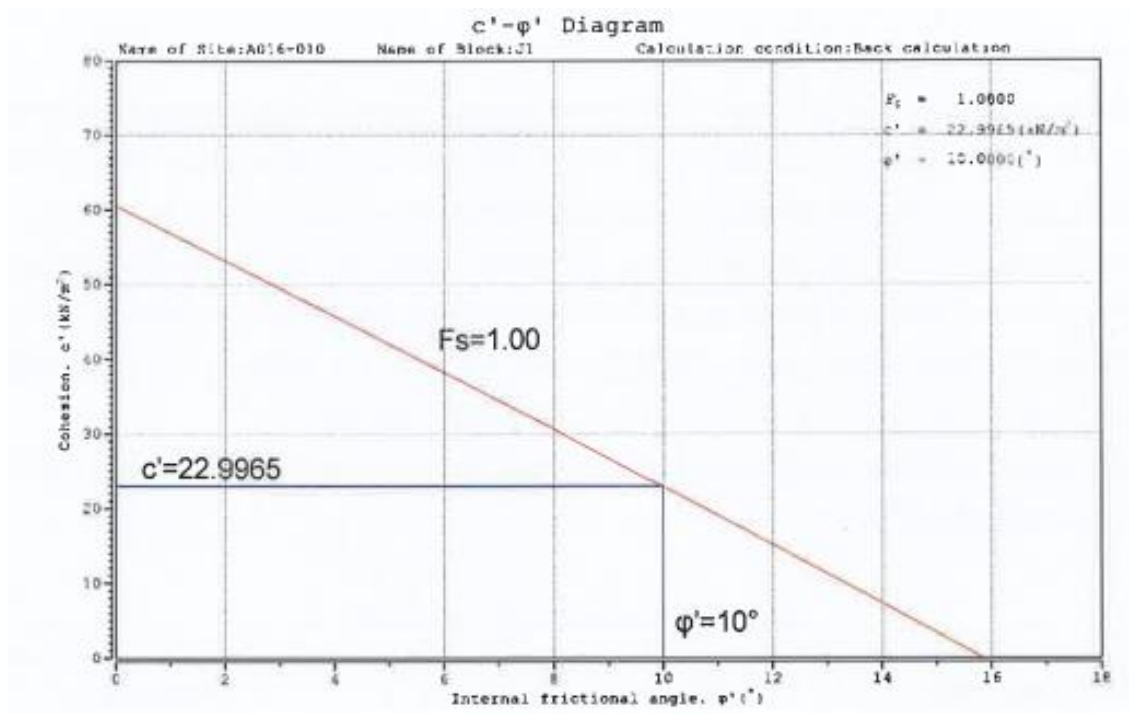
Figure 4.3: Back calculation for stability analysis (slip surface J1)
Source: (Oriental Consultants, 2016)

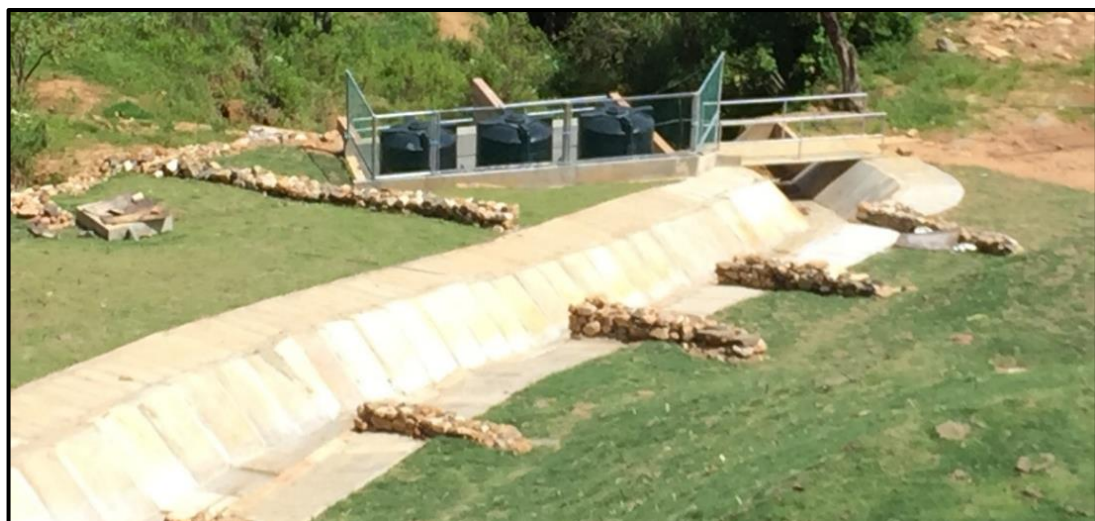
Figure 4.6: Outlet of Surface drainage system (A2 in figure 4.3)

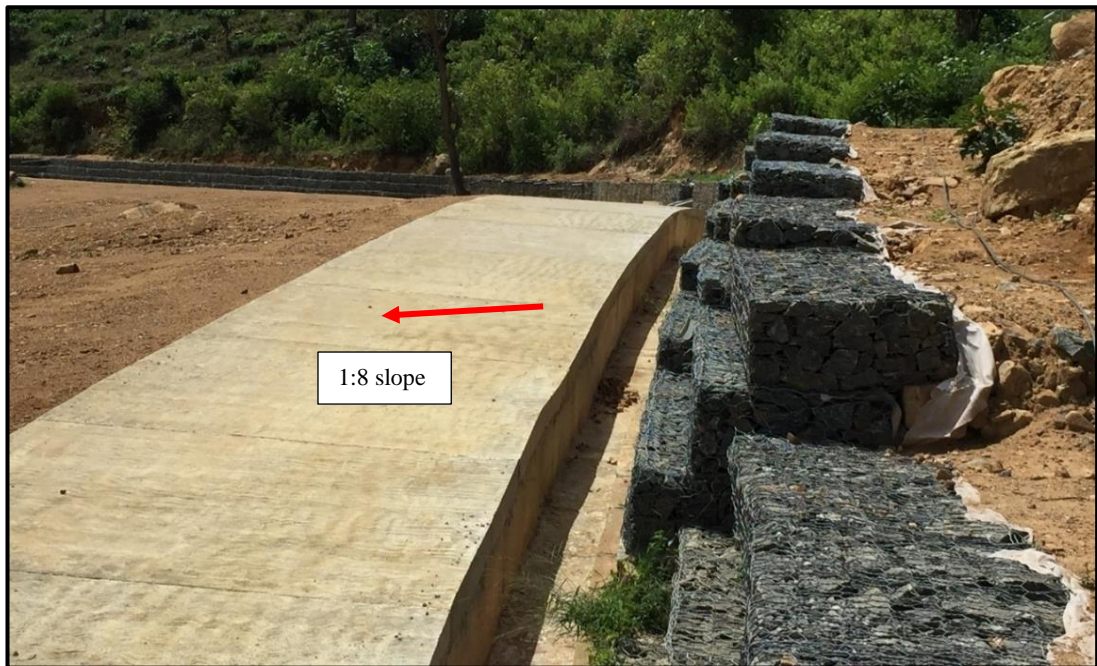
Figure 4.7: Earth removal and slope protection at the Landslide upper area (D4, D5, E4, E5 in figure 4.3)

Earth removal work was carried out at the upper region of the landslide to reduce the driving force, thereby improving the stability of the landslide. 1:8 mild slope was maintained at cut slope. Figure 4.7 and 4.8 illustrate the earth removal area with a sudden change of slope.

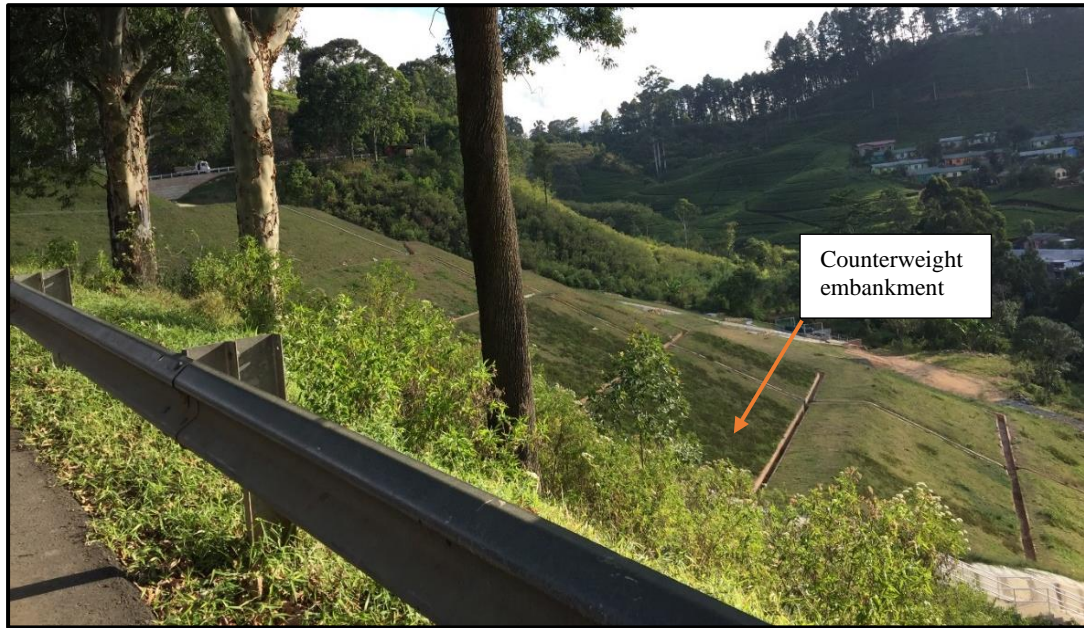
Figure 4.9: Counterweight embankment work at the landslide toe area
(B1, B2 in figure 4.3)

An embankment at the toe area of the slope was constructed to increase the resistant force by filling the earth. 1:2 filling slope was maintained with a 3m width berm at every 10m distance. Drainage inside the filling was improved with gravel drains. The counterweight embankment after the construction is shown in figure 4.9 and 4.10.

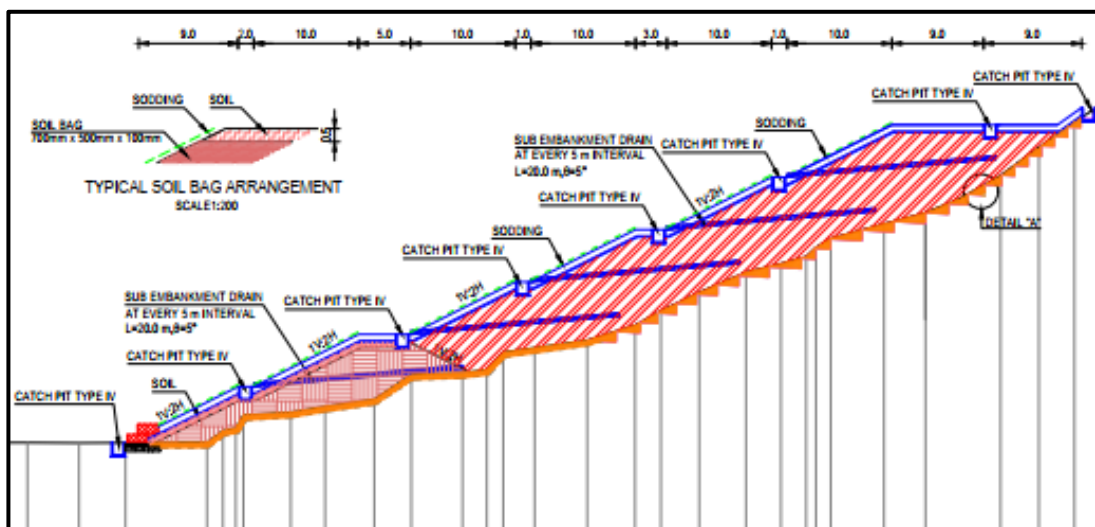
Figure 4.10: Typical cross section of Counterweight Embankment works

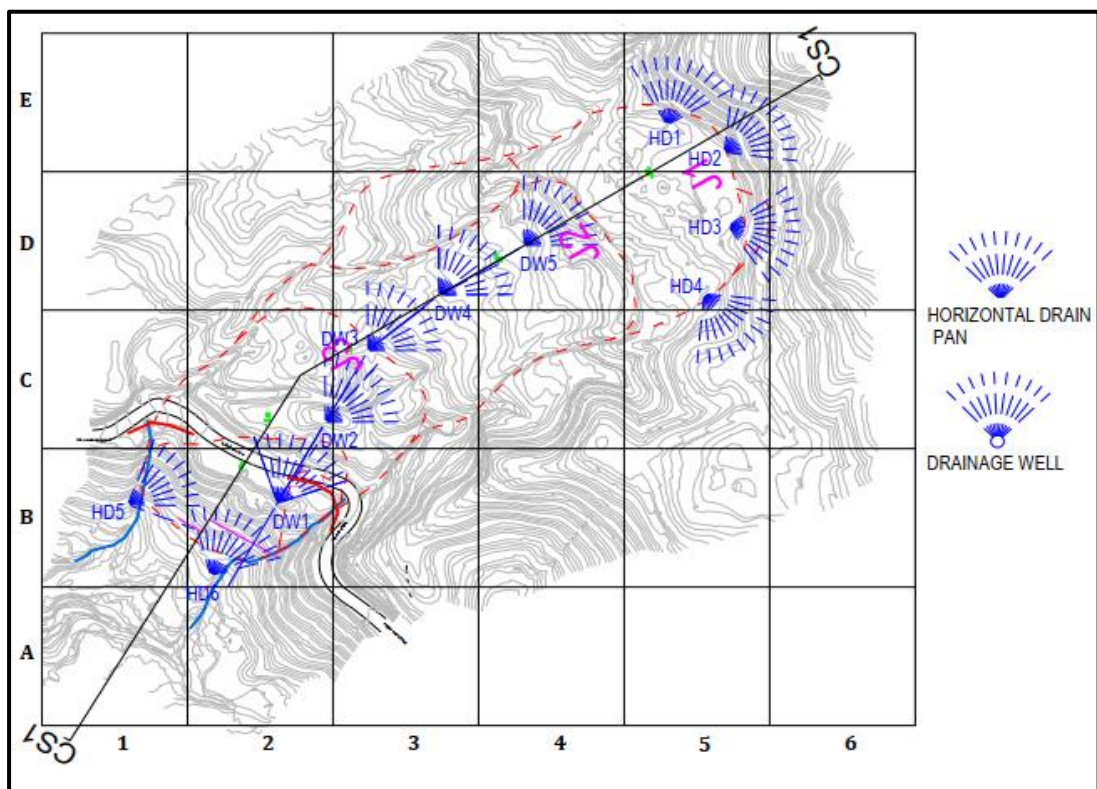
Figure 4.11: Plan view of the ground water control works

Fan type Horizontal drains were selected to lower the groundwater table effectively in narrow and long landslide. Each fan has 10 pipes in 50m length. Four fans were constructed at the crown area of the landslide while the other five constructed inside the landslide. These drains were installed at 12m deep inside the drainage wells. Every fan was constructed close to the slip surface. The expected drawdown of the water table is 3m from the highest water level that occurred at the site. Figure 4.11 and 4.12 illustrates the plan view of constructed ground water drainage work and the horizontal drains (HD 1 to HD 6) located at the toe area.

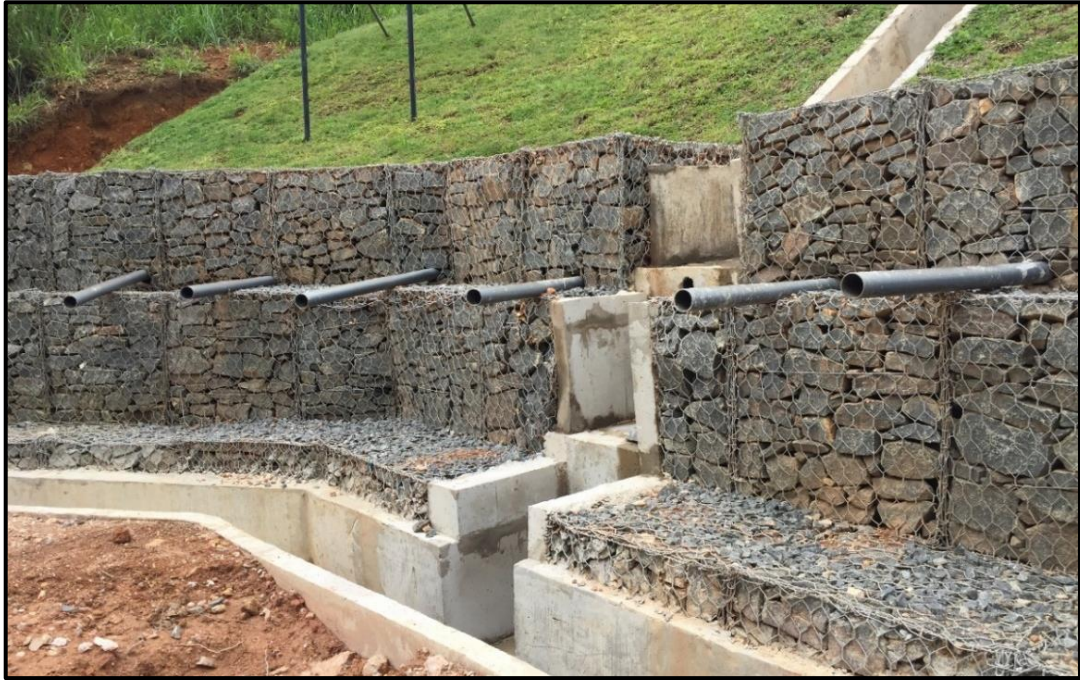
Figure 4.12: Horizontal drain outlets at toe area (B1, B2 in figure 4.9)

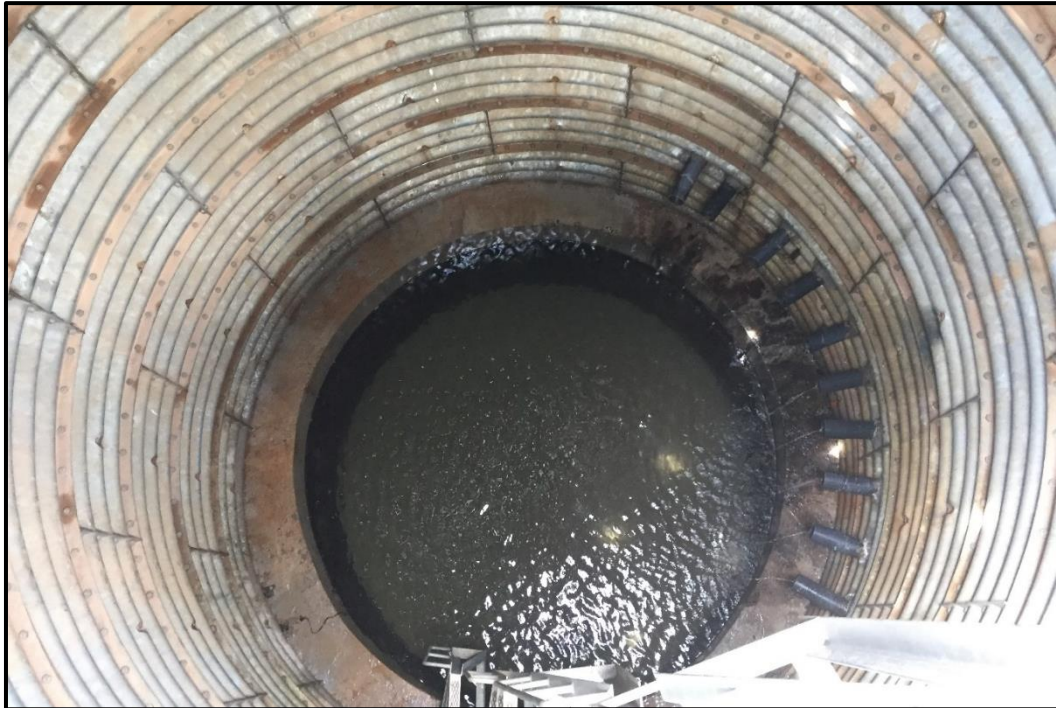
Figure 4.13 : Inside a drainage well (B2, C2, C3, D3, D4 in figure 4.9)

Five drainage wells (DW1 to DW 5) were constructed inside the landslide body to collect the groundwater from horizontal drains and themselves. The diameter of a well was 3.5m and made with steel lining plates. All wells were connected with discharge pipes at the bottom of the well. The whole system is supposed to work under gravity and pressure. The lowest drainage well collects all the water coming from the other wells and discharges it at the toe of the landslide. These wells were designed above the slip surface. The inside the drainage well after the construction and the typical cross section of the well are shown in figure 4.13 and 4.14.

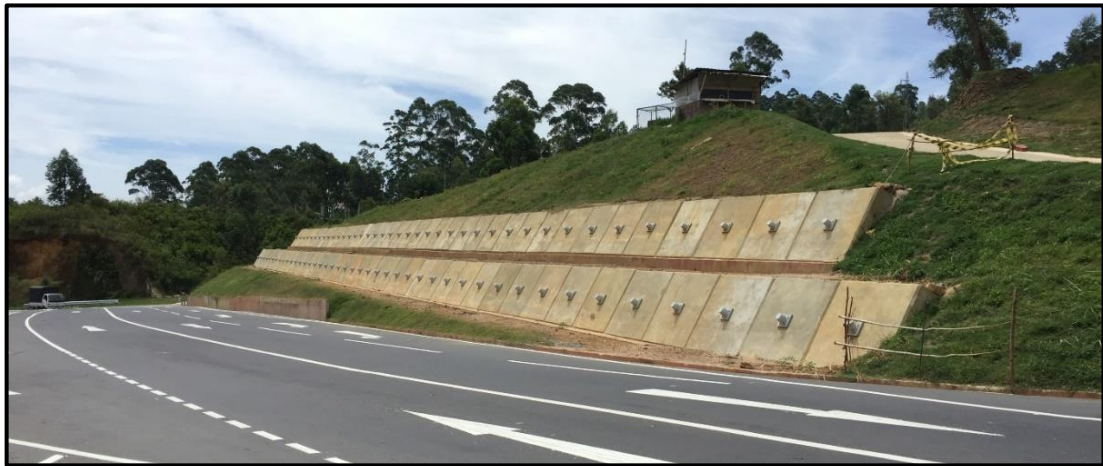
Figure 4.15 : Ground anchor beside the road (C2, B2, B3 in figure 4.8)

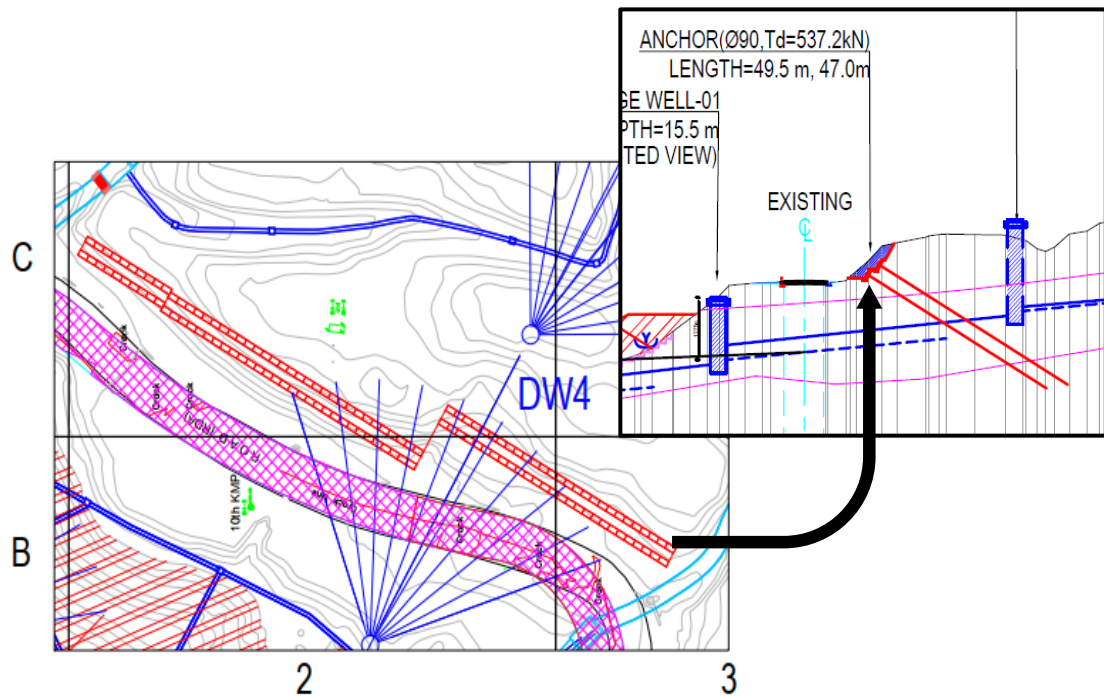
Figure 4.16: Plan view and cross section of ground anchor arrangement

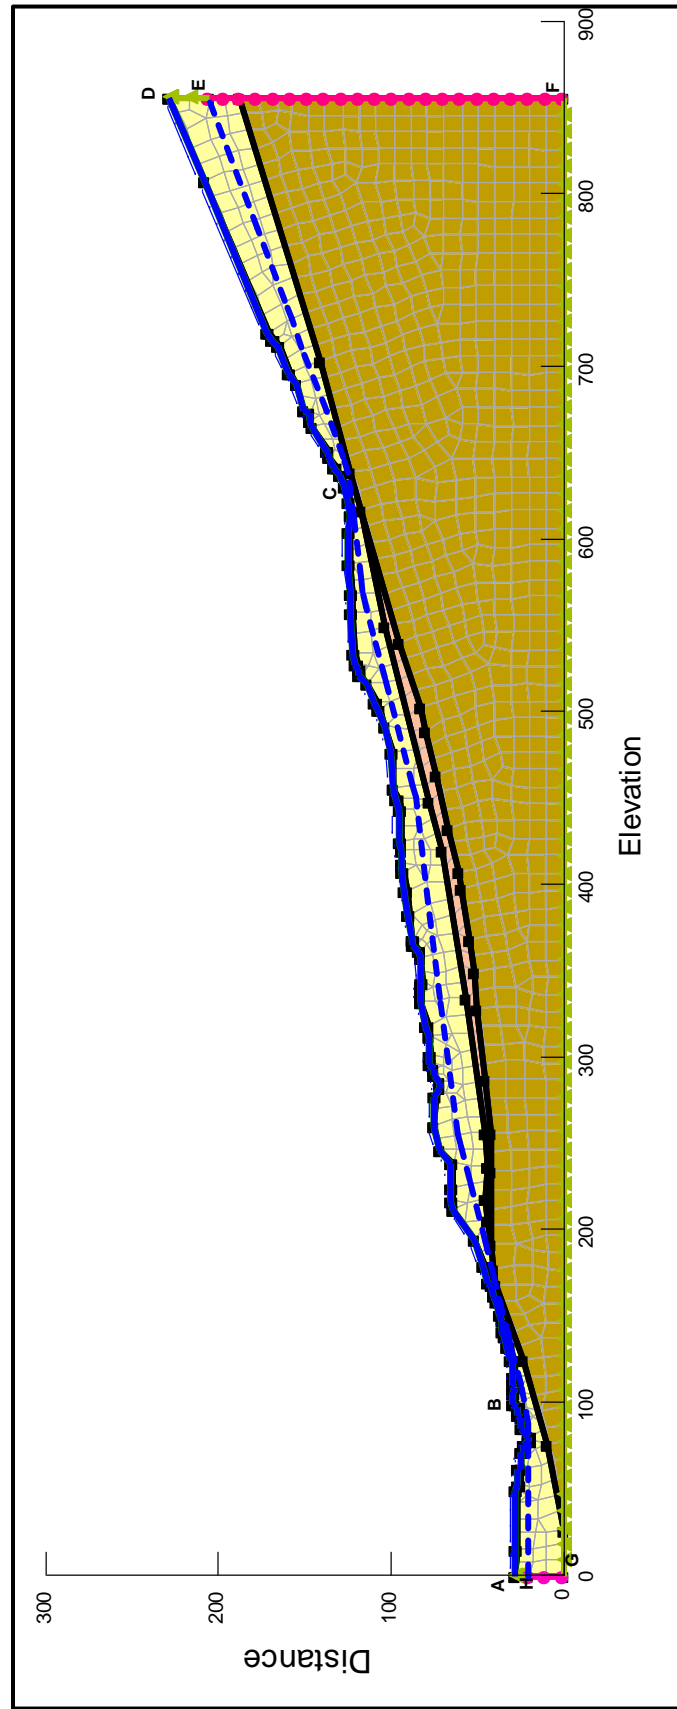
Figure 5.2: Boundary conditions applied to the profile along CS1

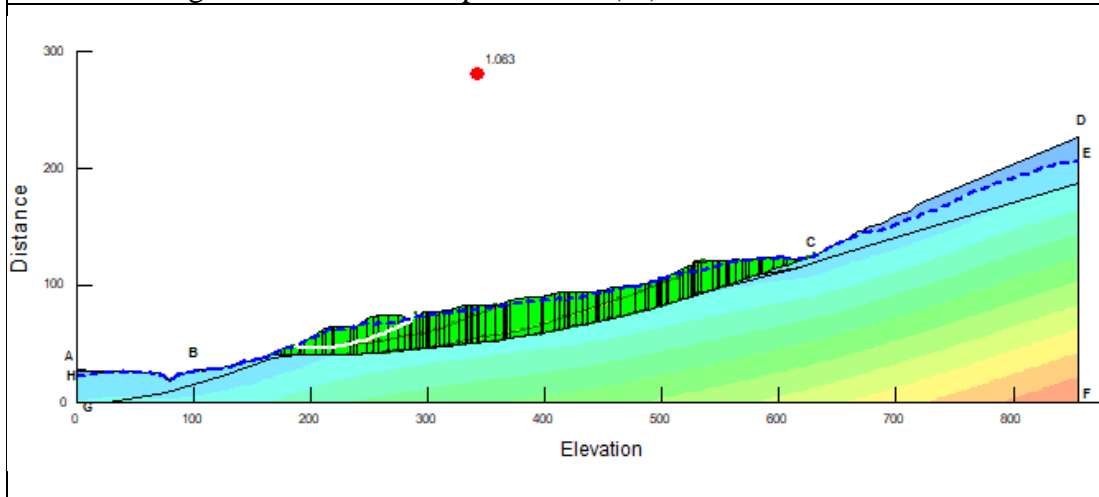
a. High water level and slip surface 4 (J4)

b. High water level and slip surface 3 (J3)

c. High water level and slip surface 1 (J1)

**Figure 5.13 : Factor of safety values for each slip surface at the high-water level
(obtained through Geoslope SLOP/W 2012 software)**

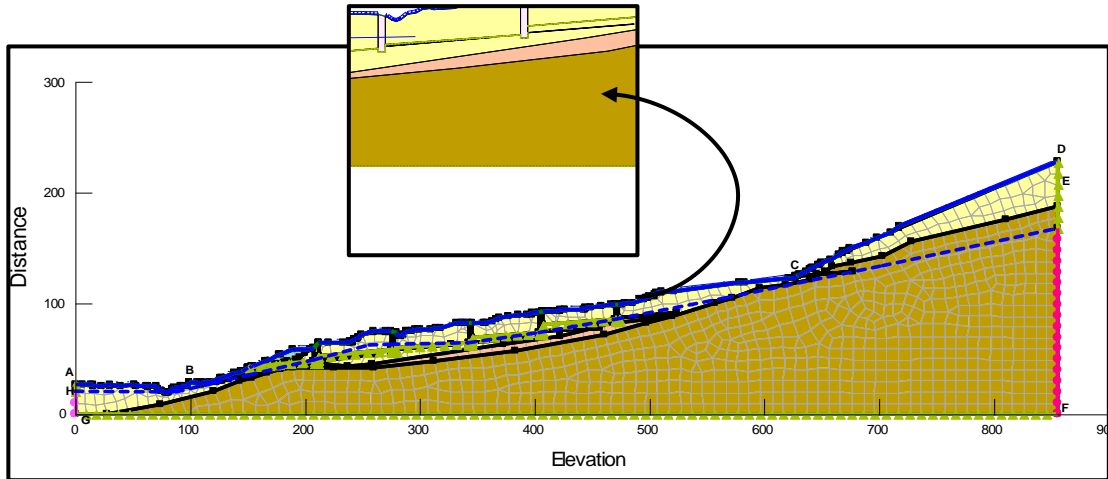
Figure 6.2: Boundary conditions applied to the profile with rectification measures

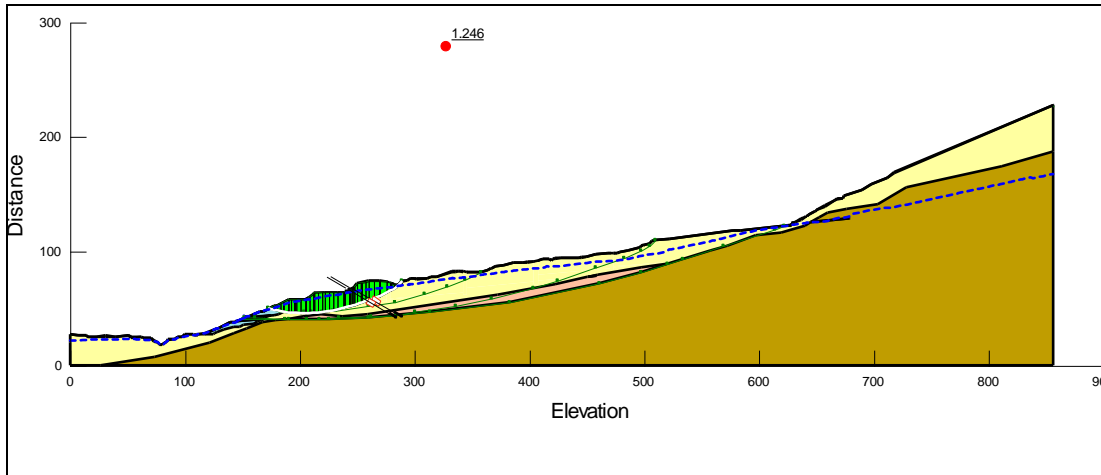
a. High water level in slip surface 4 after applying of countermeasures (47 days of rainfall)

b. High water level in slip surface 3 after applying of countermeasures (47 days of rainfall)

Figure 6.8: Factor of safety values after construction of countermeasures

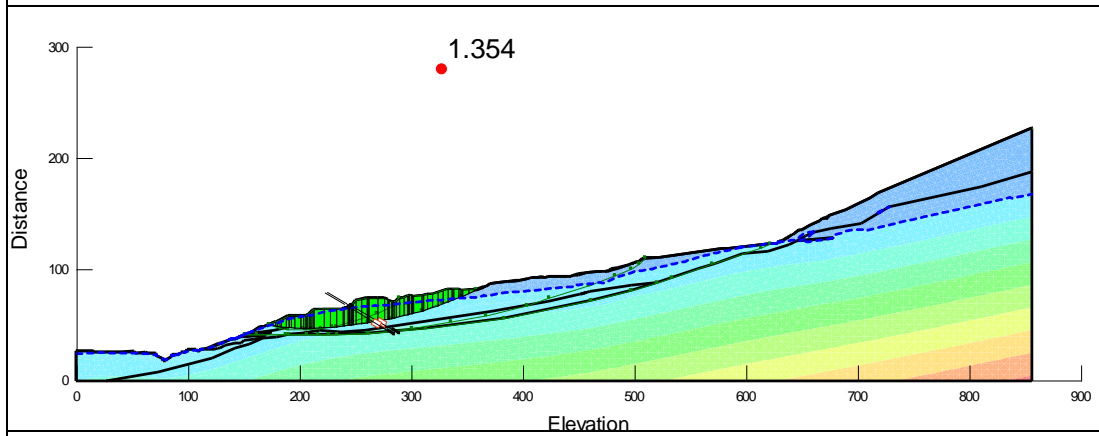
a. High water level in slip surface 4 after applying of countermeasures (67 days of rainfall 863.75 mm)

b. High water level in slip surface 3 after applying of countermeasures (67 days of rainfall 863.75 mm)

c. High water level in slip surface 1 after applying of countermeasures (67 days of rainfall 863.75 mm)

Figure 7.2: Factor of safety values after construction of countermeasures for highest rainfall record
