Reduction of Landslide Risk in Sri Lanka

Part 1 -Geomorphological and Geological Background

Time Capsule project of ISSMGE
Sri Lankan Geotechnical Society

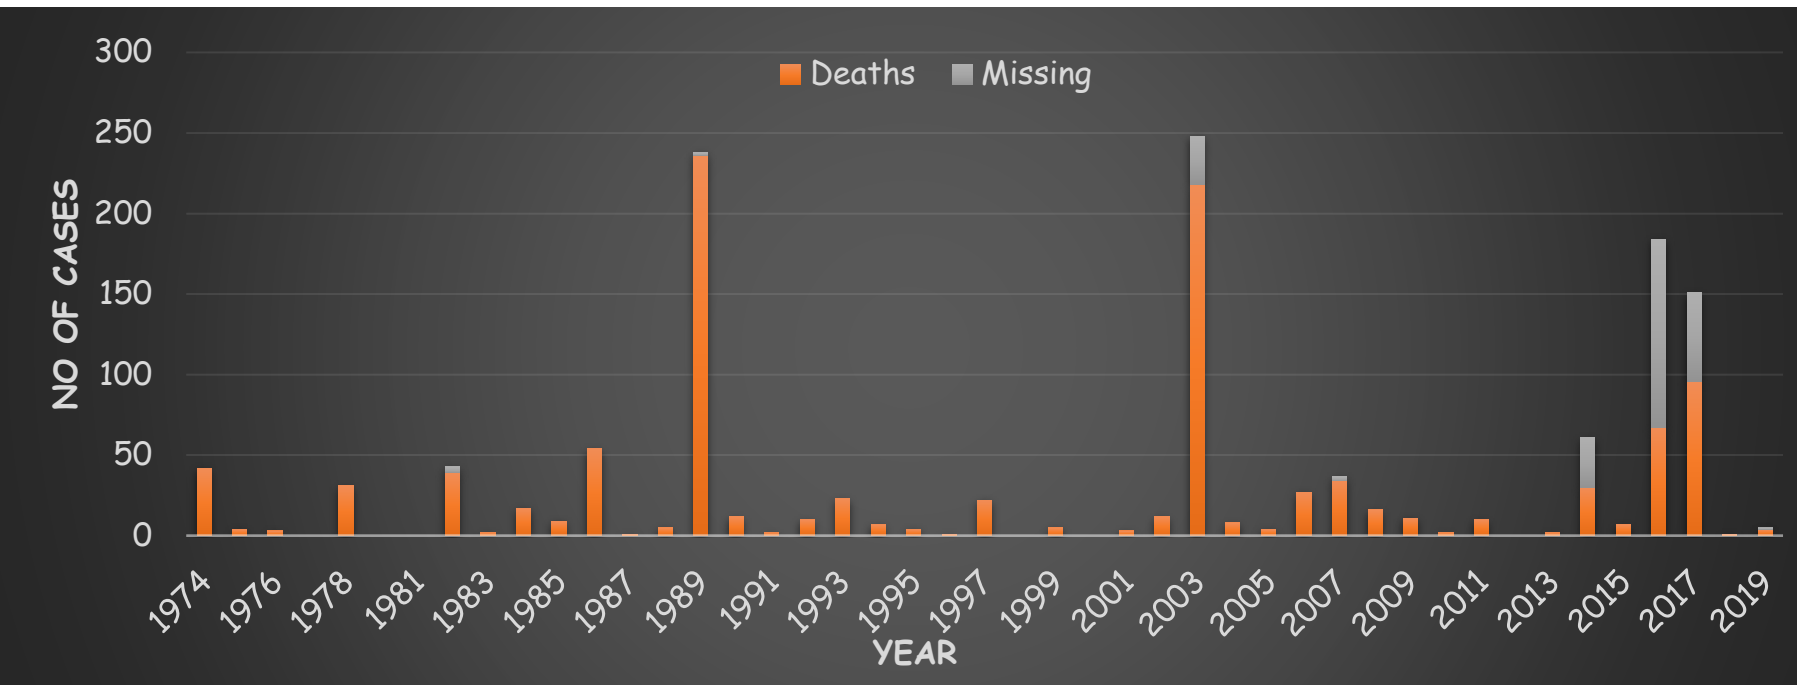
Number of deaths and missing cases each year from 1974-2019
(Total 1081 from 1974-2019)

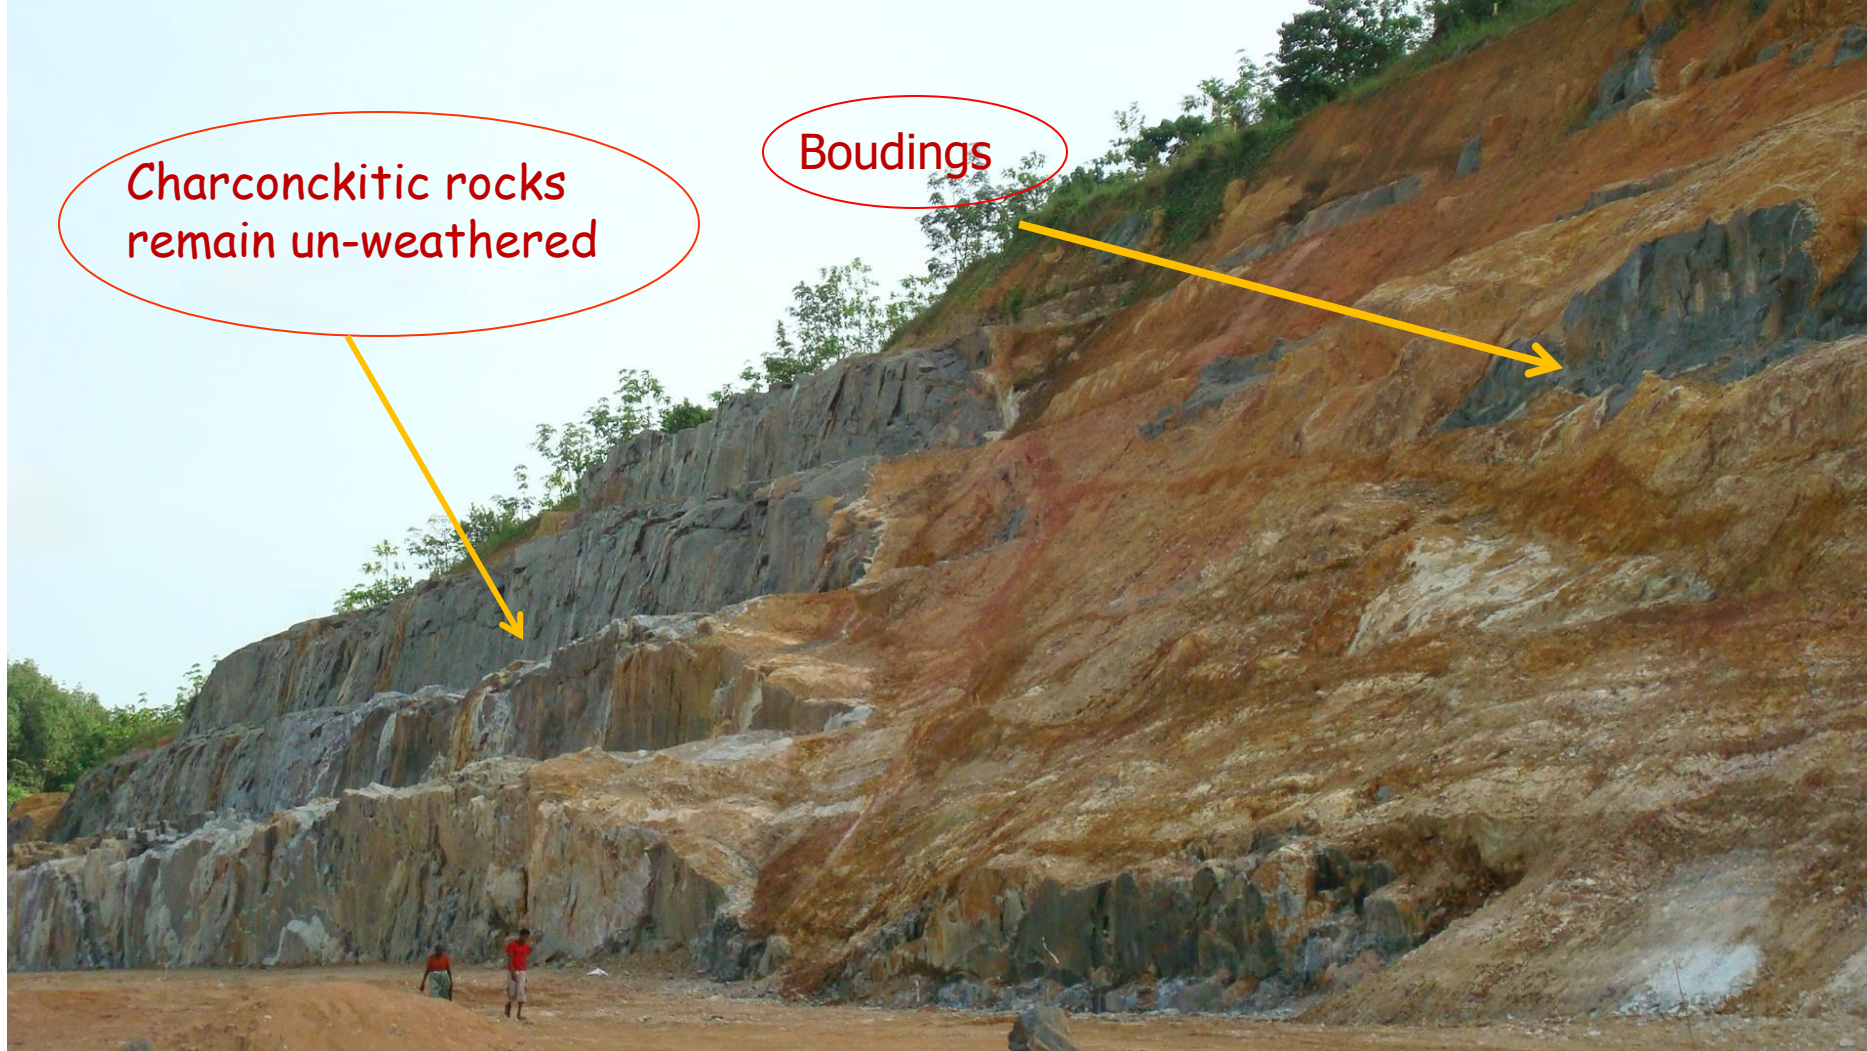
Charconckitic rocks that have high resistance to weathering remains un-weathered -known as Boudings

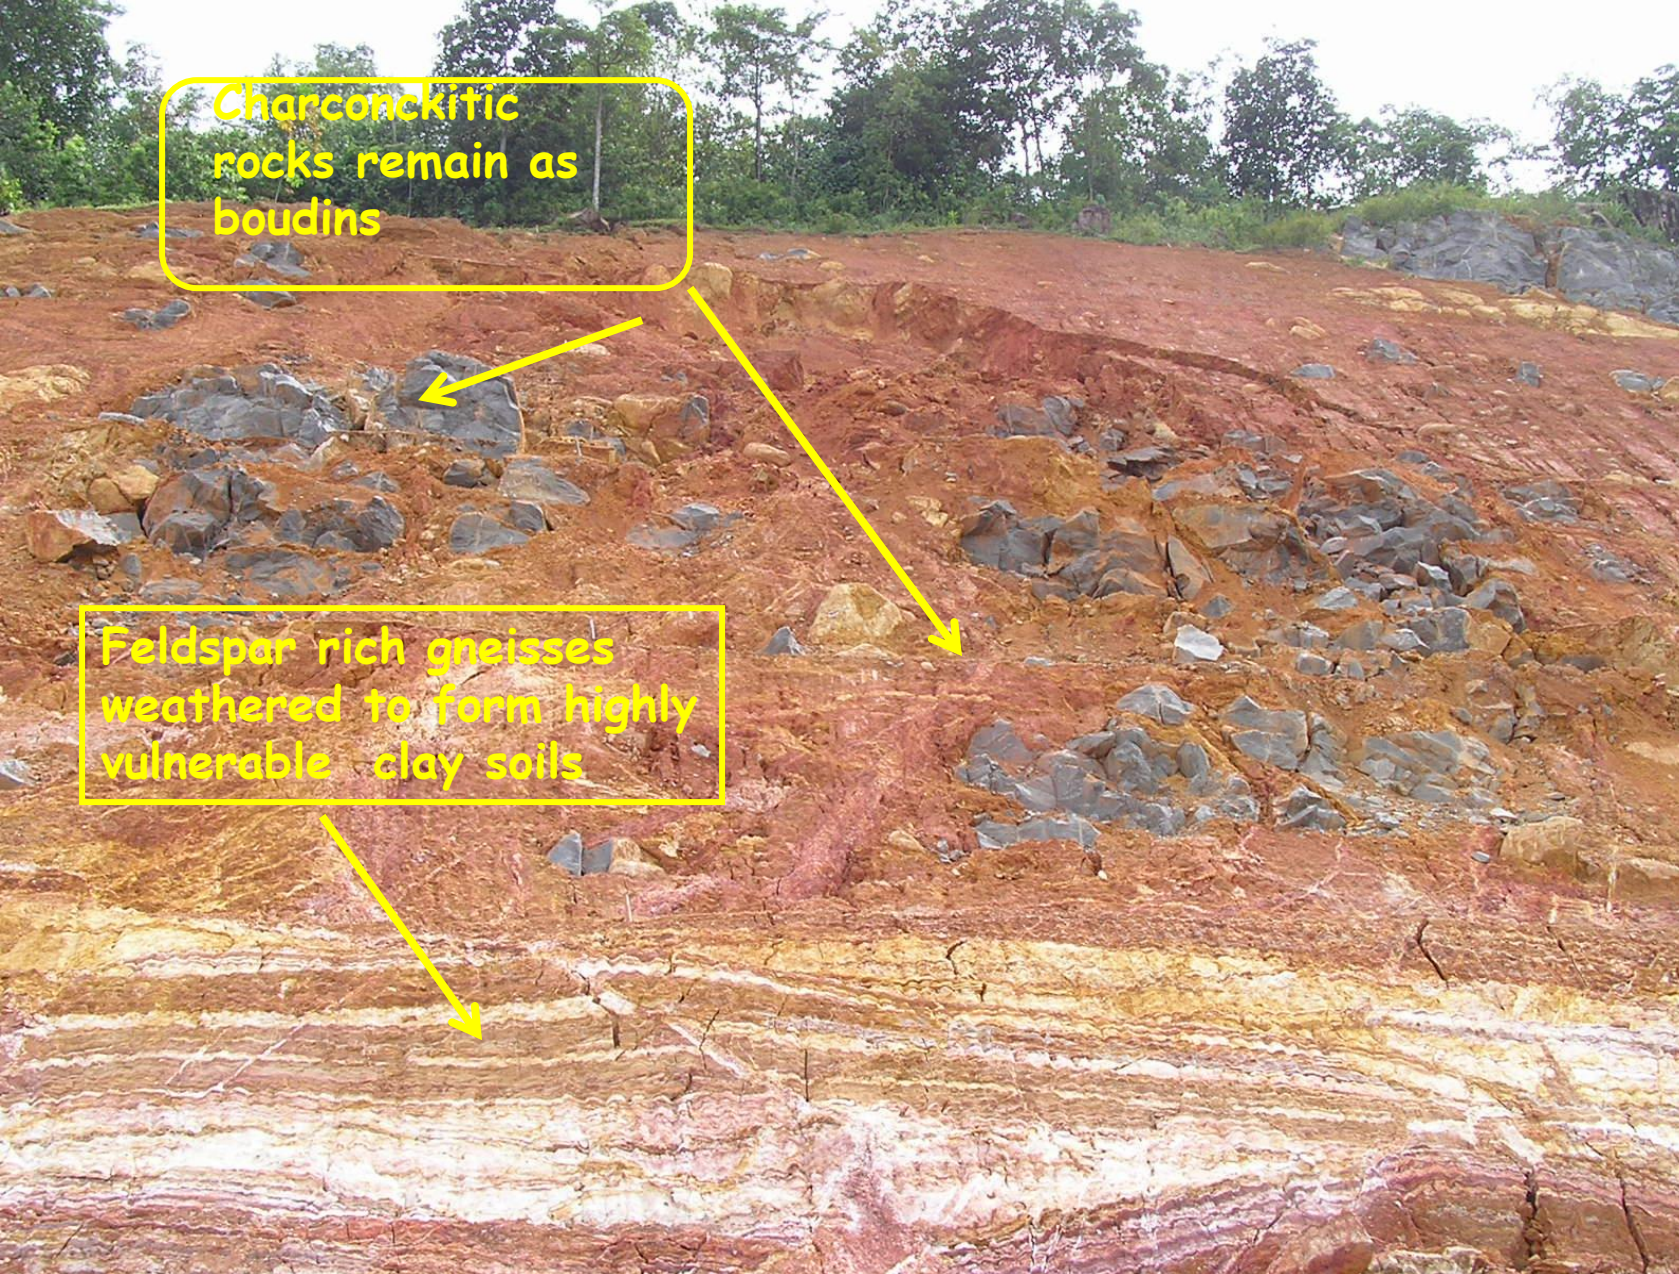
Charconckitic rocks remain as boudins

Feldspar rich gneisses weathered to form highly vulnerable clay soils

Highly heterogeneous-irregular soil/rock profiles due to tropical conditions of weathering and mineralogical changes in the parent rock.

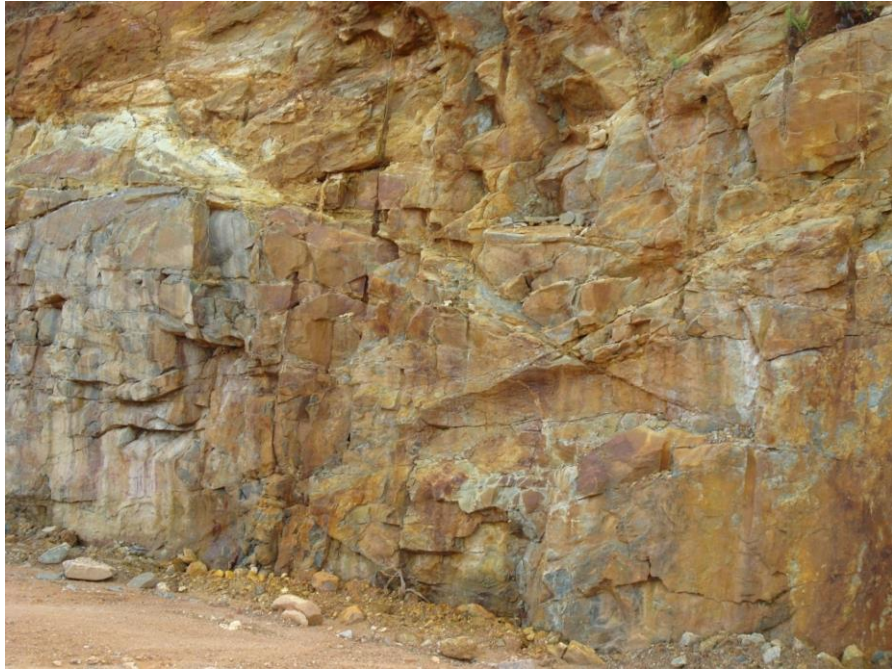
Rocks with closely spaced Joints
Those will remain as "Relict Joints" in the weathered product - residual soil

Toppling (Fall) Mode of failure or sliding could take place through relict joints in residual soil formations

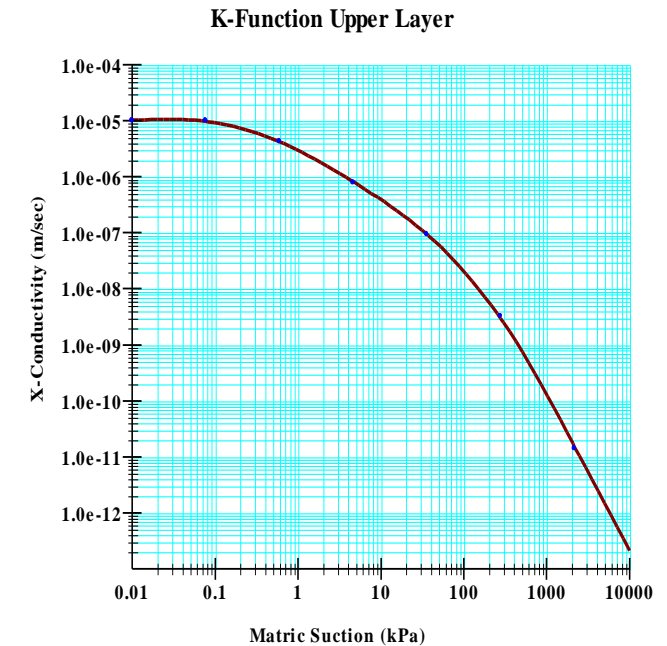
Hydraulic conductivity (Permeability) function

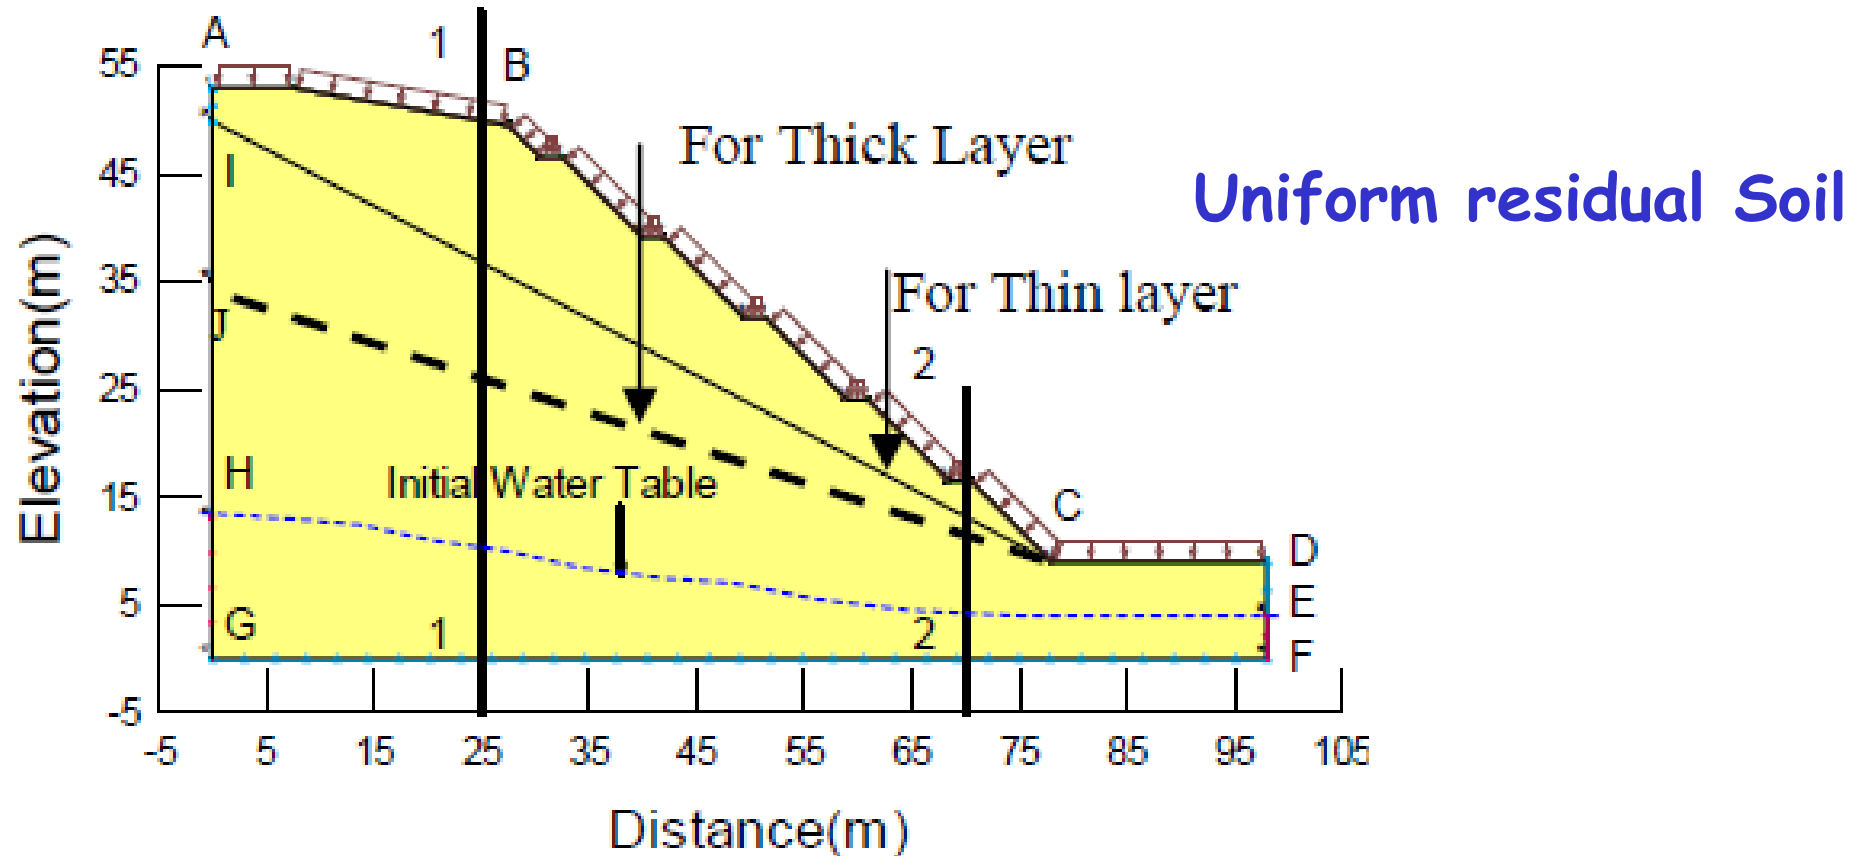
Modelling the Transient Seepage Analysis with SEEPW Software

Boundary Conditions

AB, BC, CD = I_r (Rainfall intensity)

AH, DE, FG = $Q = 0 \text{ m}^3/\text{s}$ (No flow Boundary)

EF, GH = h_t (Total head at sides)

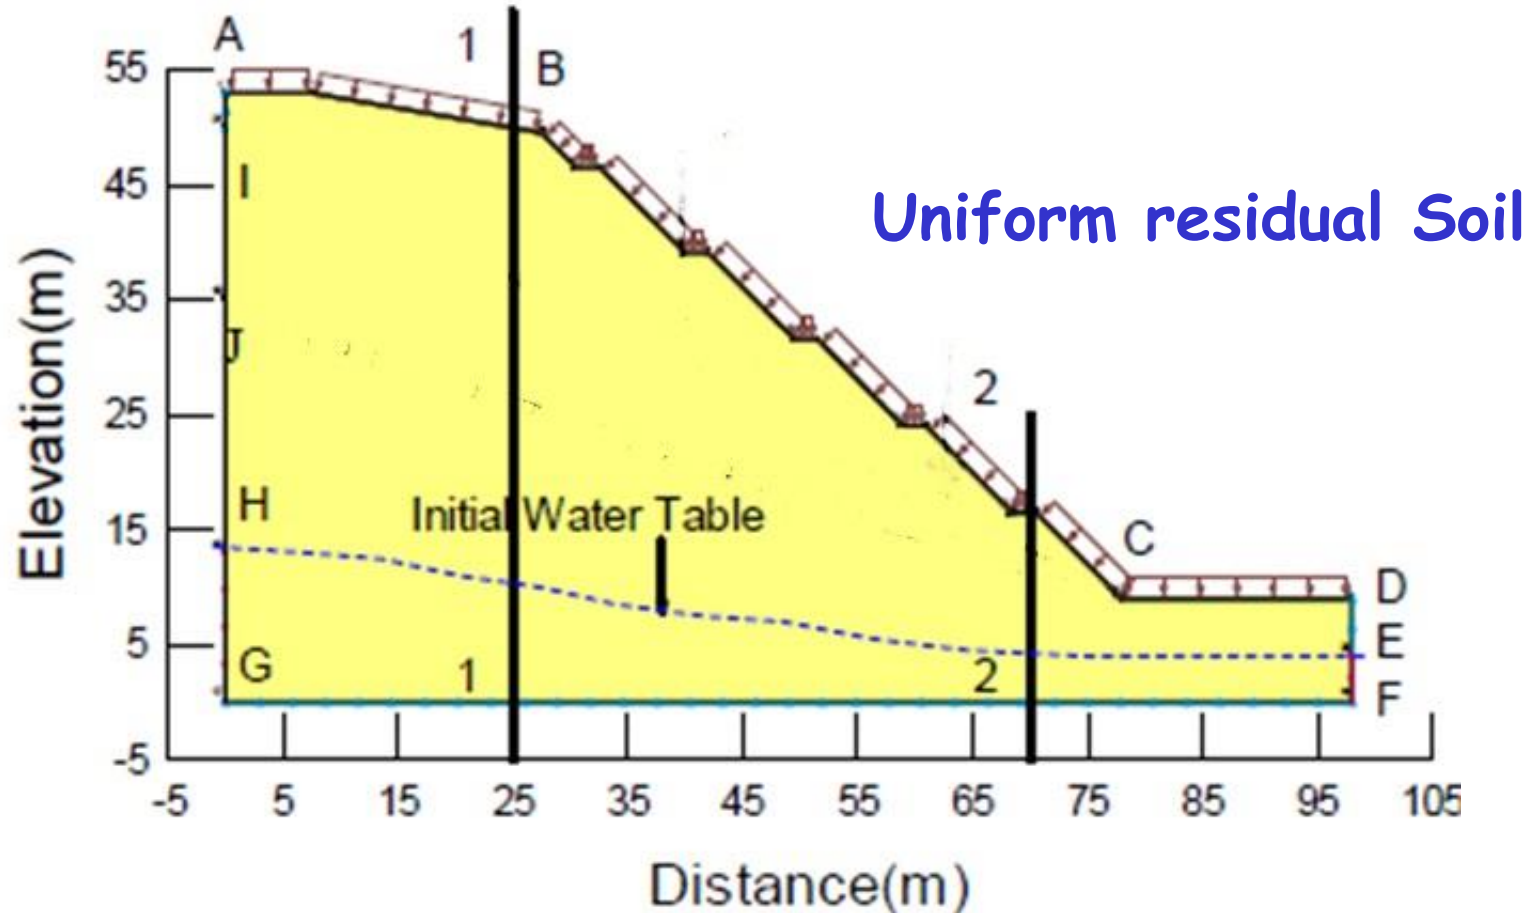
Modelling the Transient Seepage Analysis with SEEPW Software

Boundary Conditions

AB, BC, CD= I_r (Rainfall intensity)

AH, DE, FG= $Q=0\text{m}^3/\text{s}$ (No flow Boundary)

EF, GH= h_t (Total head at sides)

Weathered rock underlying residual soils

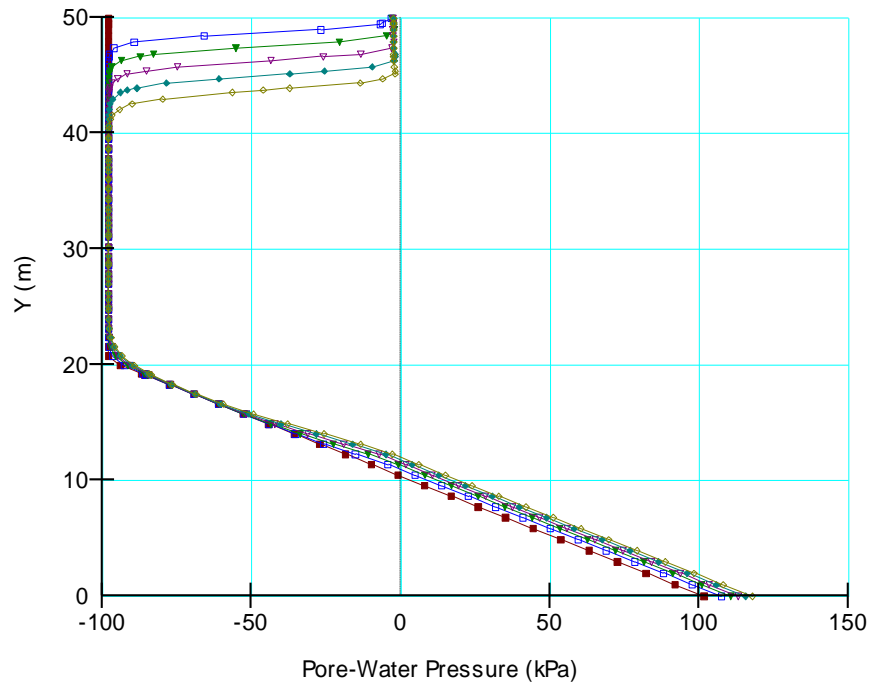
Pore Water Variation Along depth

Effect of 5mm/hr Rainfall in a Uniform Slope

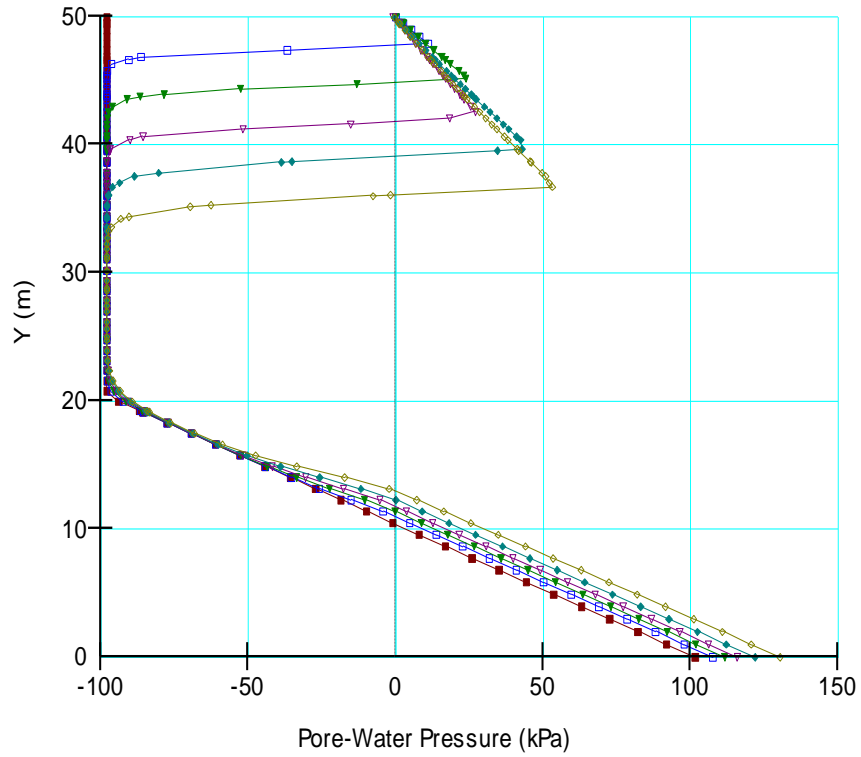
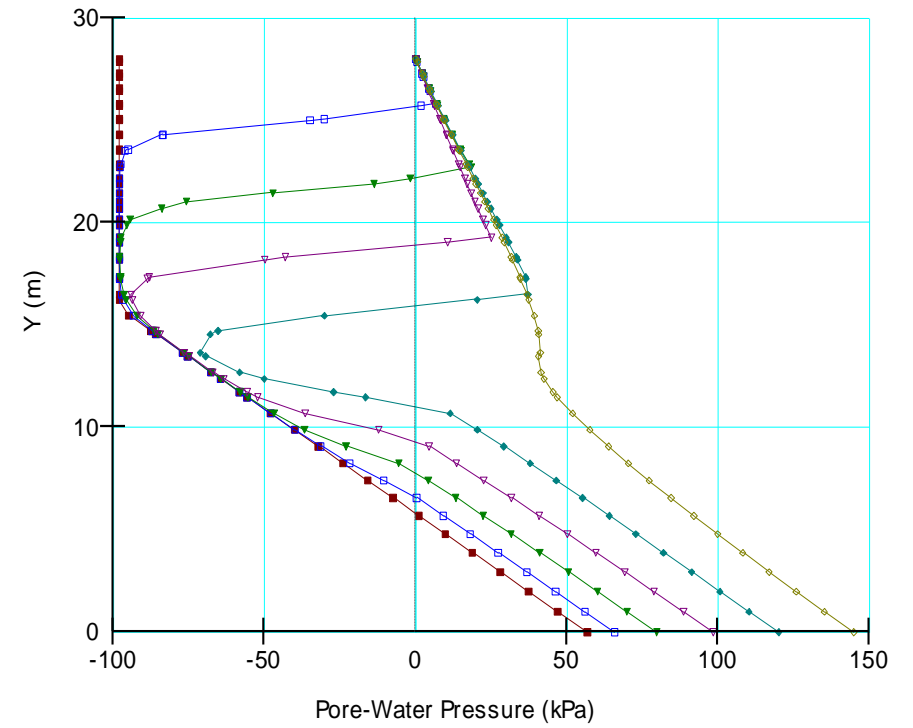
Pore Water Pressure Variation Along depth

Effect of 20mm/hr Rainfall in a Uniform Slope

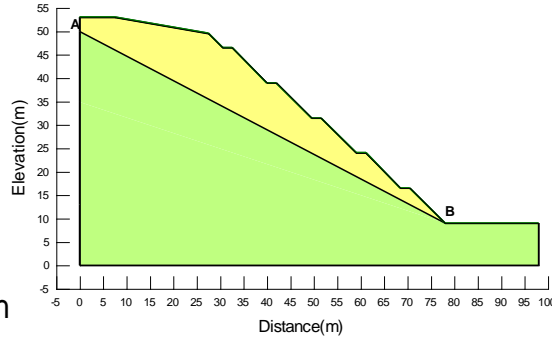
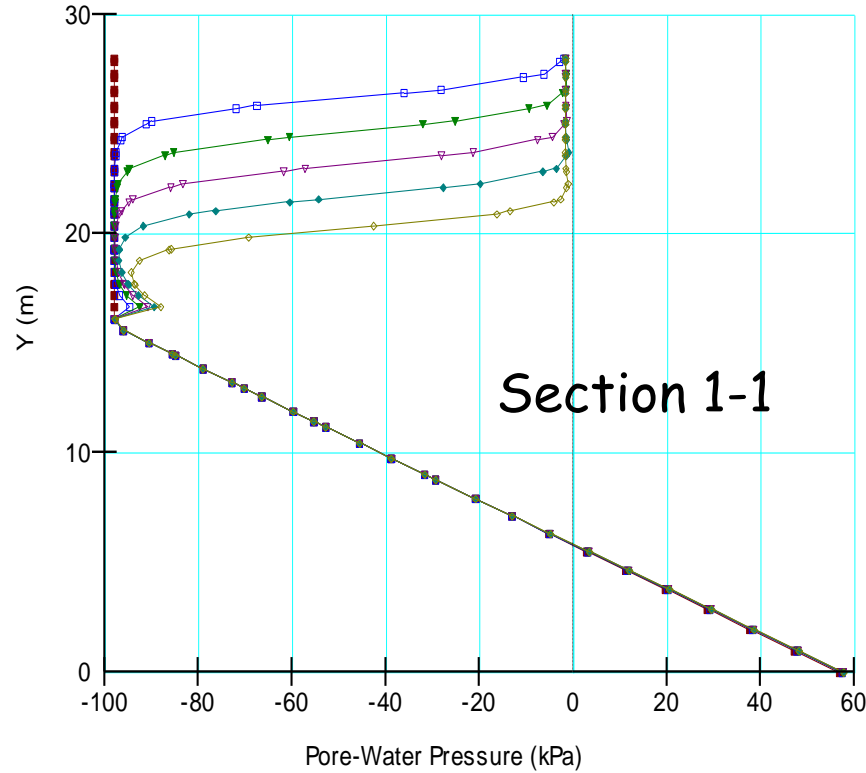
Pore Water Pressure Variation Along Depth

Effect of 5mm/hr Rainfall in a stratified Slope
 With the presence of highly impermeable weathered rock layer below the residual soil layer

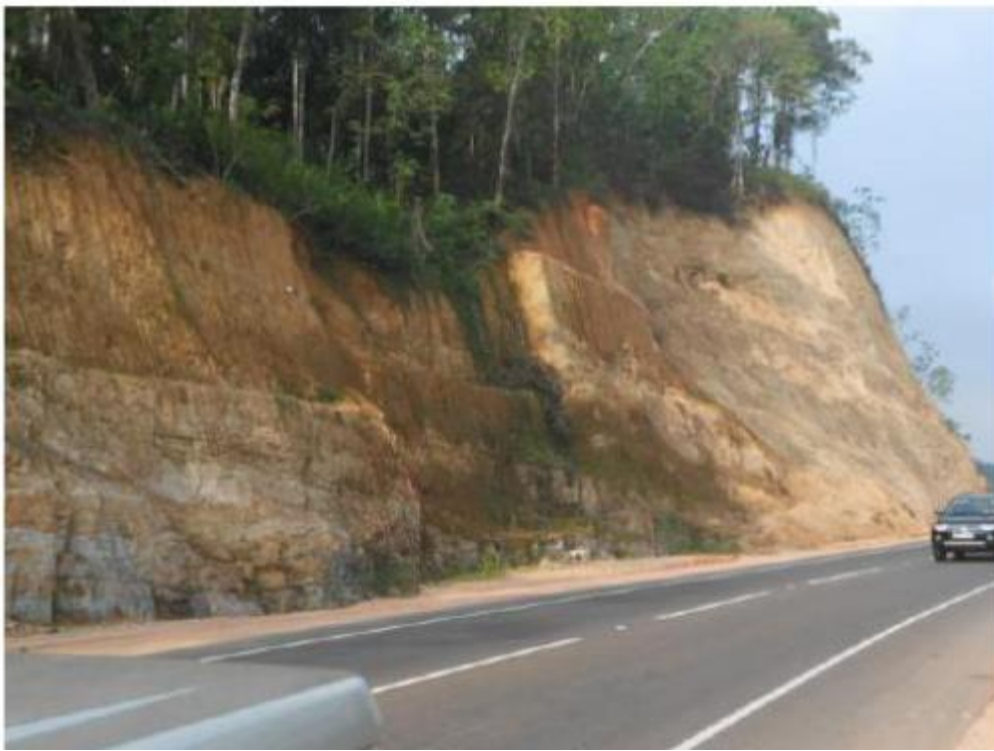
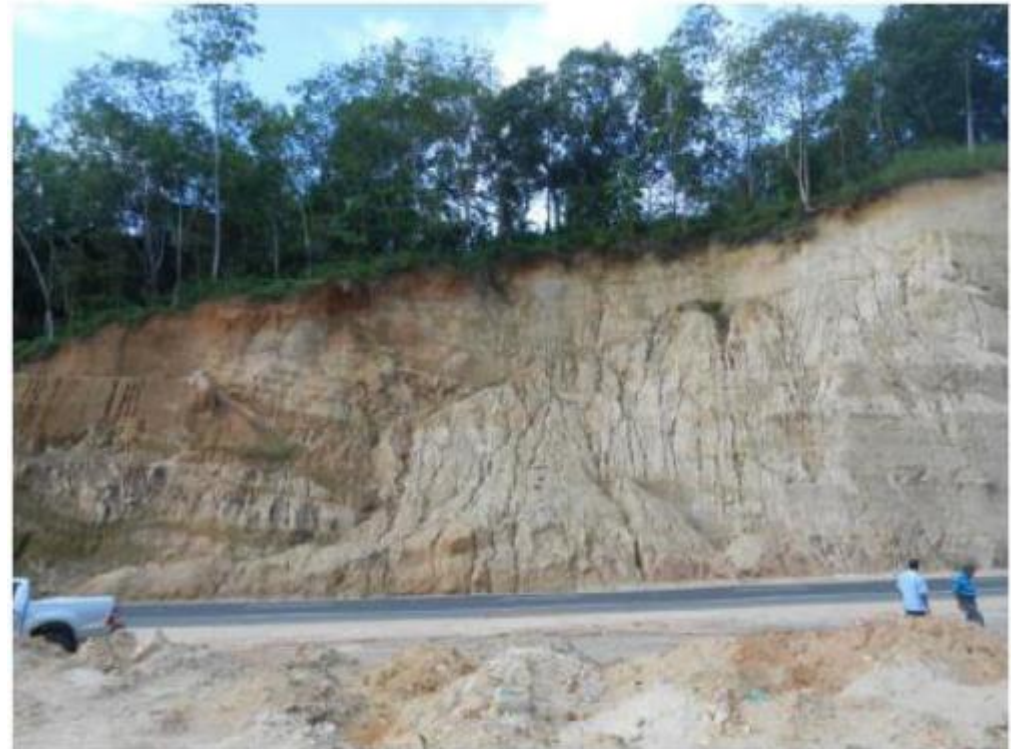
Immediately after cutting 24-3-2014

Two months later after the rain 14-5-2014

A cut slope in STDP - Galle - Matara segment

Slope was cut but drainage measures were not implemented

Uncontrolled flow of water and infiltration during rainy season

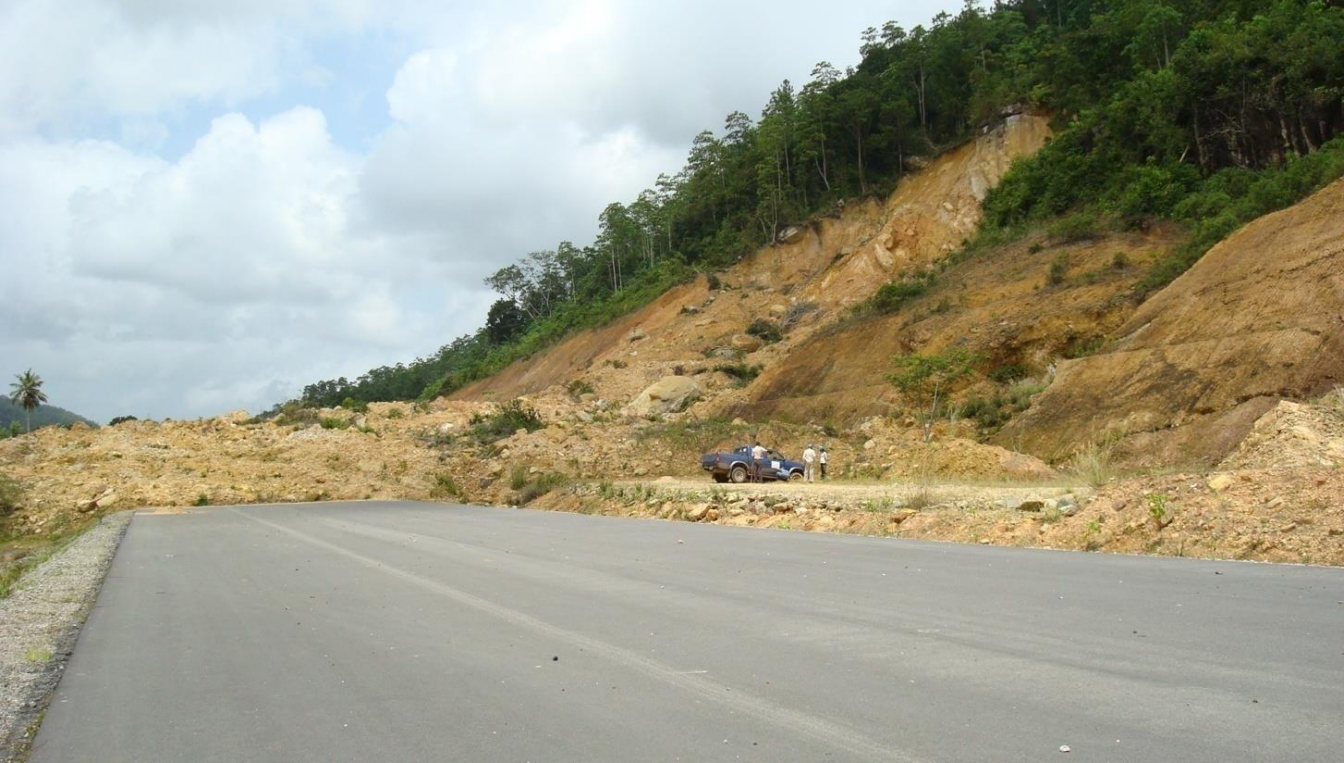
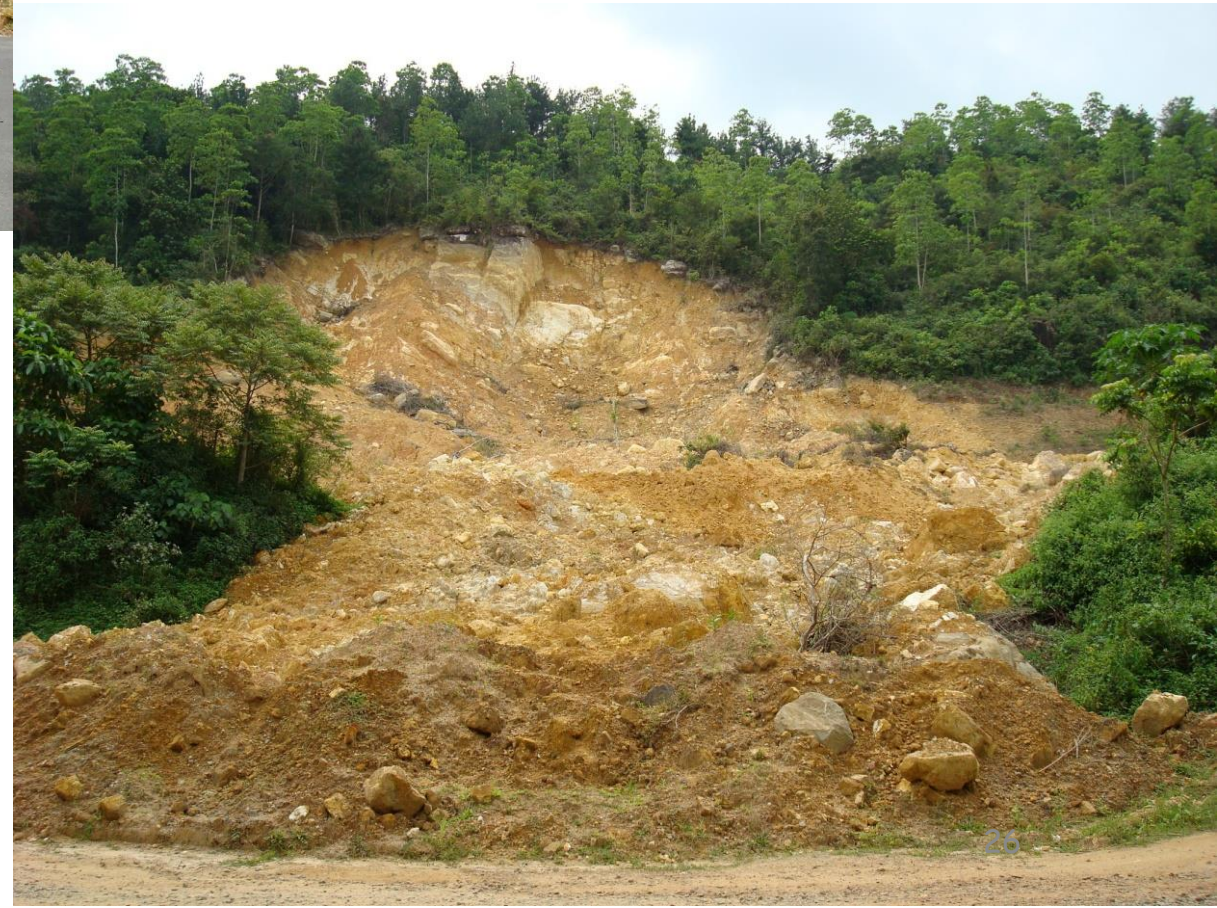
Ended up as a
catastrophic failure

A Failure in Southern Expressway at Welipenna

some disturbances in the berm drains and cascade drains installed

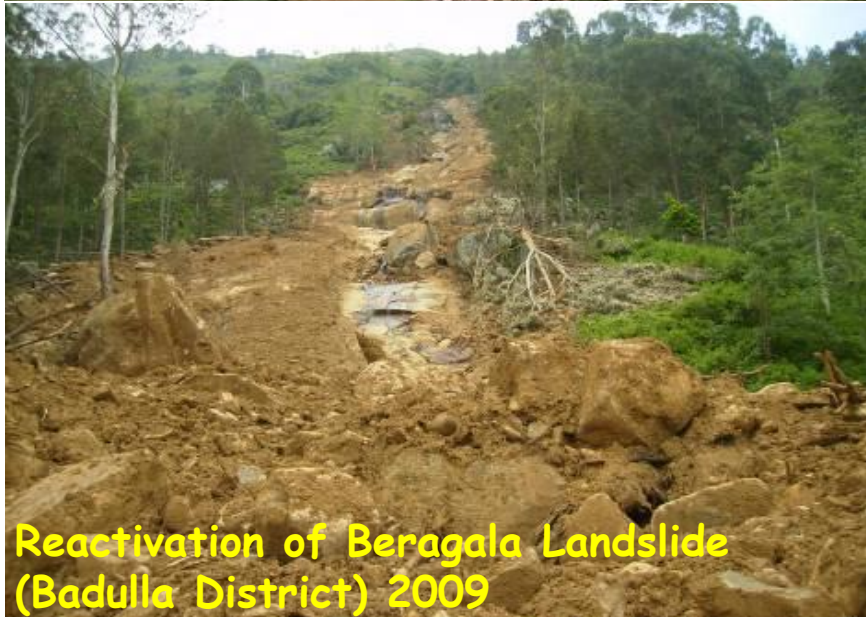
Reactivation of Beragala Landslide (Badulla District) 2009
