# Reduction of Landslide Risk in Sri Lanka

## Part 2 - Landslide Hazard Zonation and Monitoring

Time Capsule project of ISSMGE  
Sri Lankan Geotechnical Society

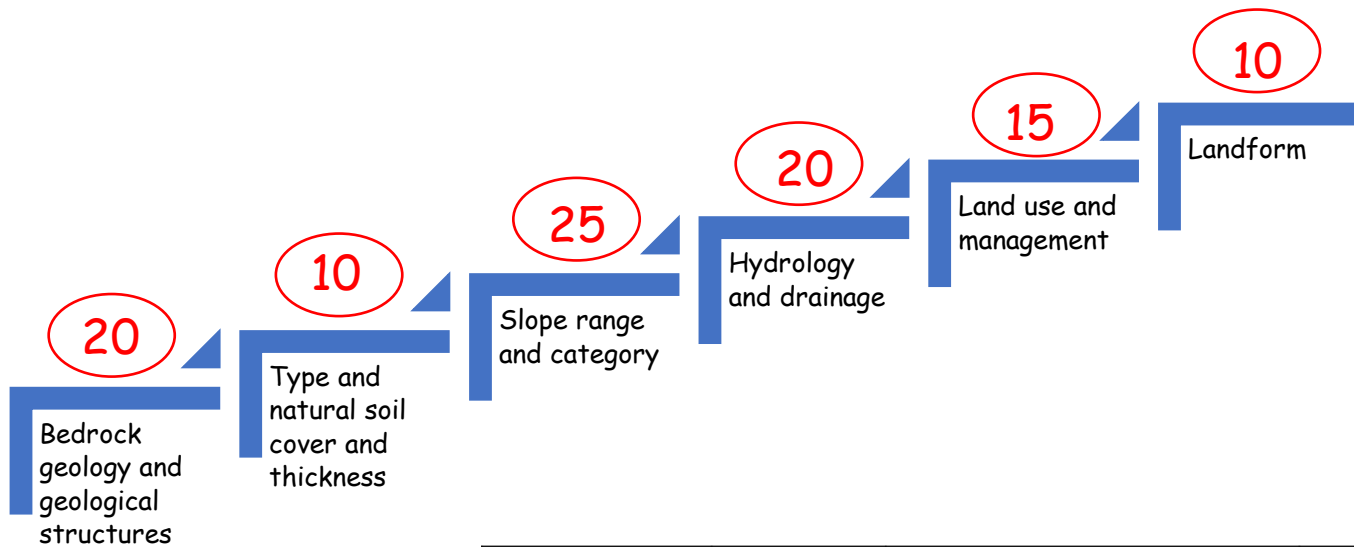
The prepared weight maps are combined using GIS to obtain an overall hazard rating for different zones

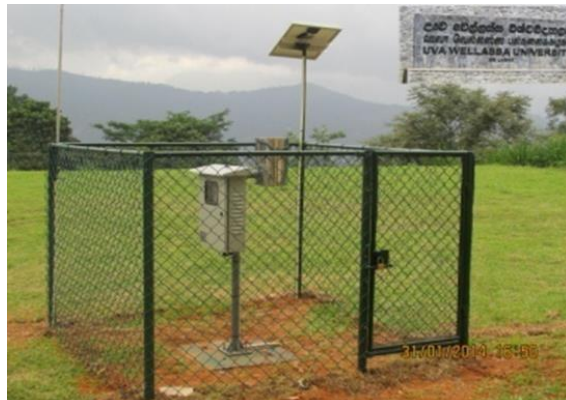
- NBRO has been assigned the task of issuance of Landslide Early Warning
- 325 automated rain gauge stations in pre-selected catchments in landslide prone districts
- These stations are now working in the automated rain gauge network of NBRO for landslide early warning

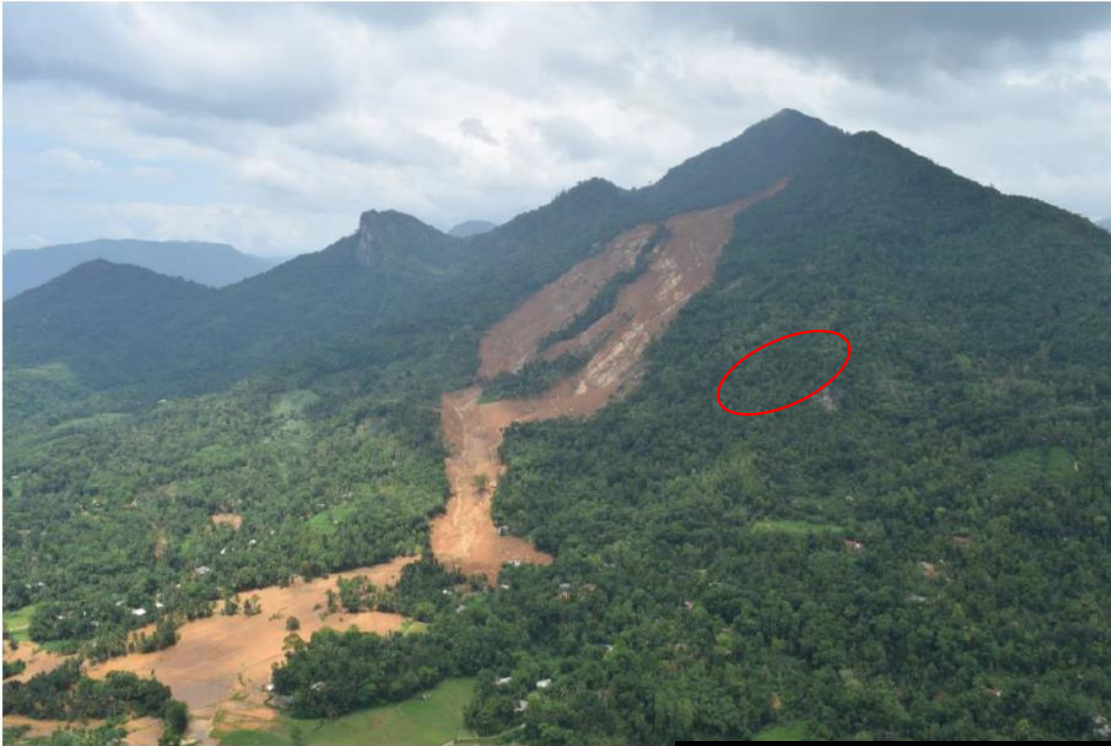
# Landslide Runout Assessment

- ILLWIS & PC-Raster
- Flow -R
- RAMMS
- Kanako
- DAN 3D

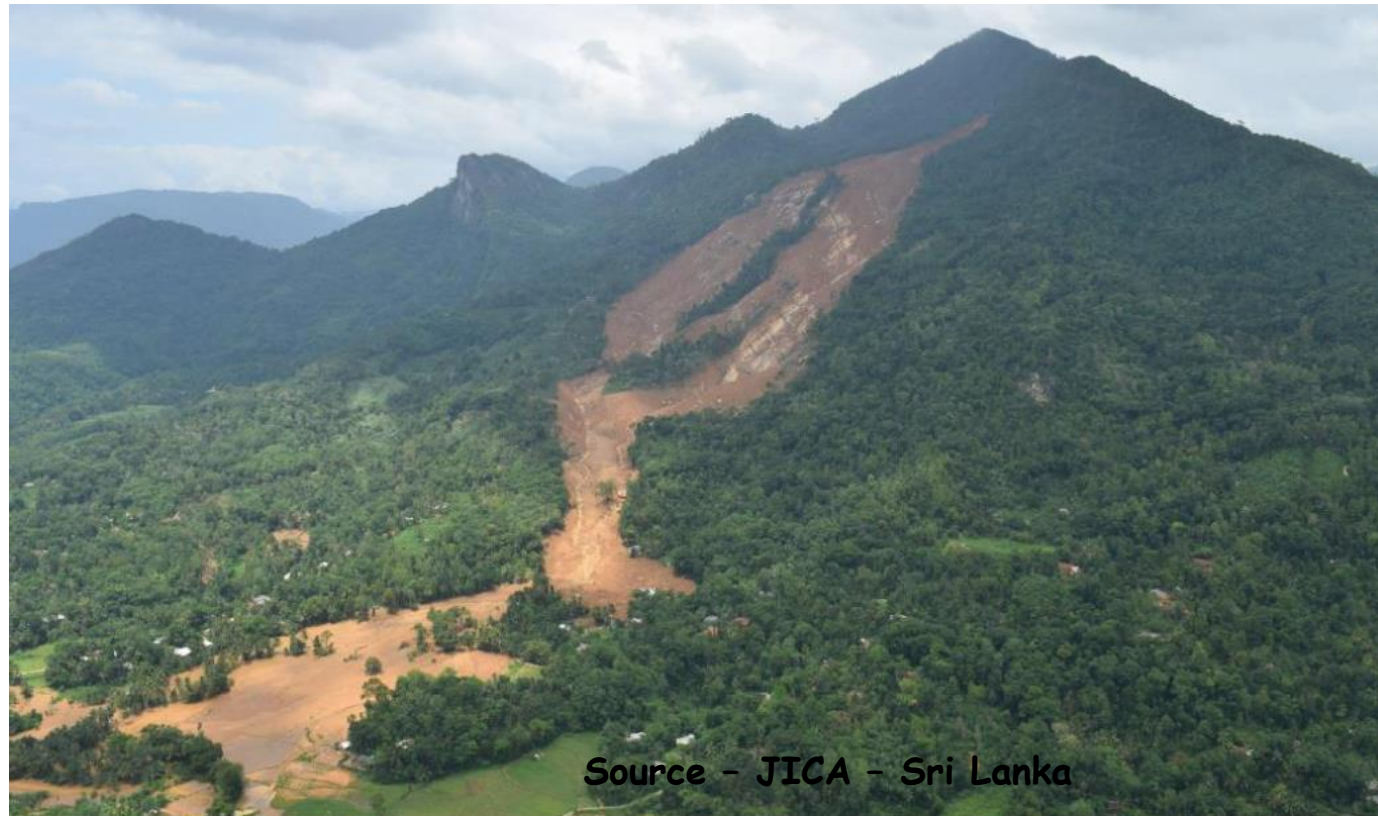
The view of the whole landslide from north direction

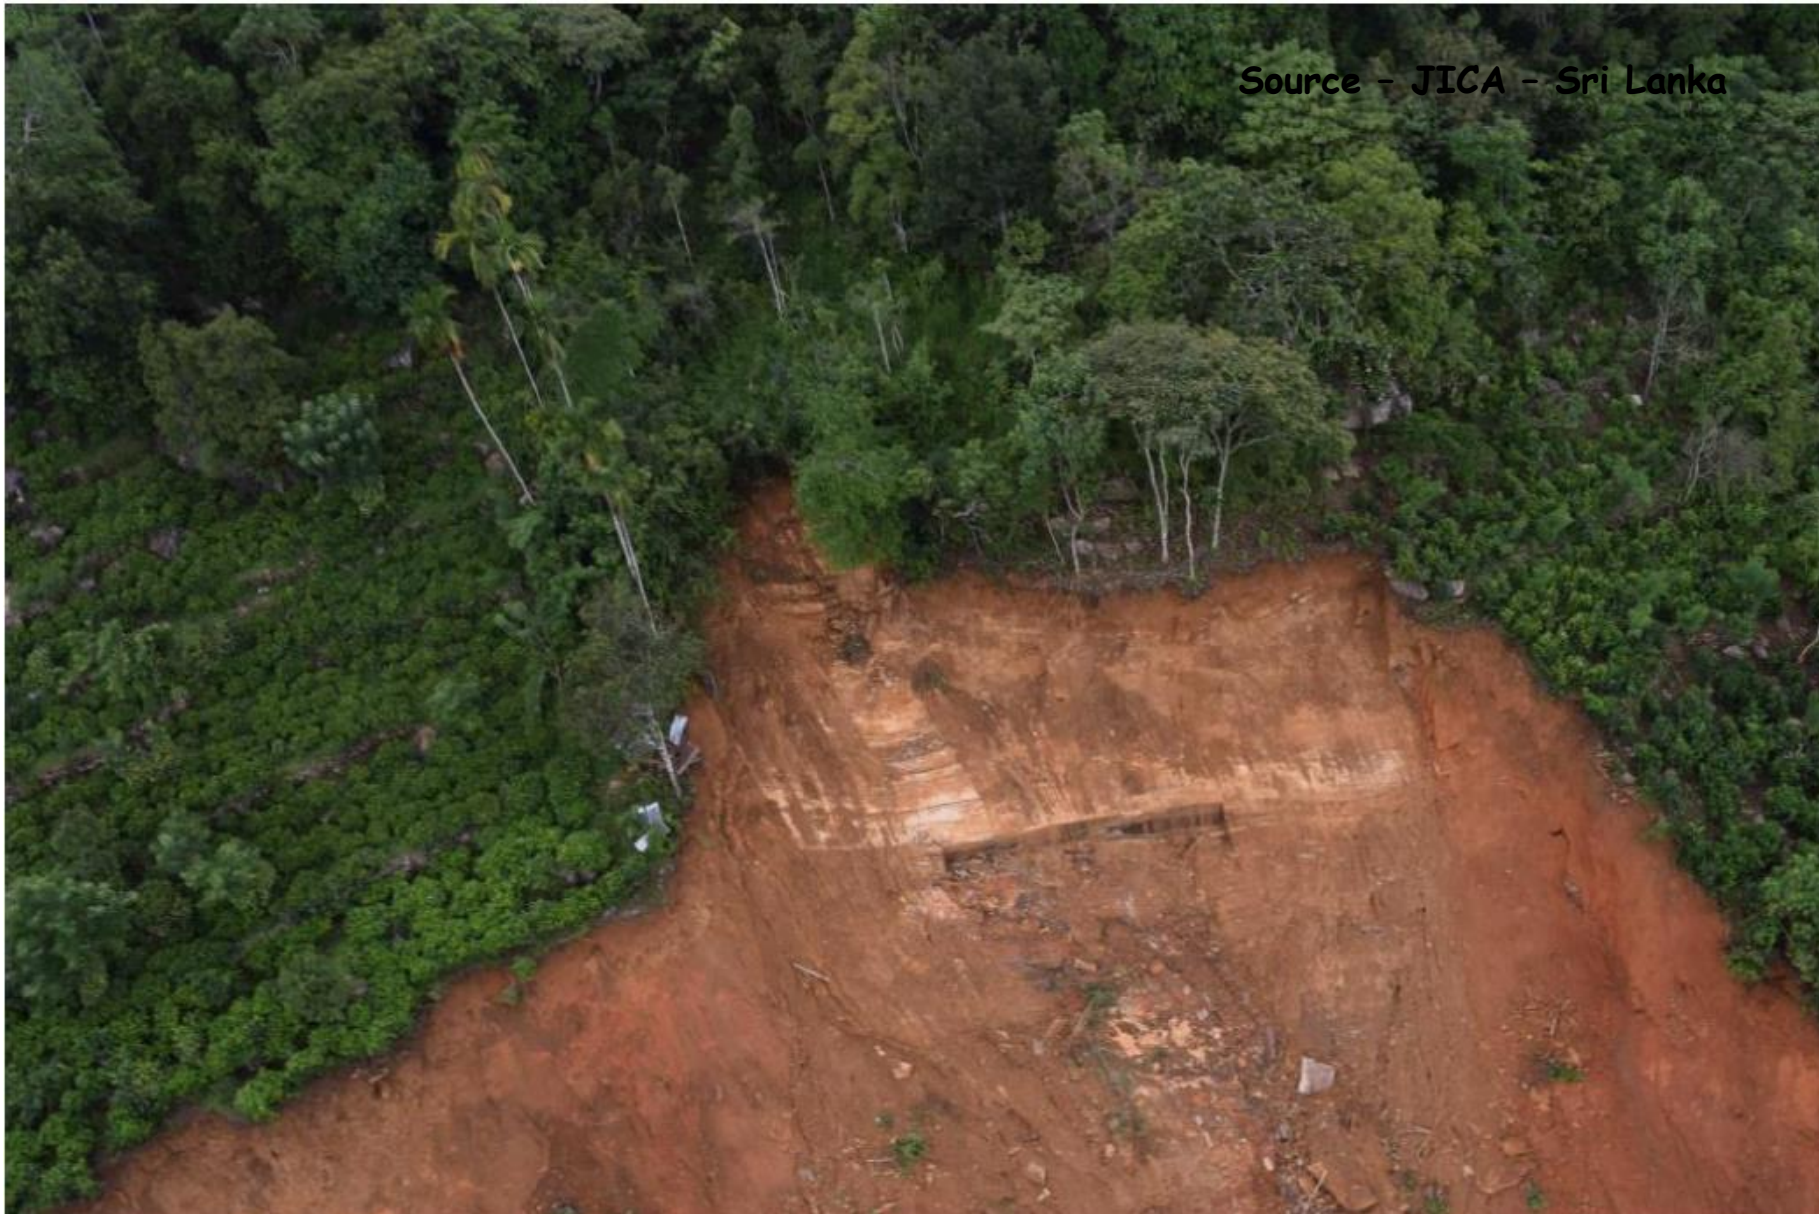
The crown of the landslide - An aerial view

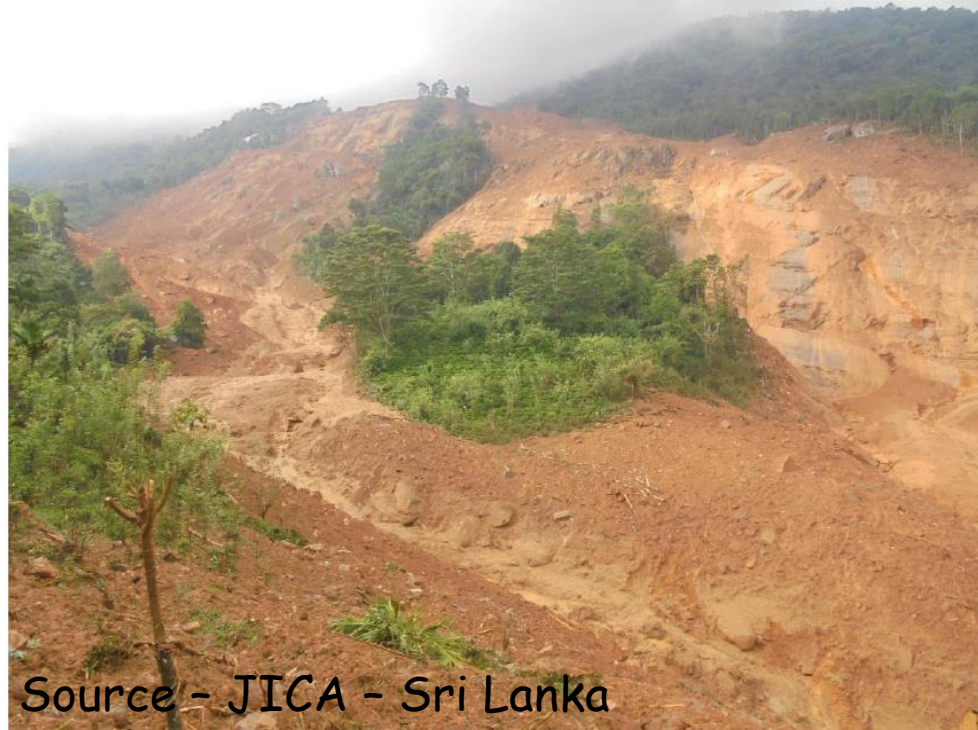
This debris flow moved down to the flat terrain at the intermediate level where number of houses were located. The thick layer of colluvium in this terrain too, had got saturated and the debris flow originated from the top destabilized it further with the impact.

The slide has turned into a debris flow very quickly completely destroying the houses in the terrain. The debris flow had then moved down the second steep escarpment destroying the houses in the lower level. The speed of the debris flow would have increased several times more when it moved downwards along the escarp slope of about 70° angle .

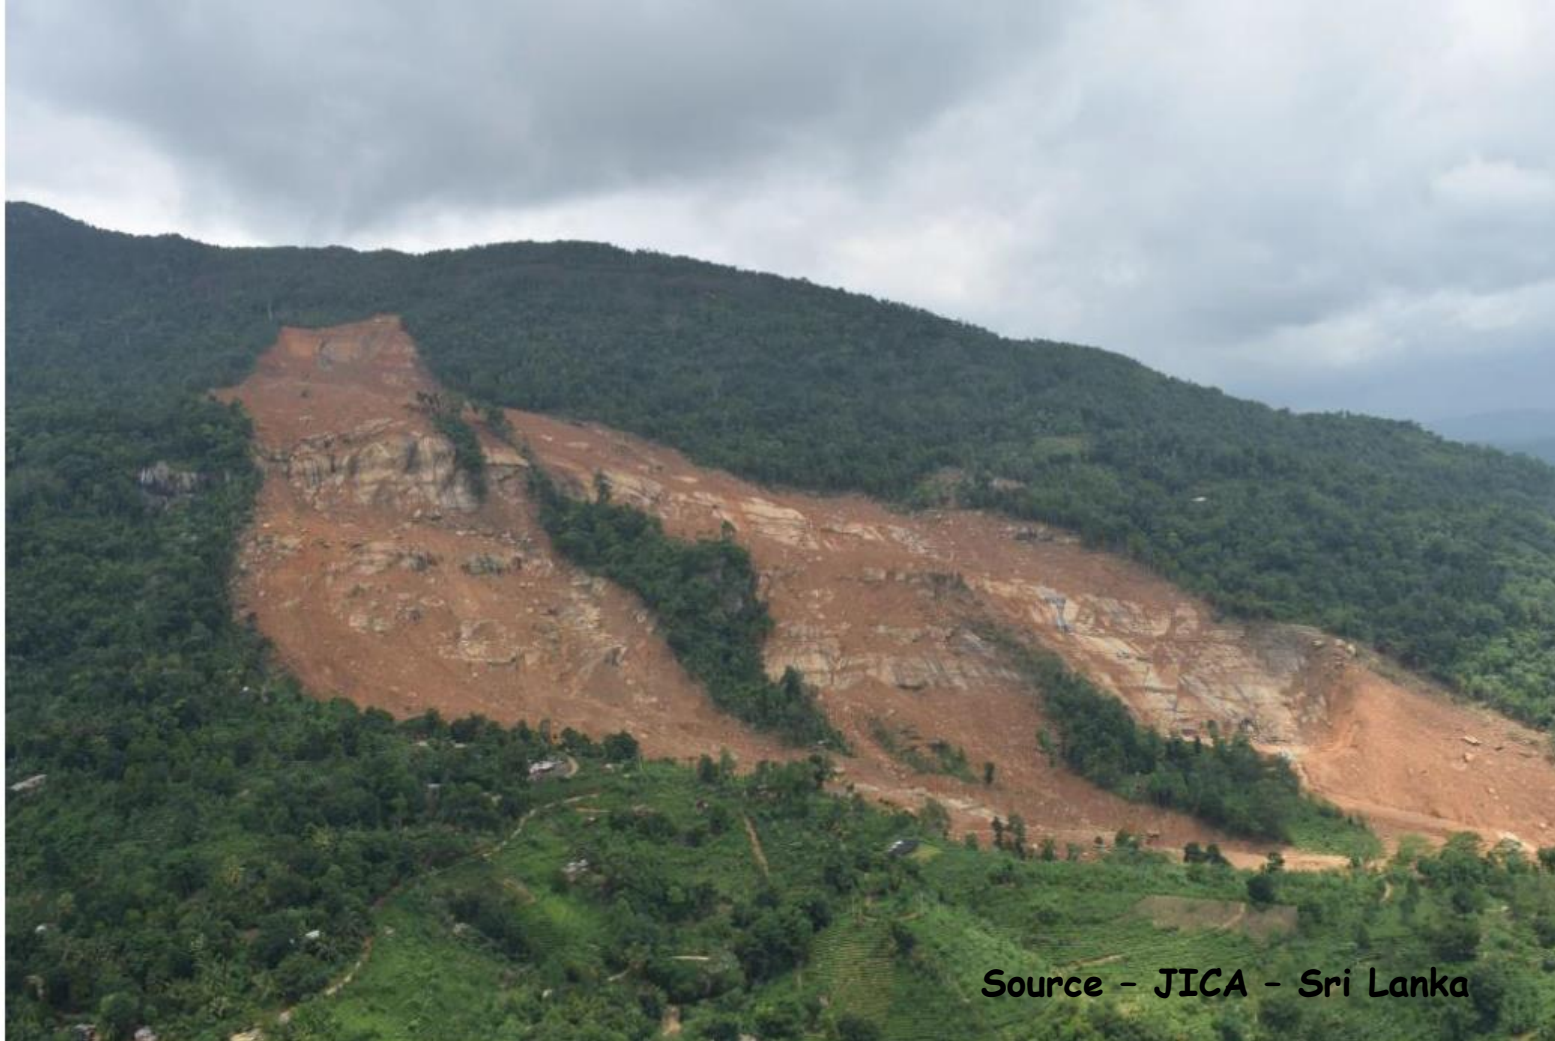
The whole view of the site from West direction

Completely unaffected houses and a natural forest cover could be observed at the intermediate area of the slide.

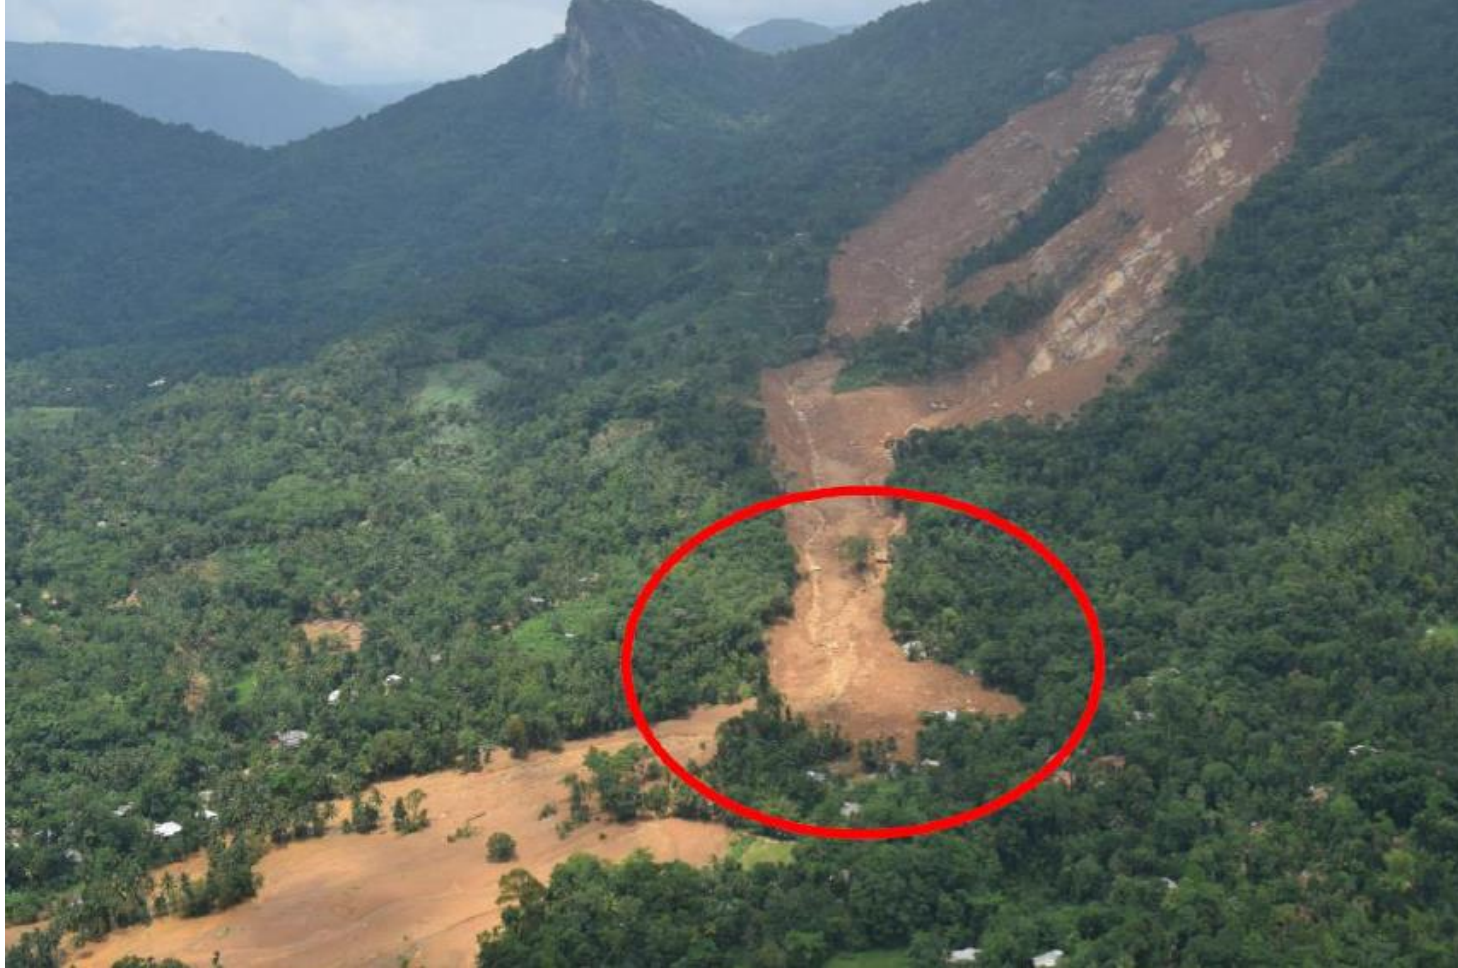
- The mass of collapse flew from two directions. : The left side is about 75-125 m wide while the right-side is about 350-450 m wide.
- It joined into one stream and ran down as a debris flow.
- The position that the main body of debris flow stopped shown by the circle.

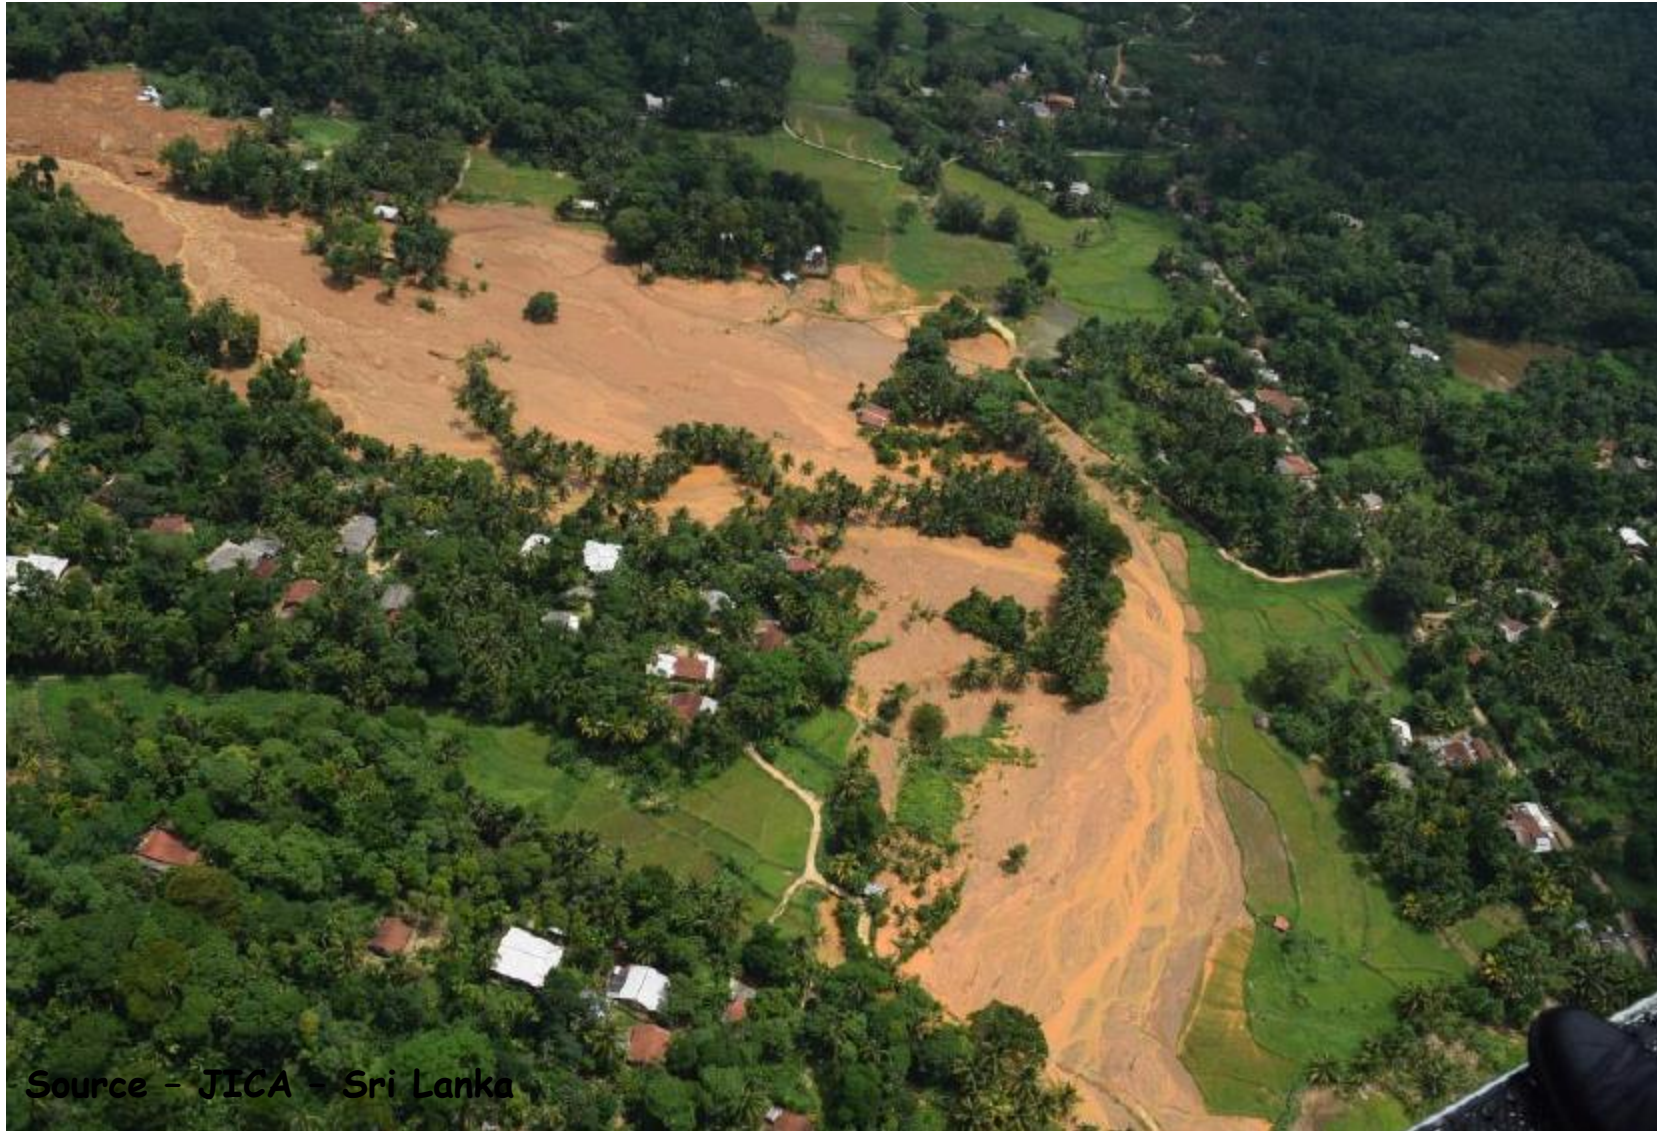
Area where debris flow flooded. The soil and mud are flooding

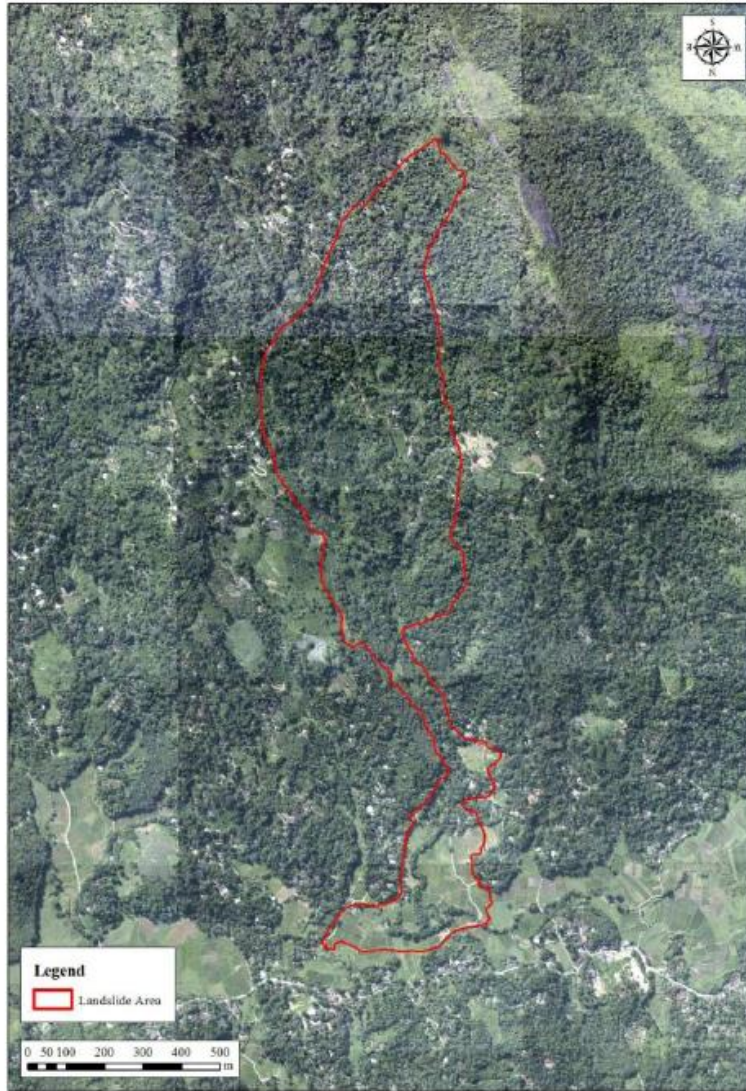
**Comparison of the site - Before and After**

Before (26th Dec 2015)

After (22nd May 2016)

Ortho Image by LiDAR Survey

0.5 m Resolution

Aerial Photo by Chopper

0.5m Resolution

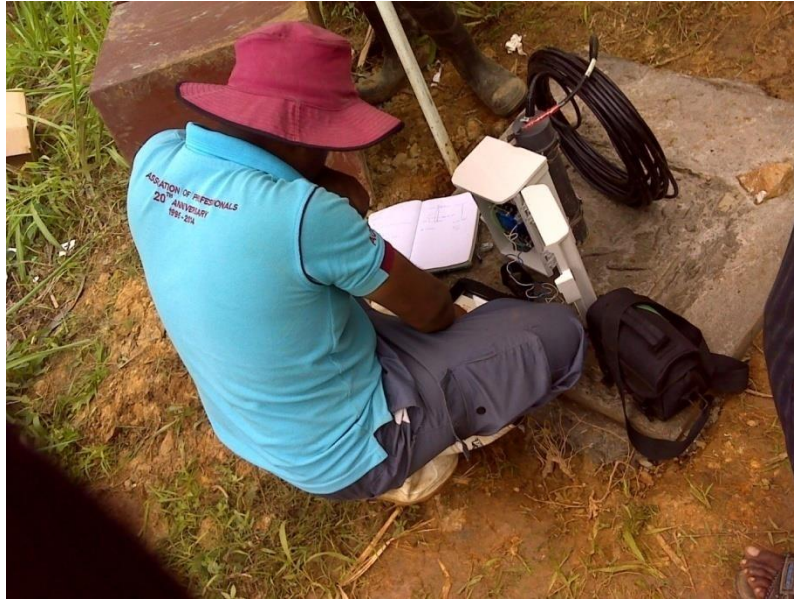
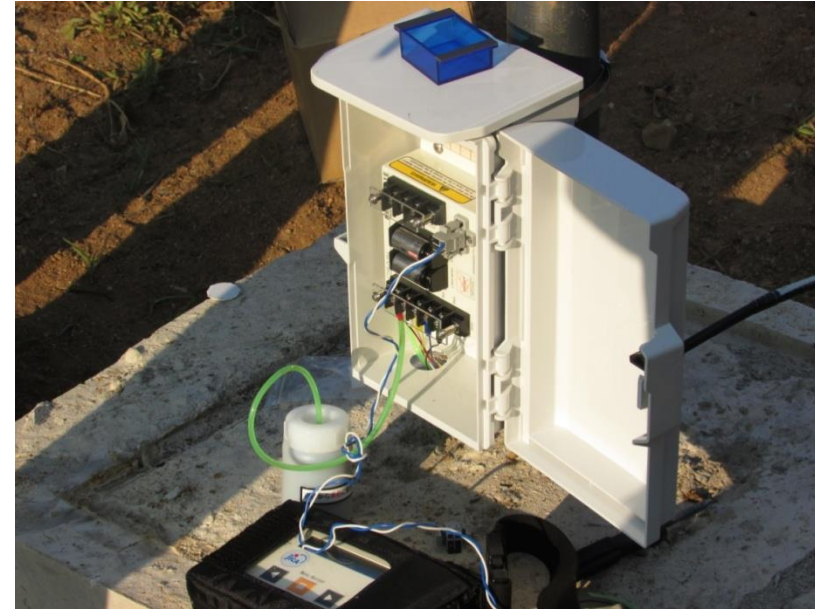
## Water Level Gauge - Installation and Monitoring

This would provide the groundwater level in the borehole. Useful only under simple ground conditions of uniform soil

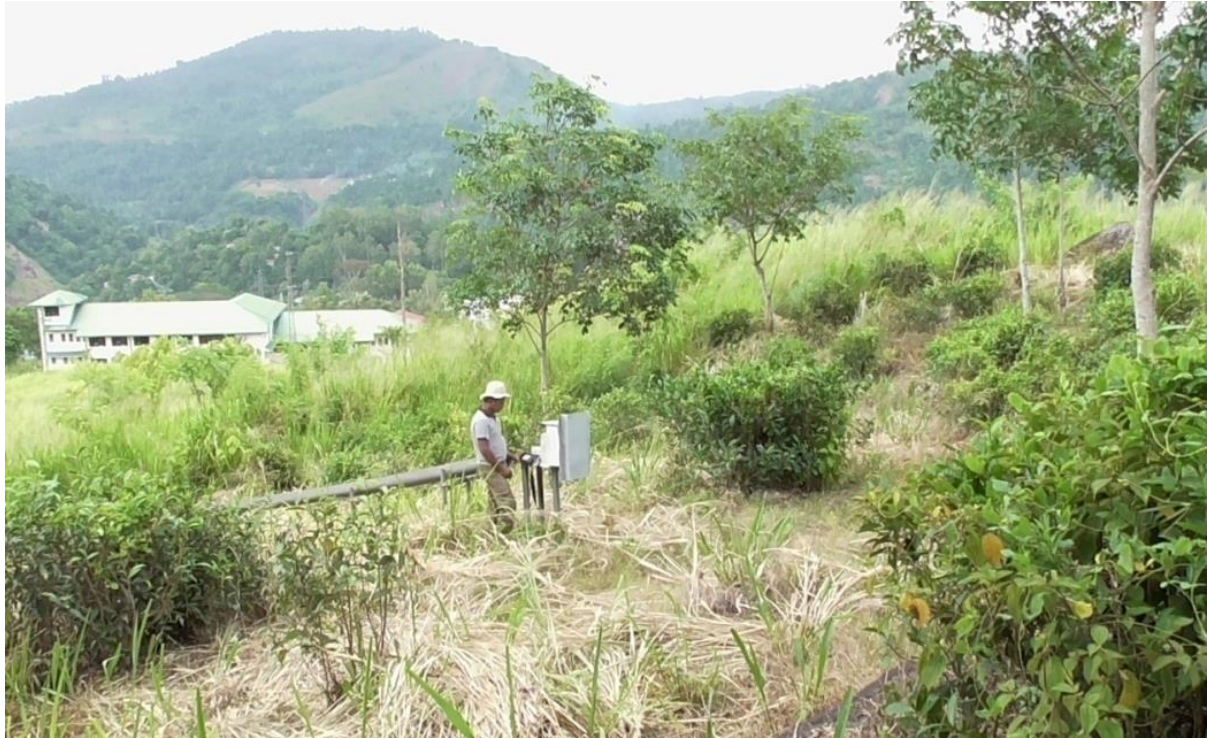
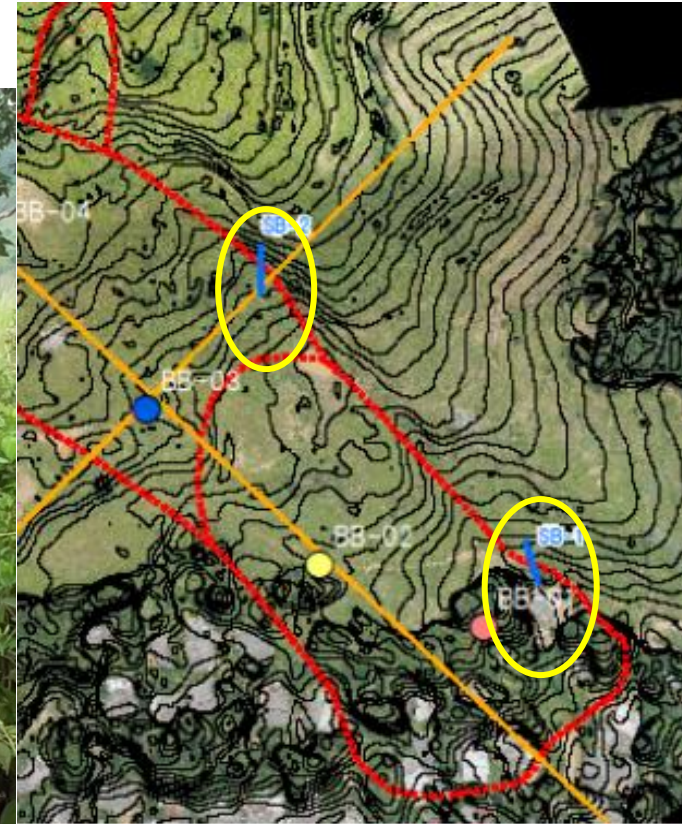
## Extensometers are used to detect ground movements at surface level

One end is outside the potential slide area and the other within the slide area. Identify appropriate locations by a careful study

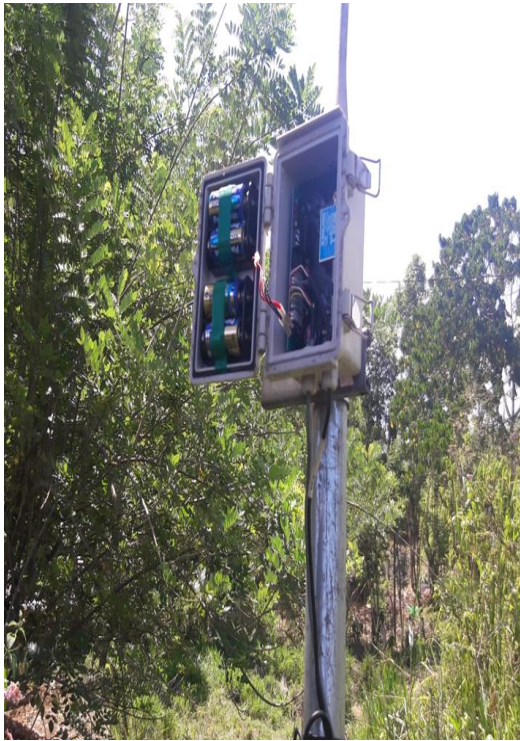
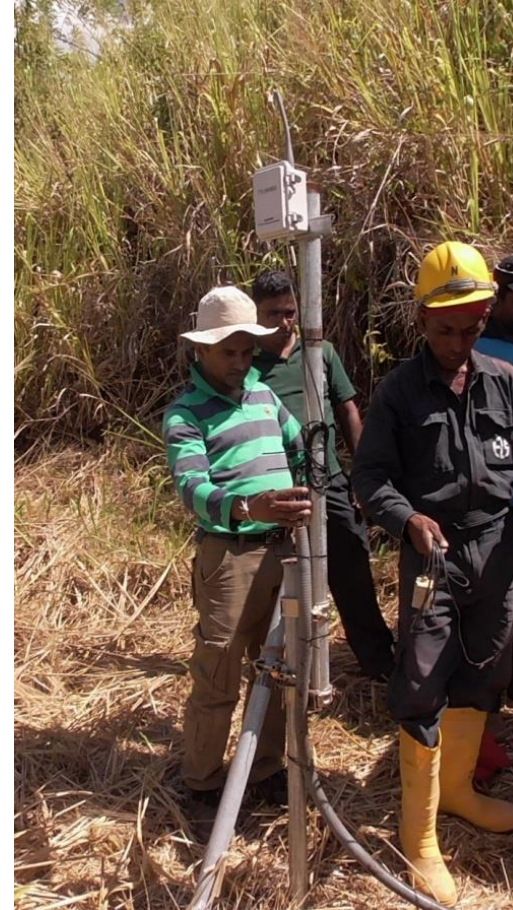
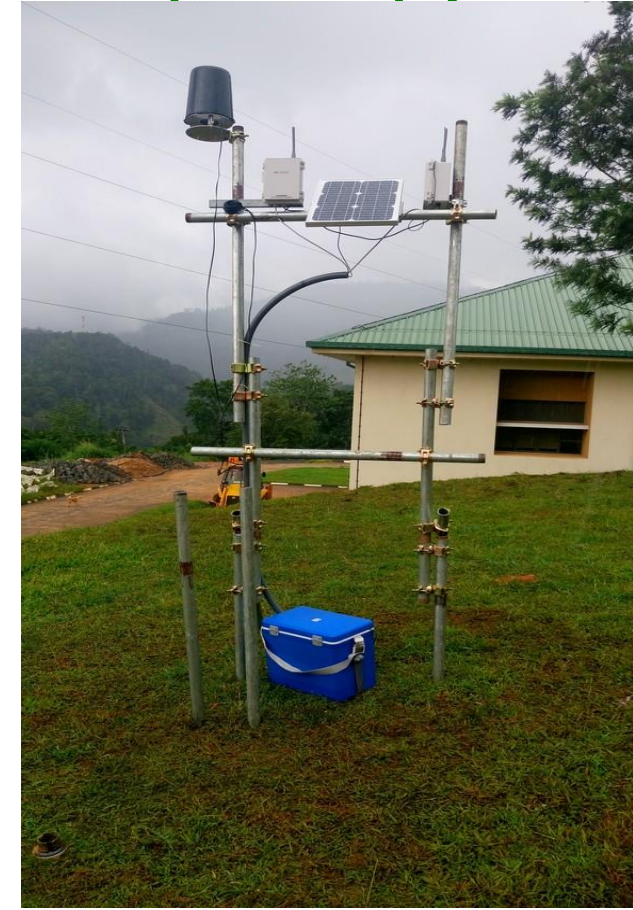
# Tilt Sensors Uchimura, Towhata, Lin Wang (joint research with University of Tokyo)

Capable of measuring tilt angles (rotations) and progressive deformations.

The long wire of an extensometer is not required, and therefore, the installation and maintenance are simple and inexpensive.

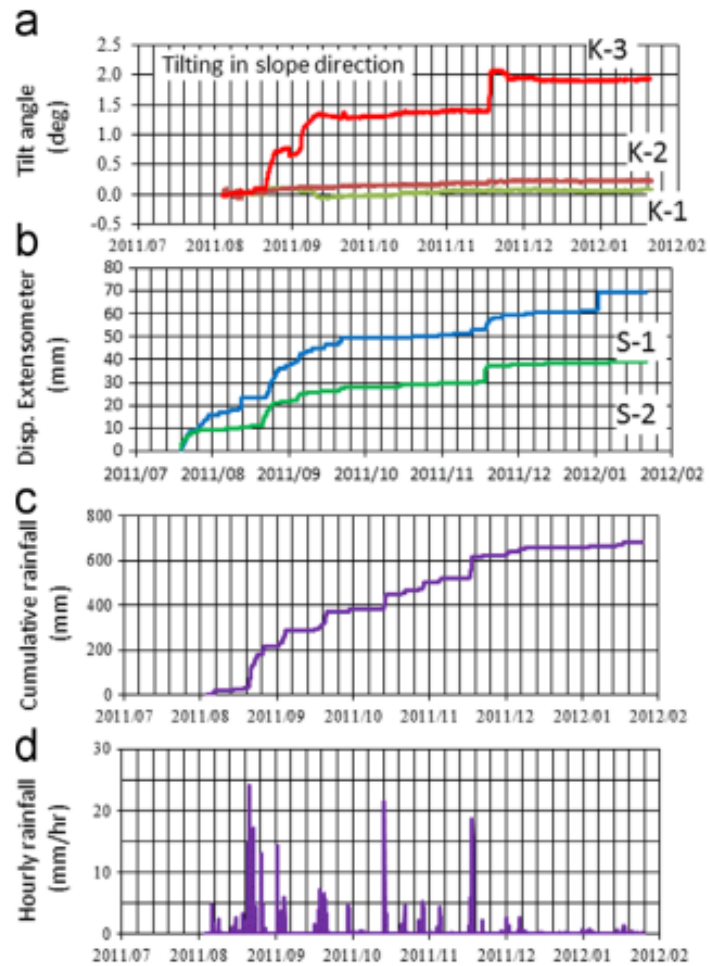
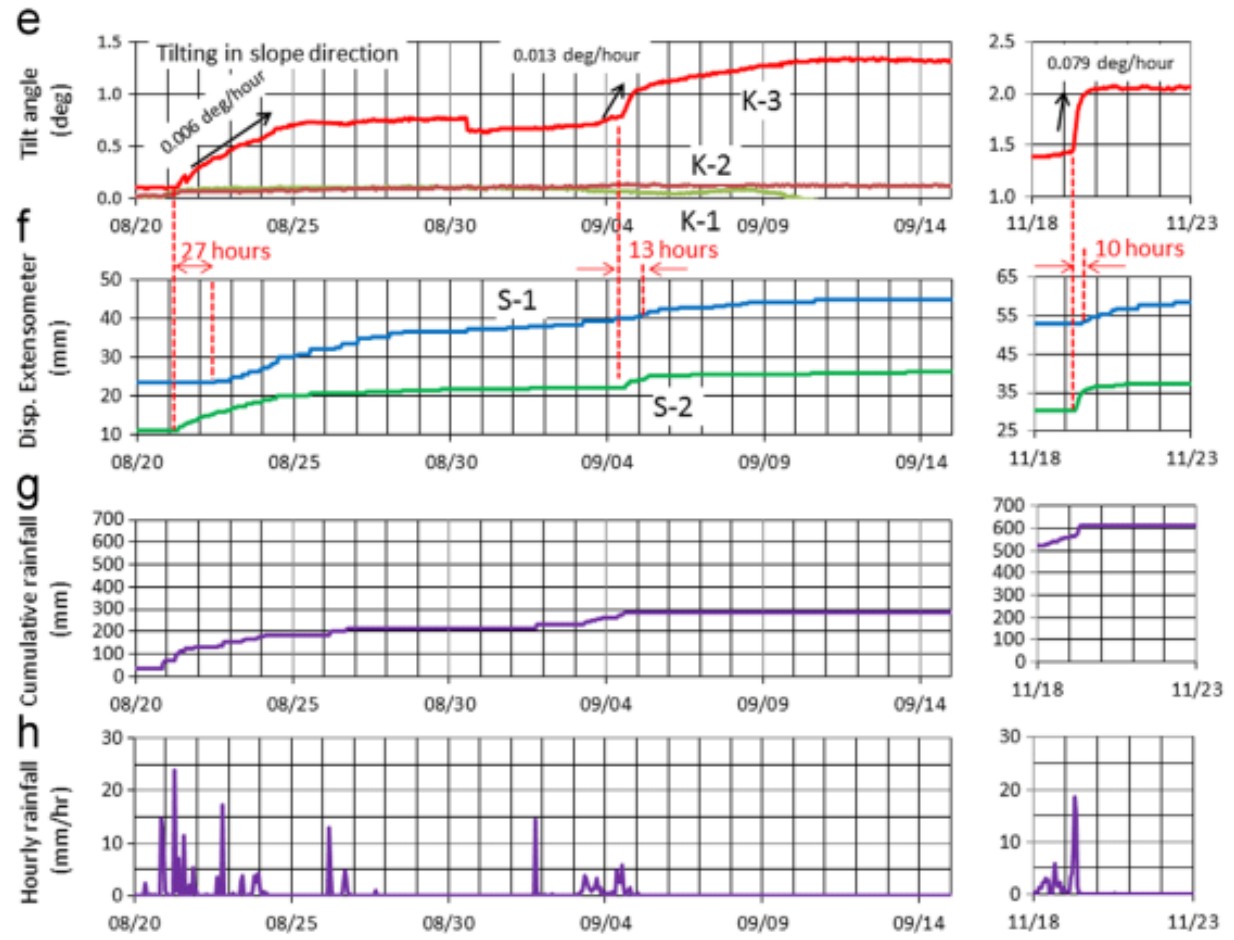
## Time histories of monitored items

(d) rainfall

- a) Tilt angles by surface tilt sensors
- b) displacements by extensometers
- c) accumulated amount of rain
- d) rainfall intensity
- e-h) Zoom up for heavy rainfall events

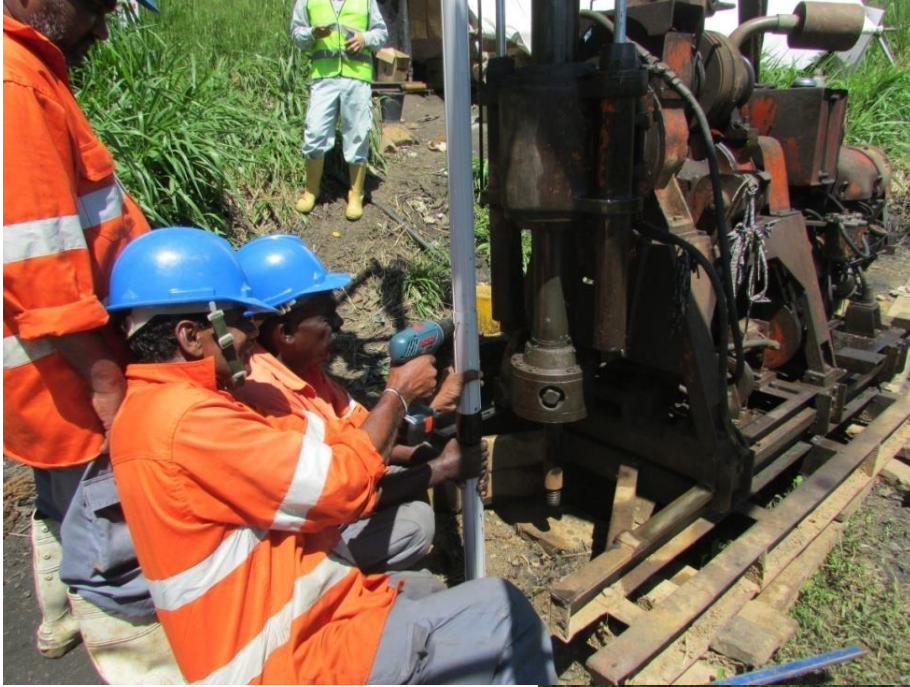
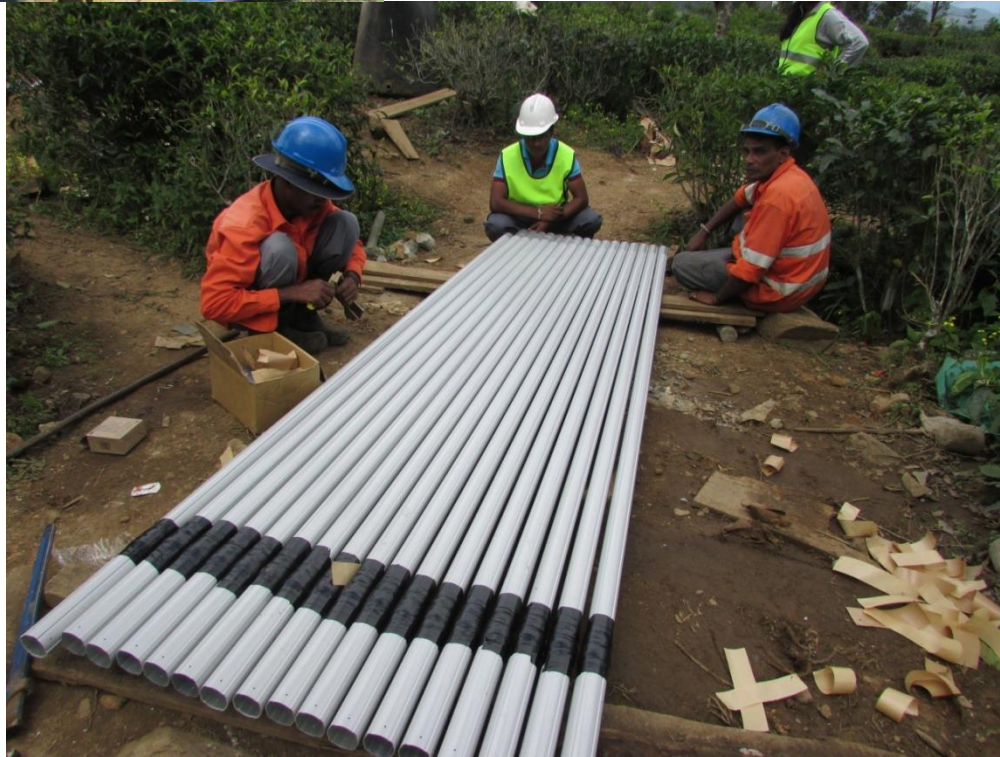
Inclinometer  
-Installation

Inclinometer tubes are used to identify deeper level surface movements along a potential sliding surface.

Should extend below the potential failure surface

The commonly used probe is a biaxial probe which contains two perpendicular accelerometers, so only two passes of the probe are required to measure movement in the four different directions.

One accelerometer measures the tilt in the plane of the inclinometer wheels which tracks the longitudinal groove of the casing, while the other accelerometer measures the tilt in the plane perpendicular to the wheels. Thus, in a biaxial probe, the A-sensor is oriented to the A direction which is parallel to the wheels of the probe, and the B-sensor is oriented transverse to the wheels in the probe.

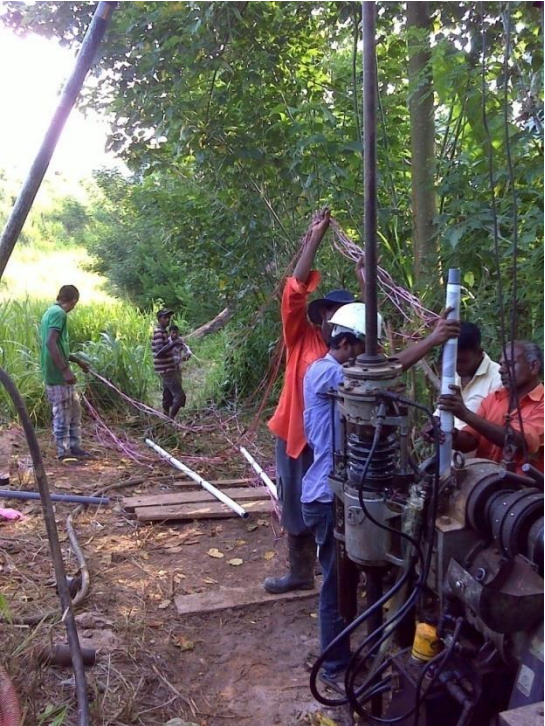
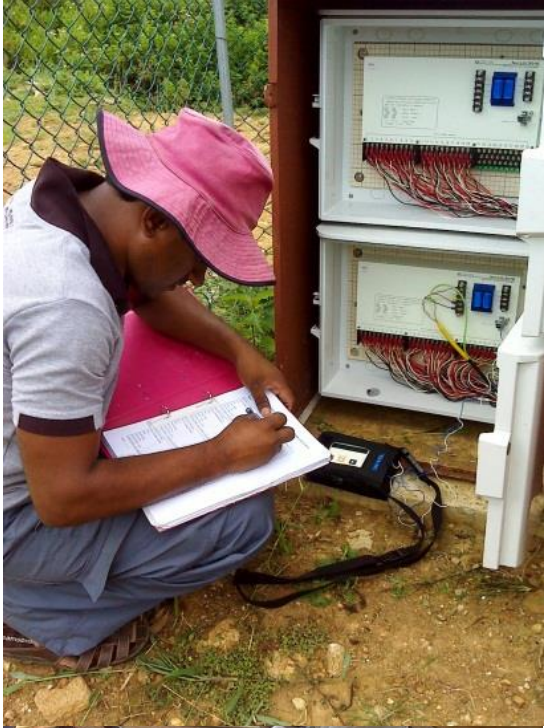
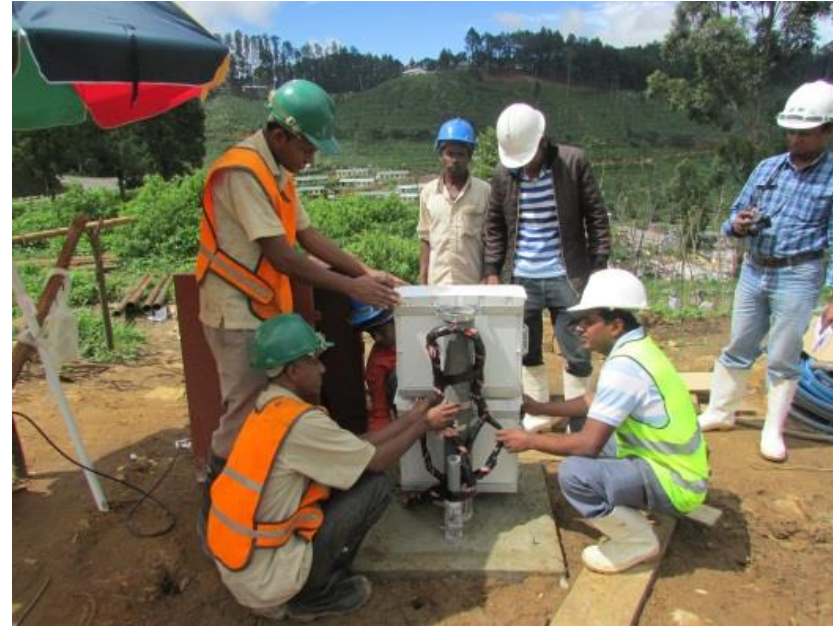
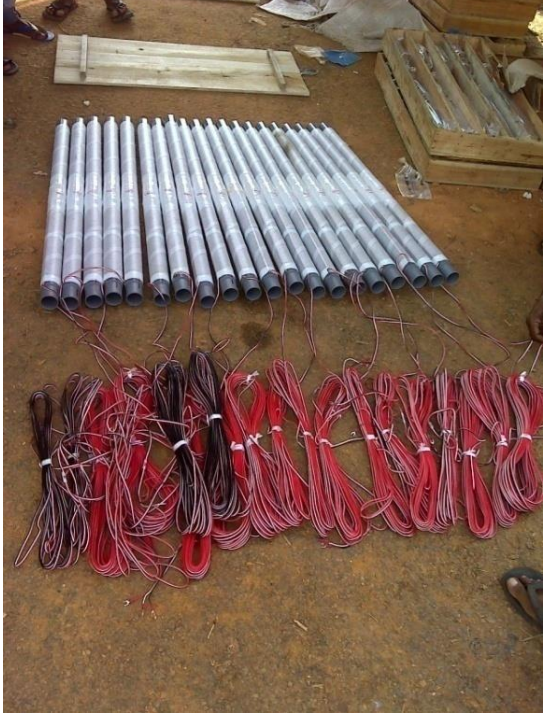
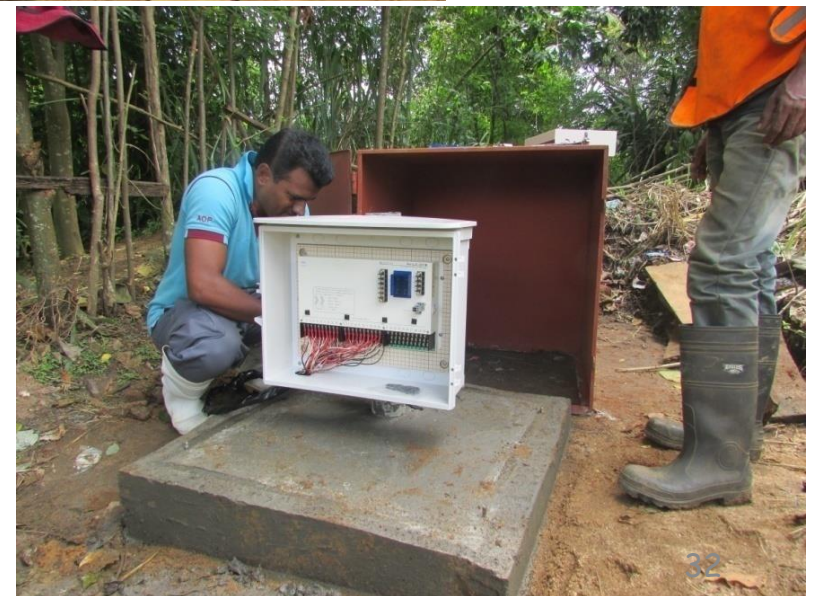
# Landslide Monitoring with Strain gauges

Are used to identify strains - movements at different depths

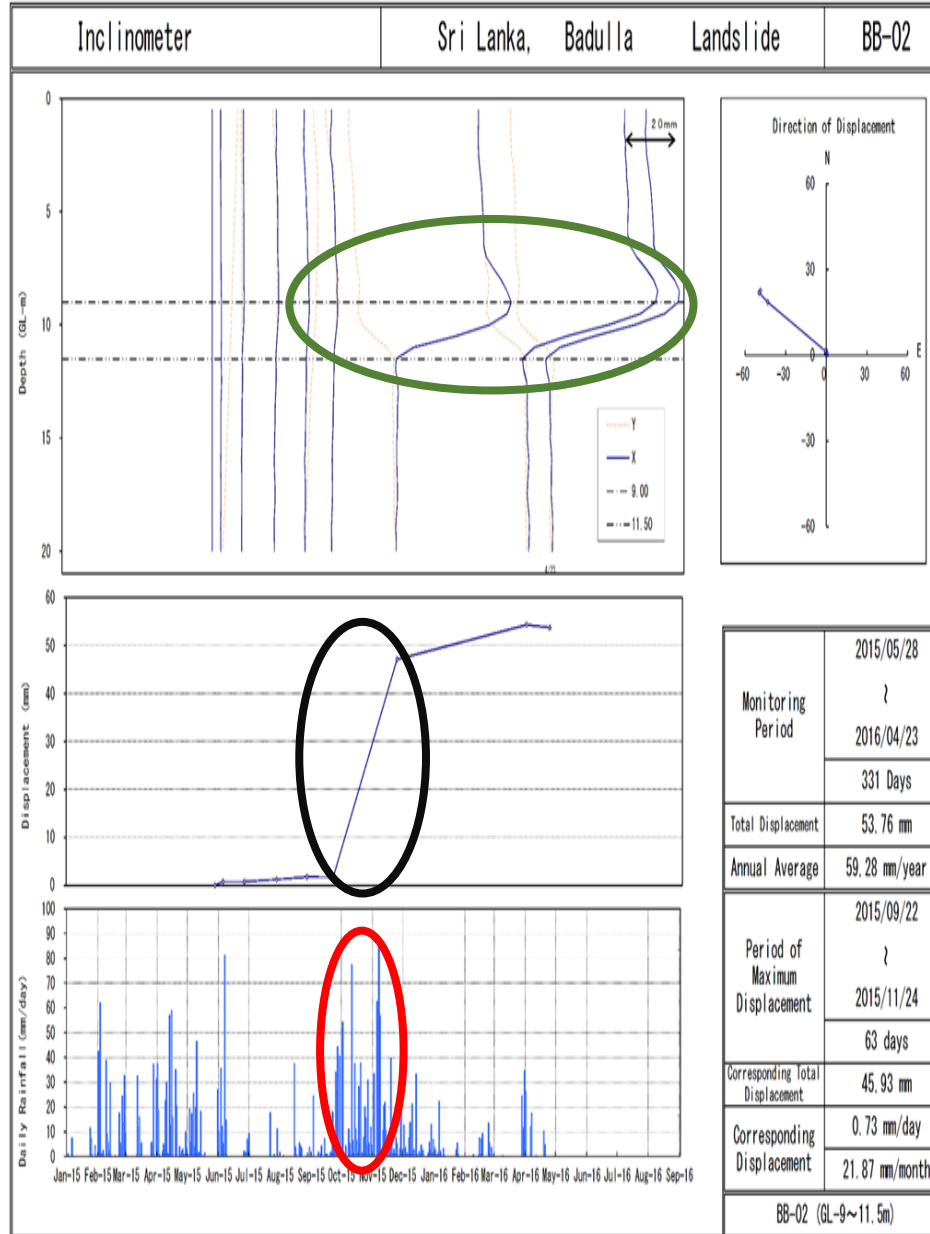
# Response of inclinometer to rainfall

- Considerable cumulative displacement were observed at the depth of GL- 9.5 m - 11.5 m of BB-2 inclinometer.
- From the end of September 2015 to the end of November, active movement occurred at that depth.
- The displacement was 45 mm during 2 months.
