# Reduction of Landslide Risk in Sri Lanka

## Part 2 - Landslide Hazard Zonation and Monitoring

Time Capsule project of ISSMGE  
Sri Lankan Geotechnical Society

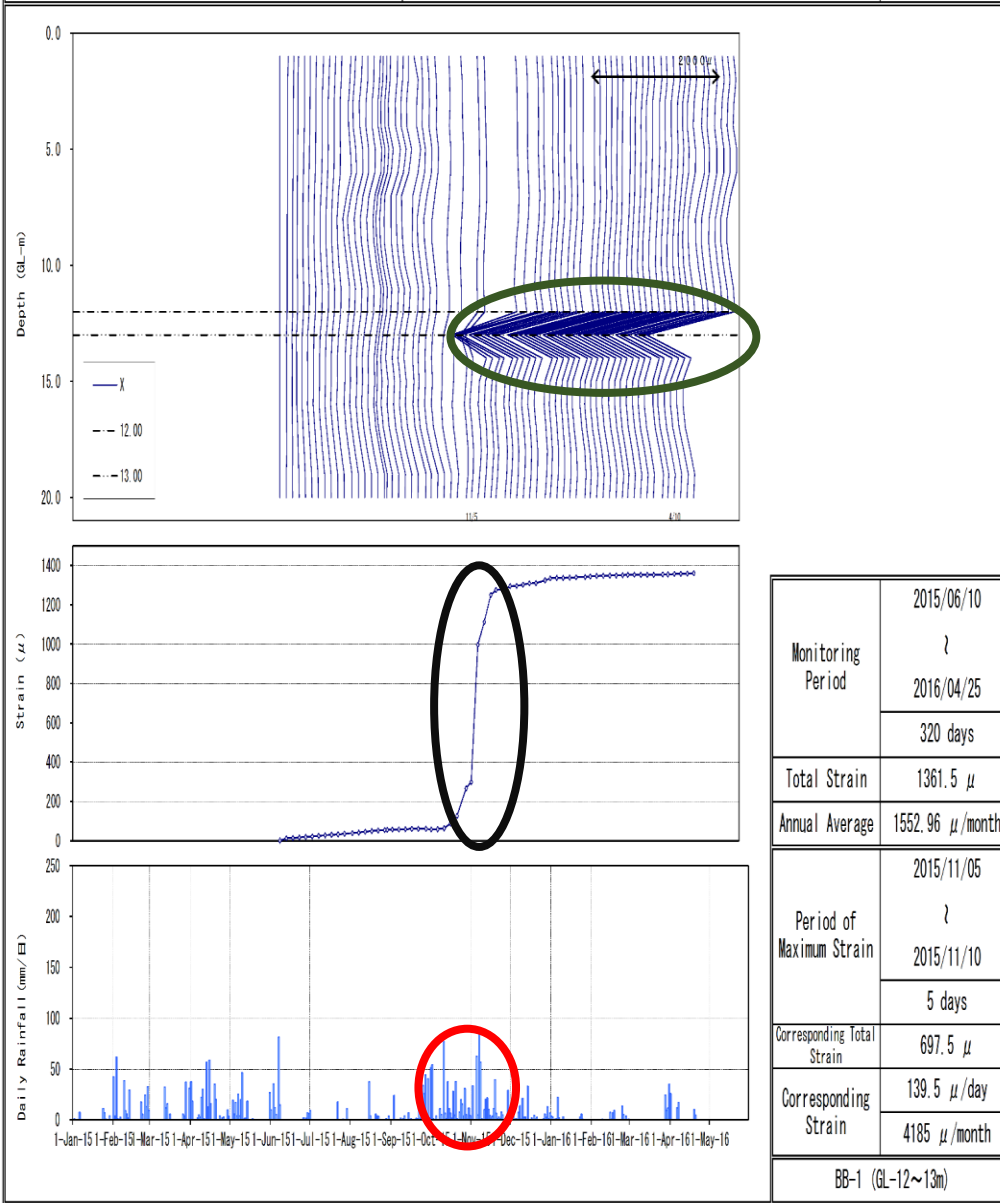
## Response of Pipe Strain gauge to rainfall

- A considerable cumulative displacement were observed at the depth of G.L-12.0 m - 13.0 m of BB-1 inclinometer.
- The movement has increased from the end of October 2015 to the middle of November 2015.
