Reduction of Landslide Risk in Sri Lanka

Part 4 - Mitigation of Landslide Risk by Multiple Measures- Case Histories from; Southern Expressway, Ginigathhena and Kahagolla

Time Capsule project of ISSMGE
Sri Lankan Geotechnical Society

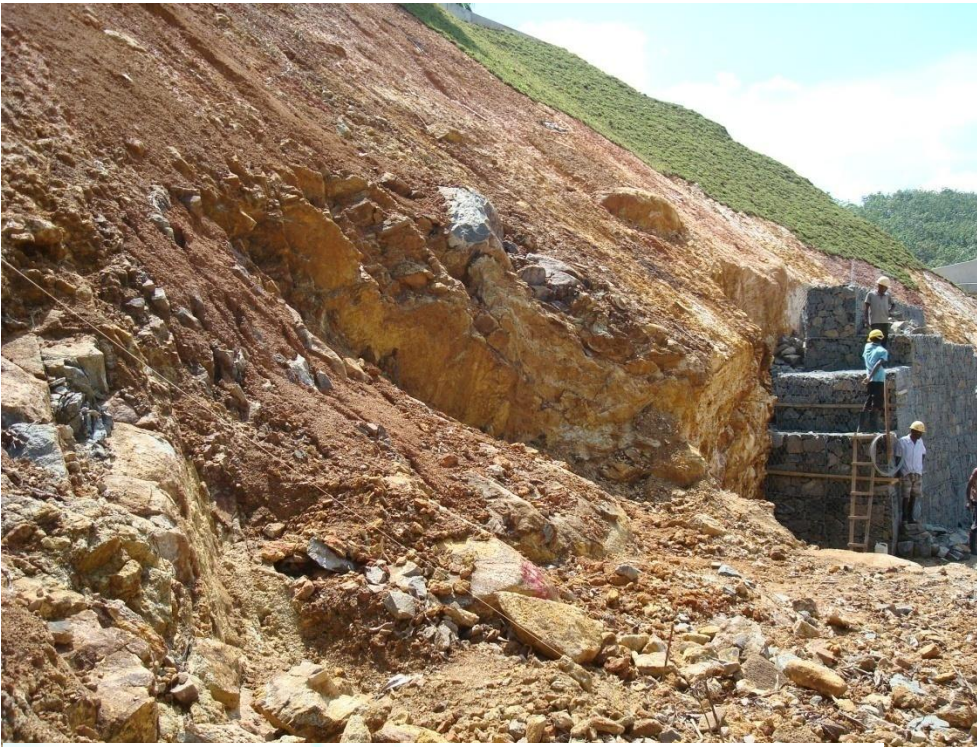
This cut for a bypass road in the Southern expressway was supported by gravity wall at the toe in addition to surface drainage measures. With that the house at the crest could be saved.

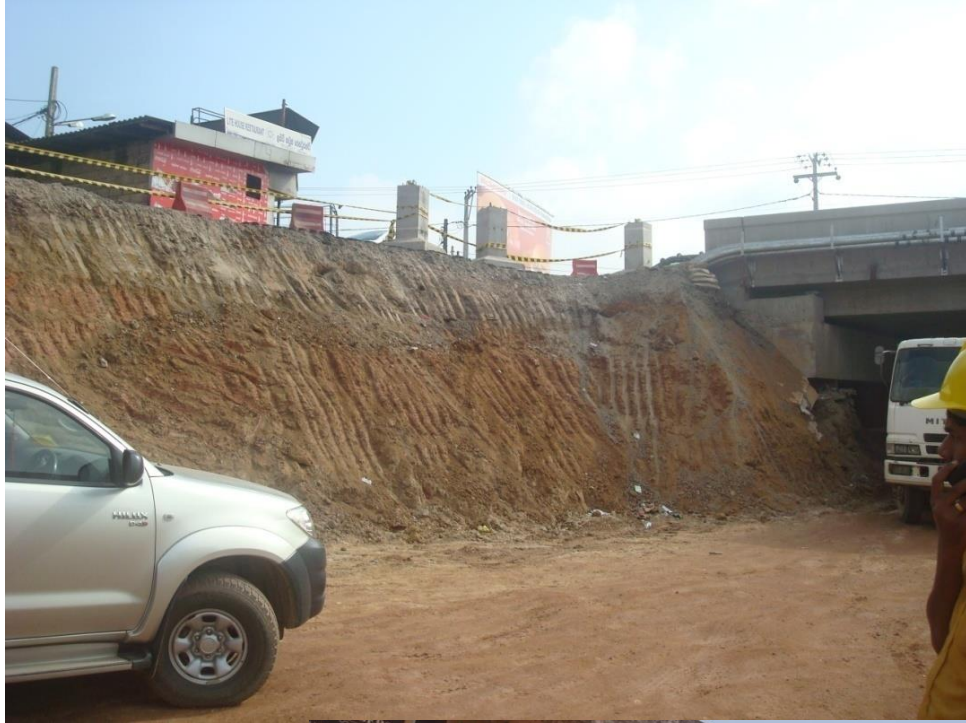
Construction of a Mass Concrete wall to support a cutting in the CKE - Approach to the underpass at A3.
The soil in the cut is a strong lateritic soils in an unsaturated state. It can remain stable under dry conditions but the wall was constructed and surface drainage was improved to ensure stability in all seasons

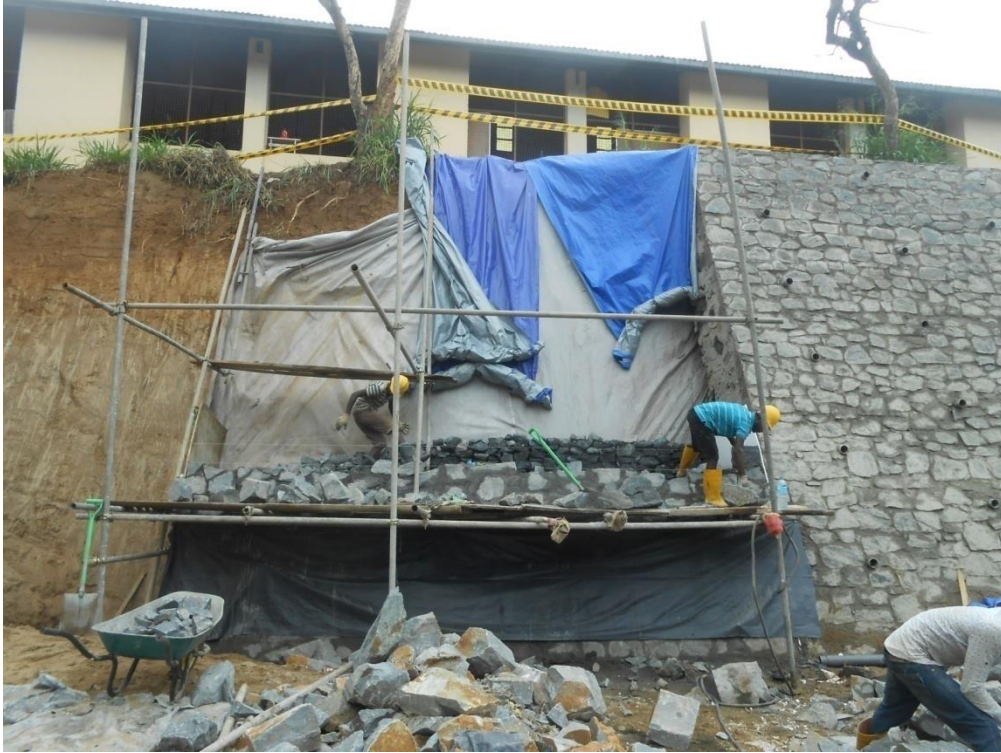
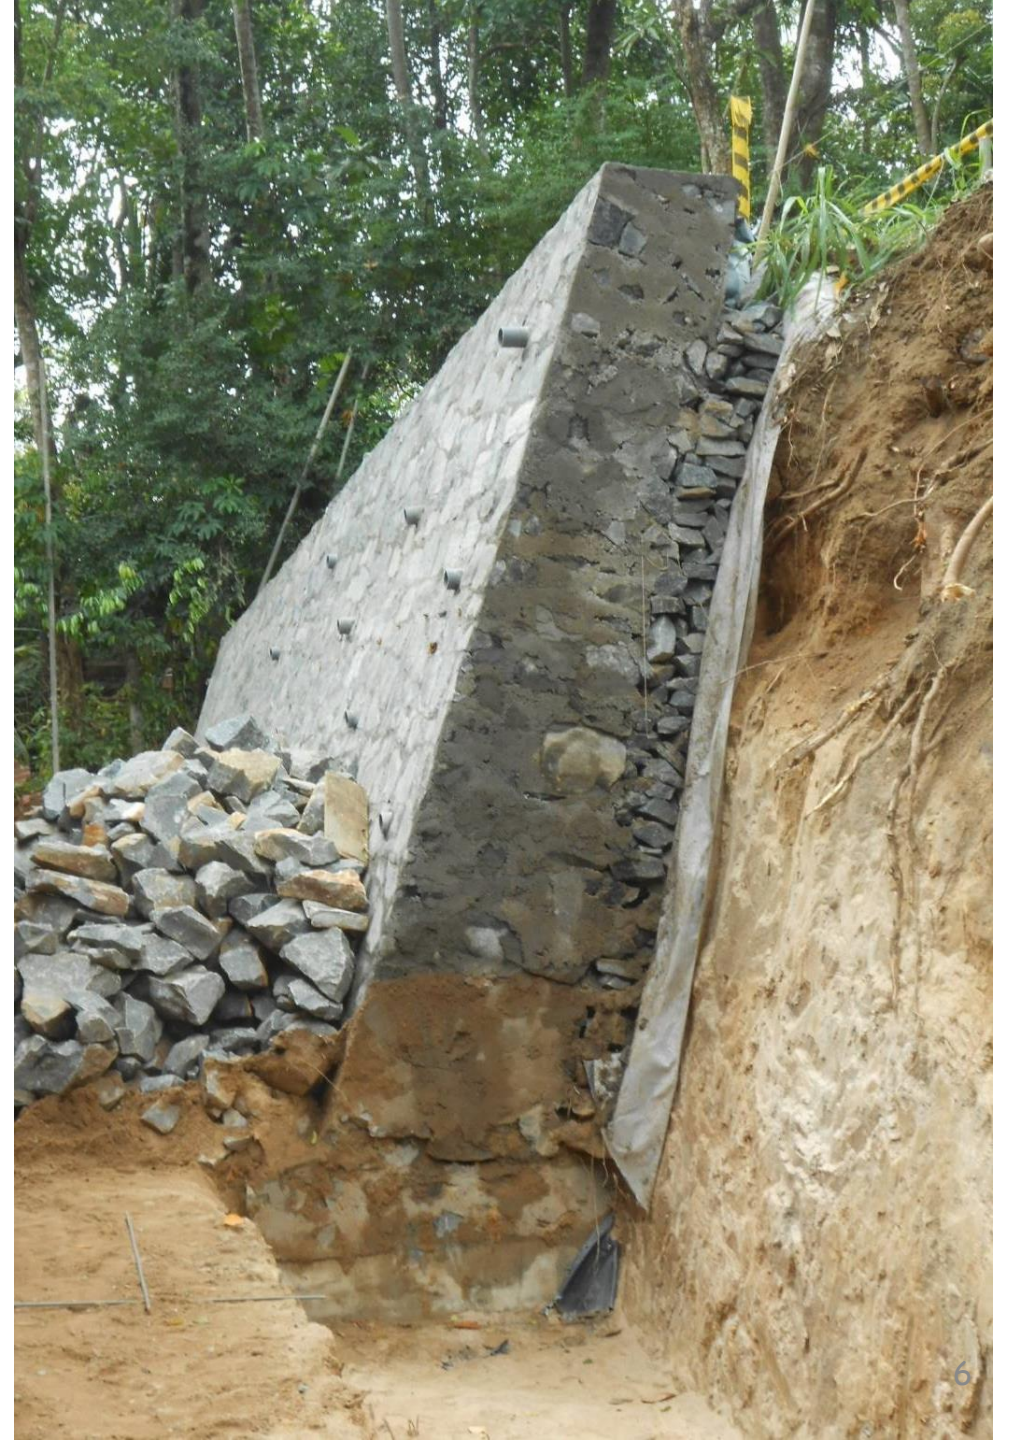
Gravity Walls with back batter Supporting an existing slope which is unstable during periods of heavy rain.

Drainage layer behind the wall and geotextile behind the drainage layer.

A surface drain was constructed behind the wall.

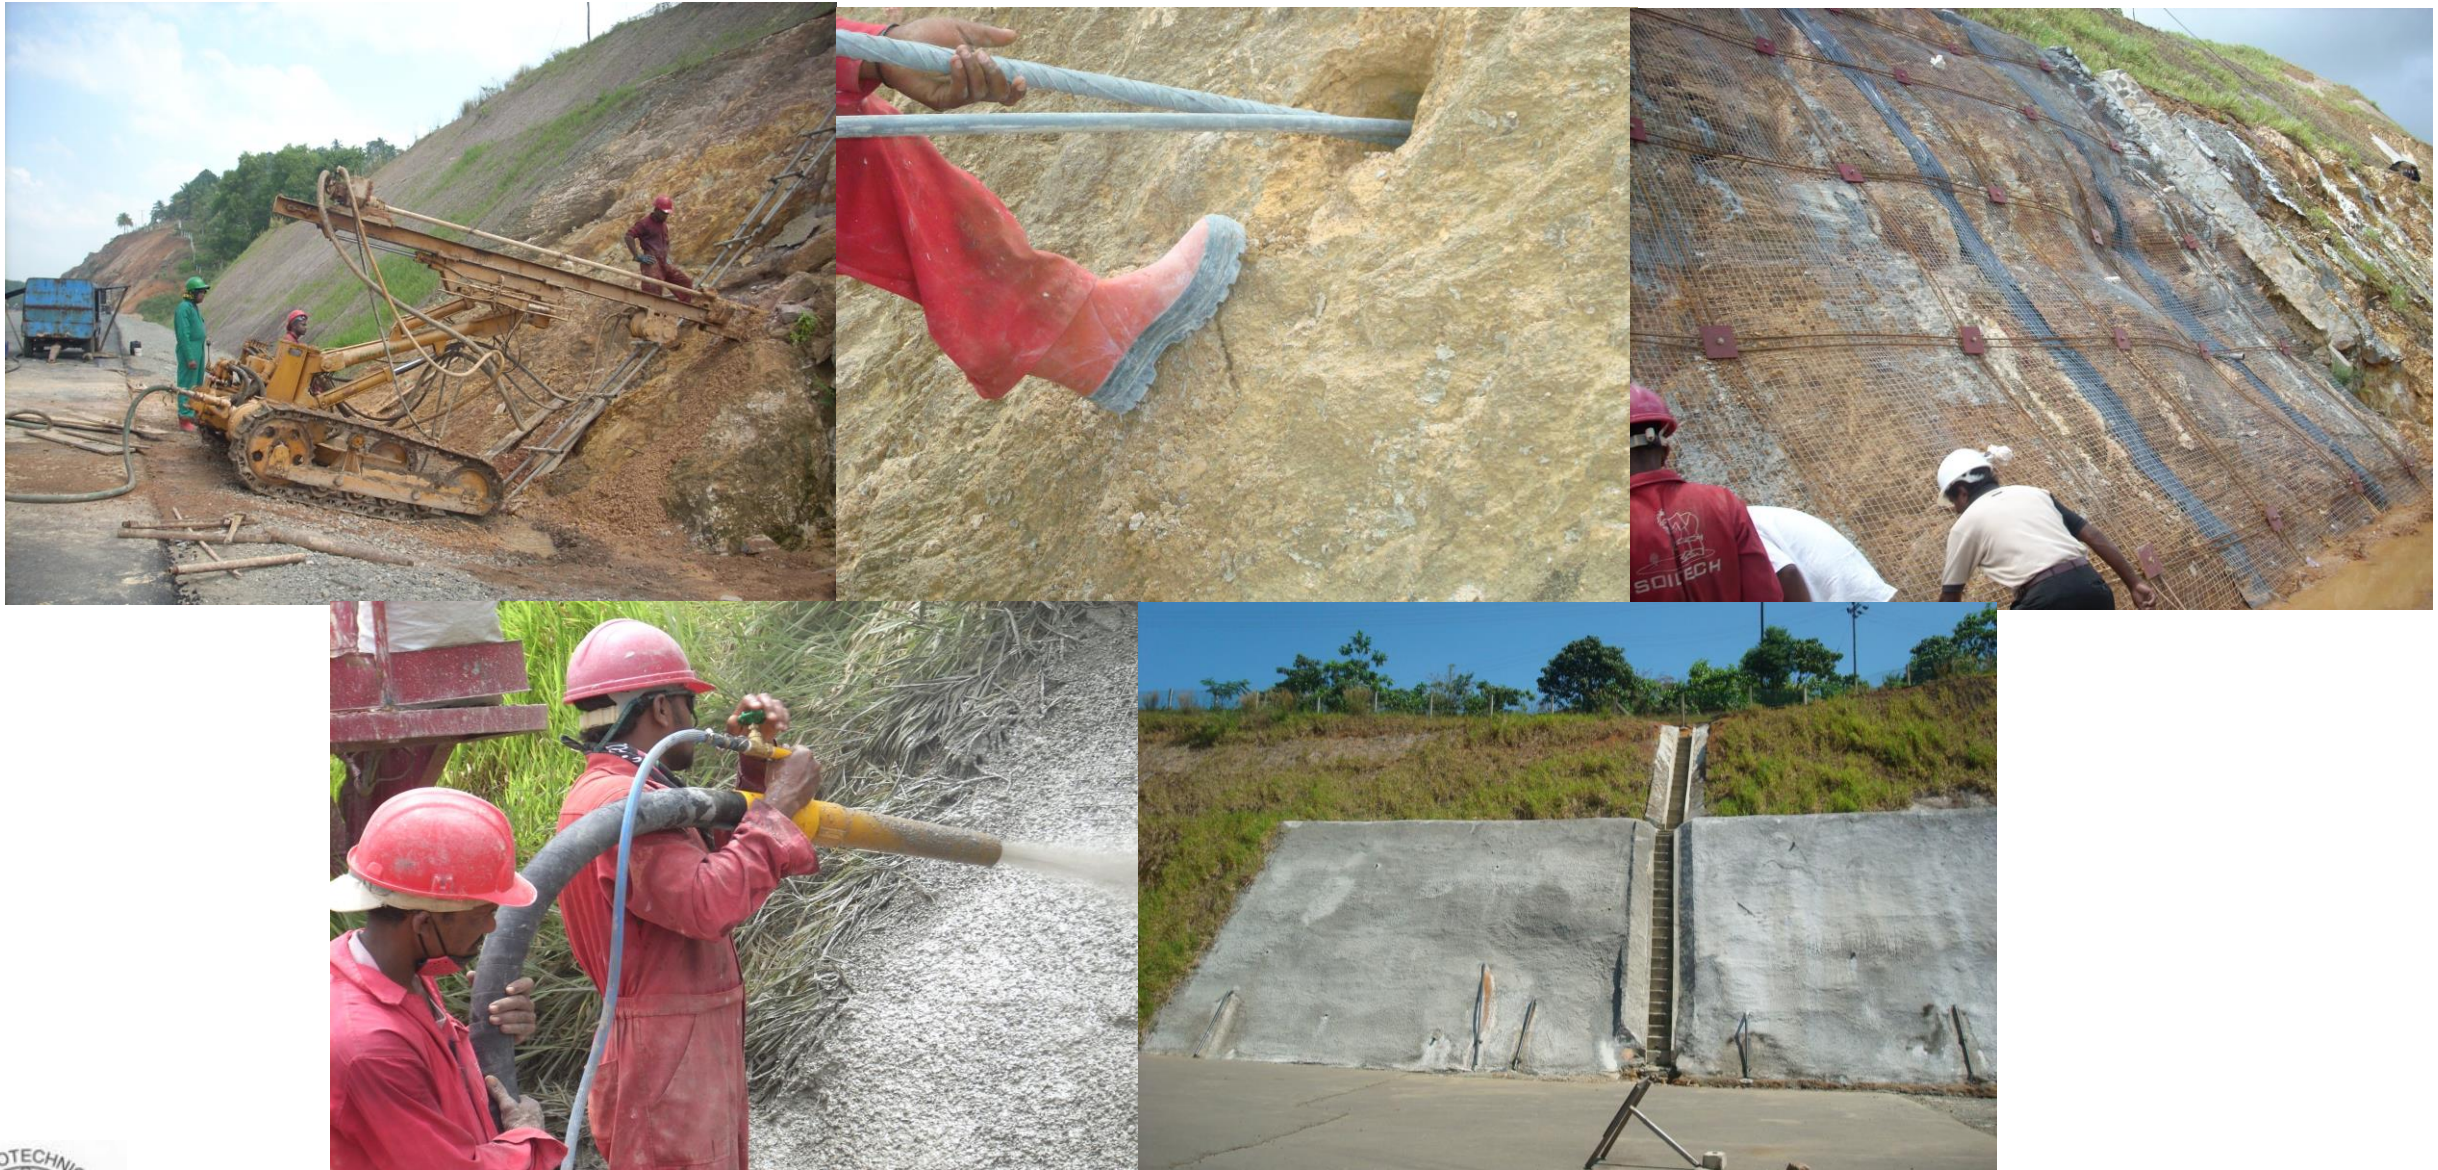
Soil Nailing in the Southern Transport Development Project

Drilling the hole, installing the nail and grouting, placement of reinforcement and shotcreting

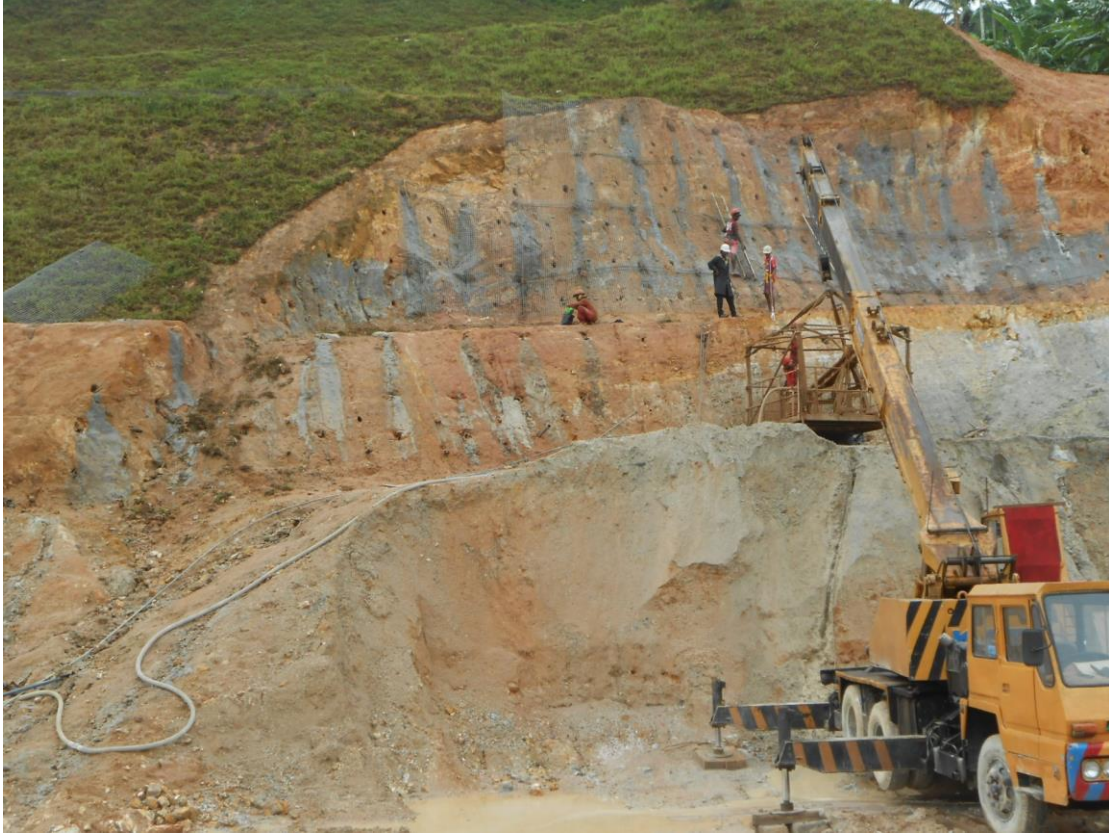
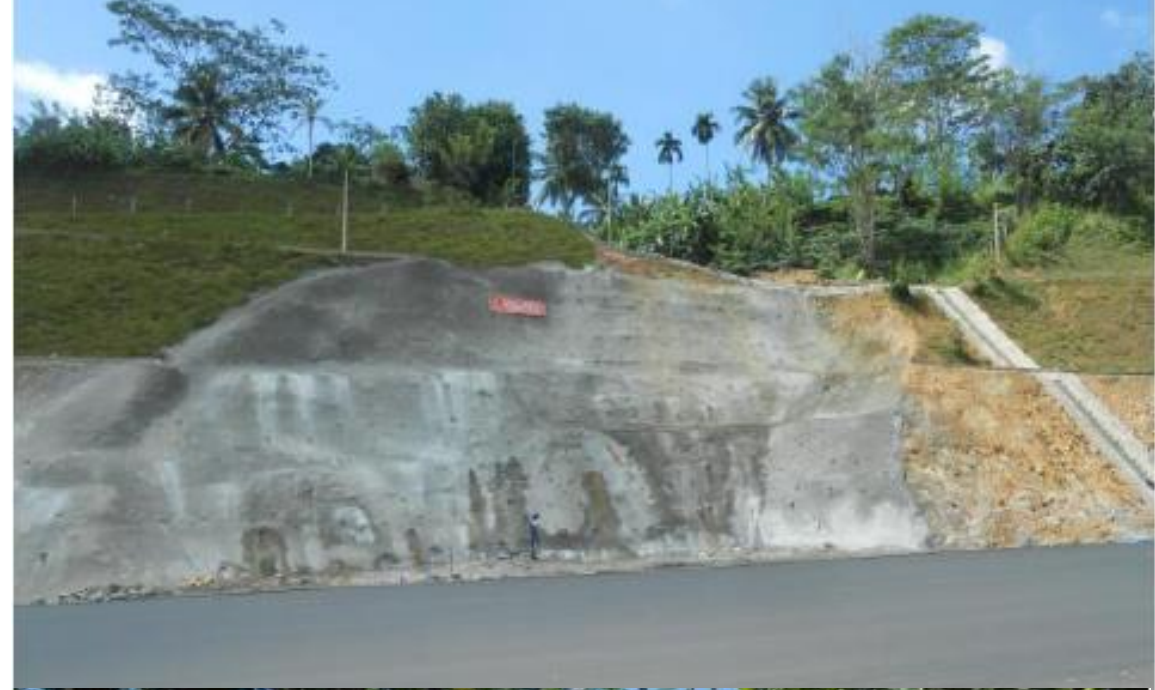
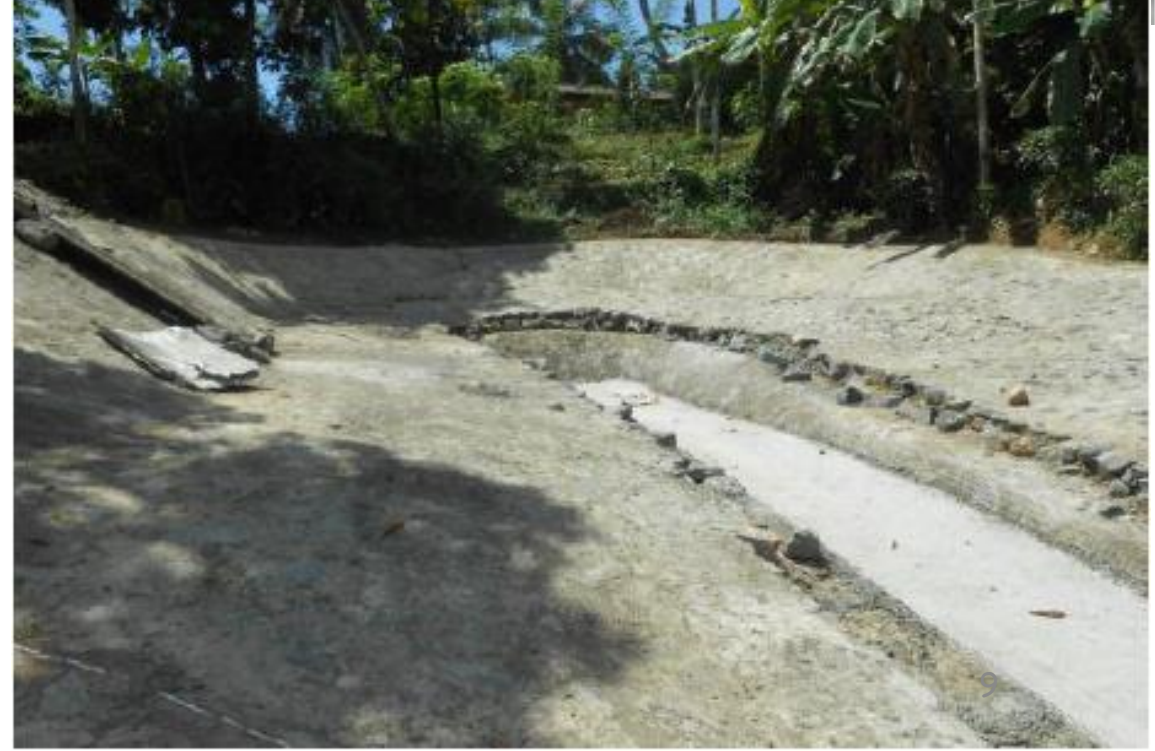
Soil Nailing with a shotcrete facing

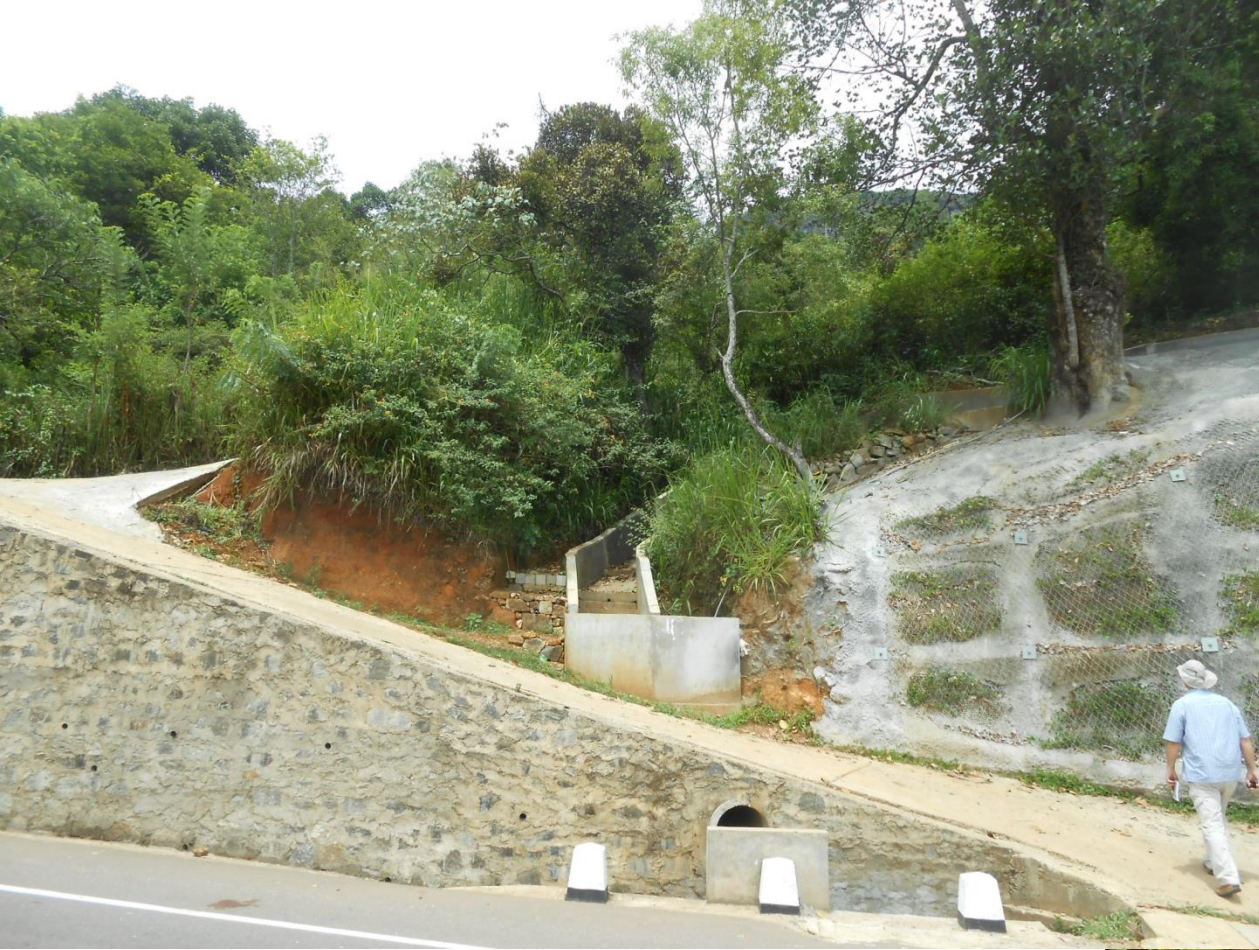
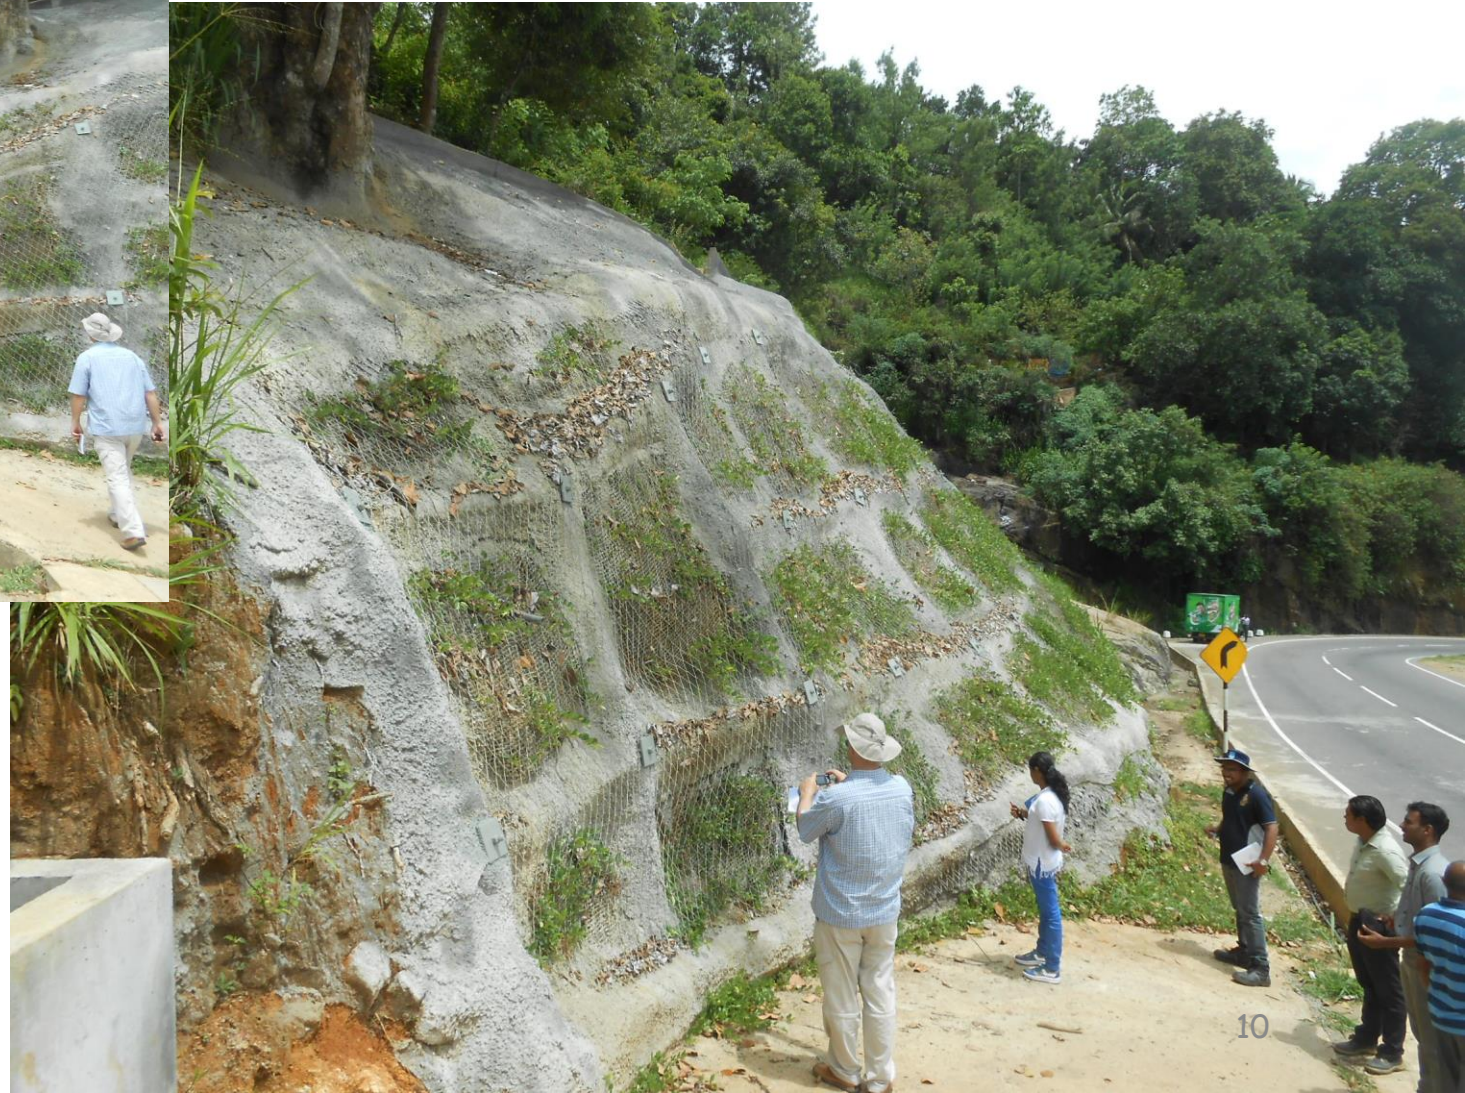
A basin drain at the valley to collect all the water and direct that to a cascade drain

Nail heads are connected by beams.
In between, vegetation introduced
by hydroseeding

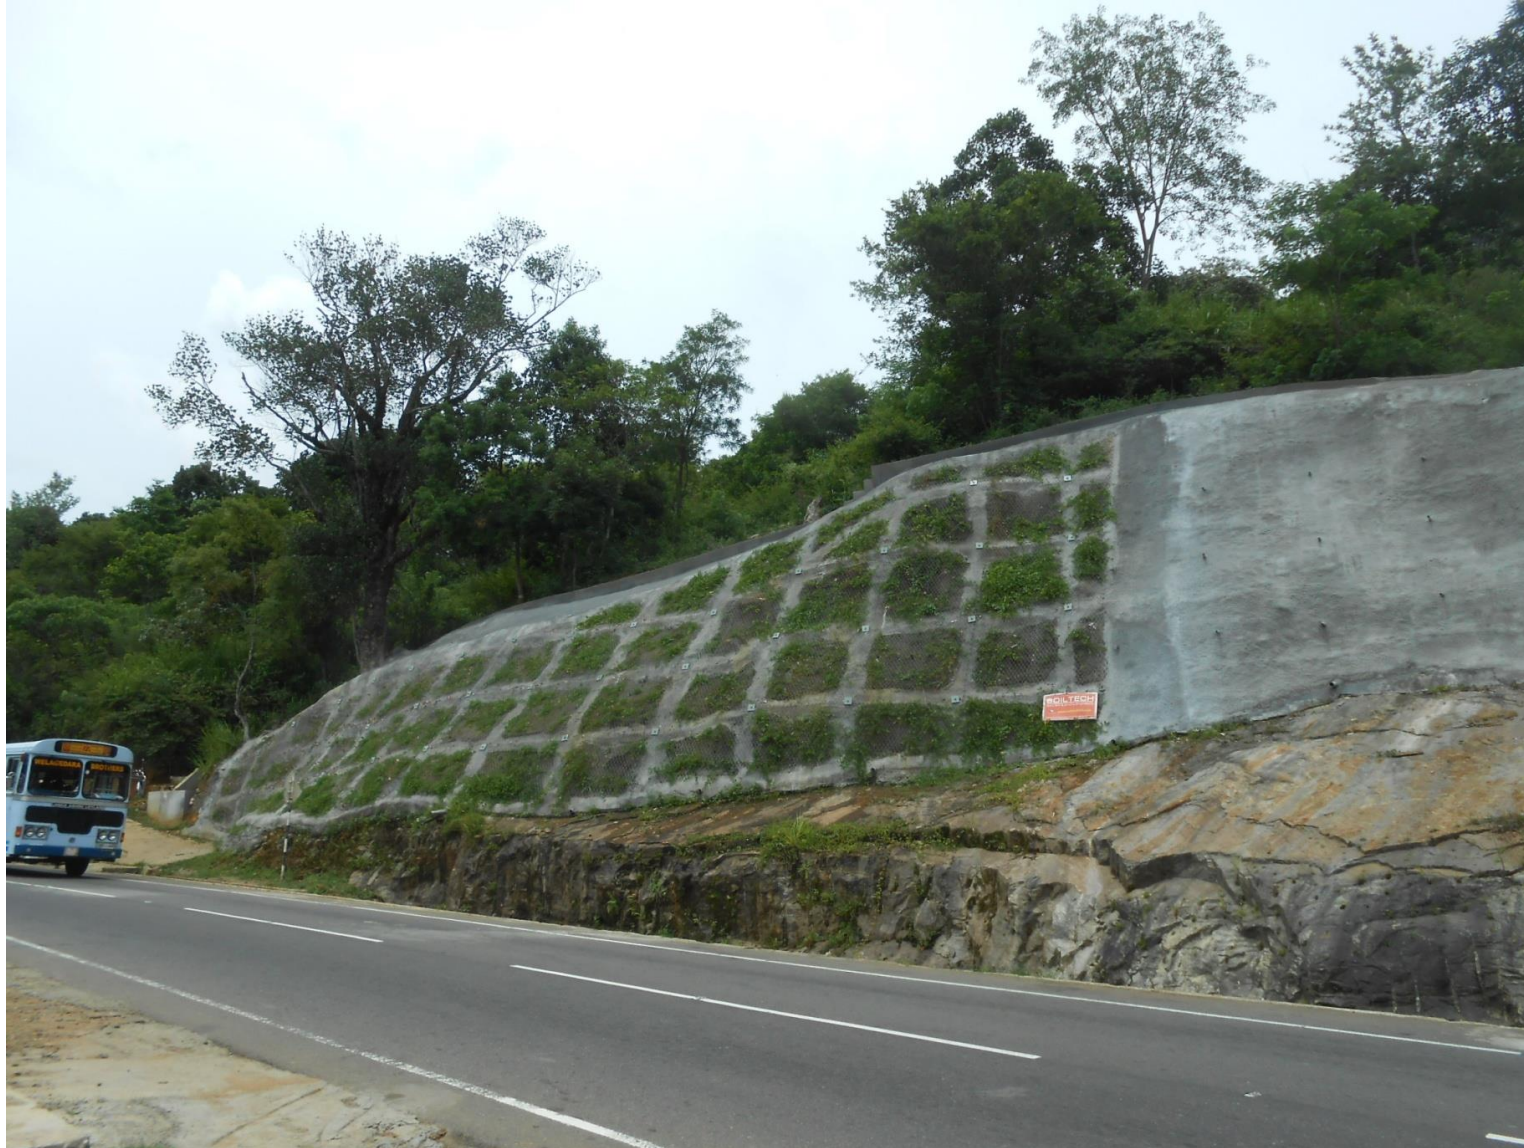
Cut off drains at
the crest of the
slope

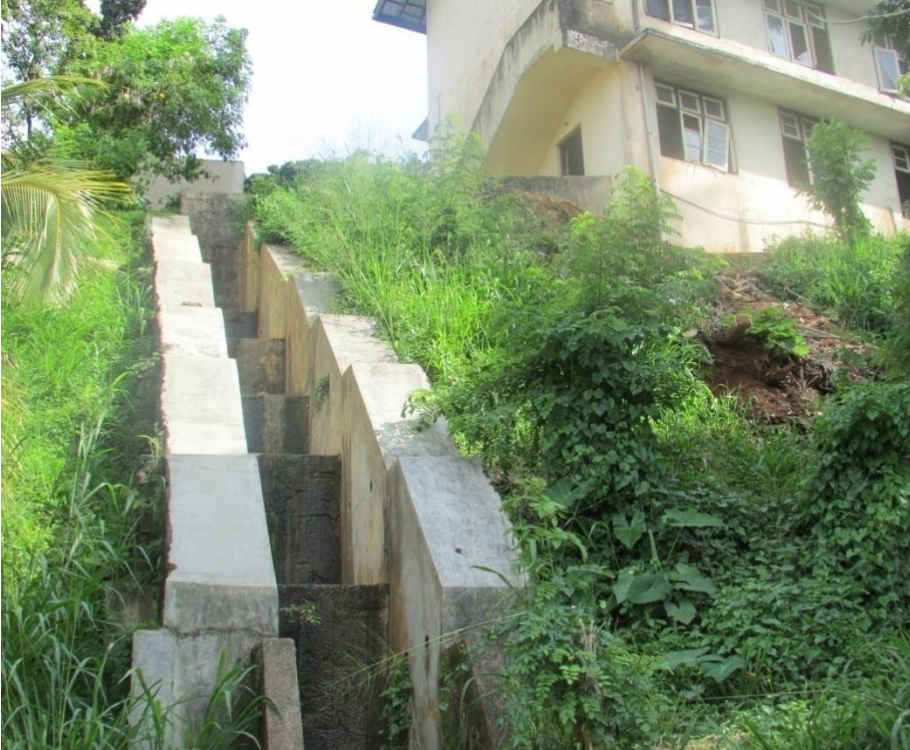
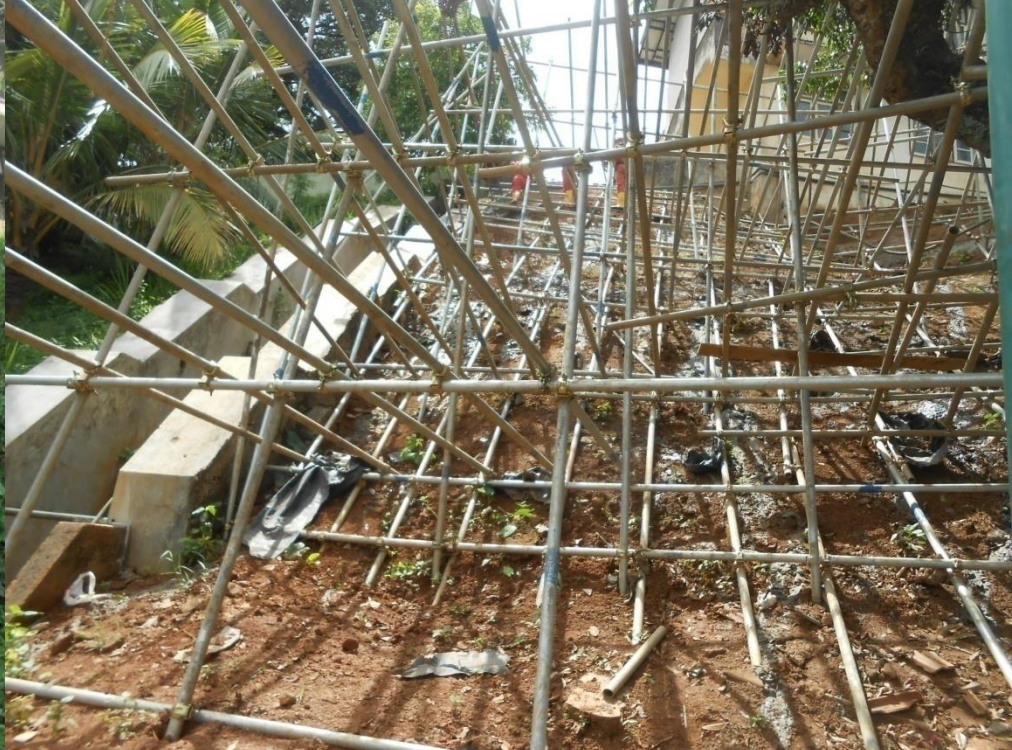
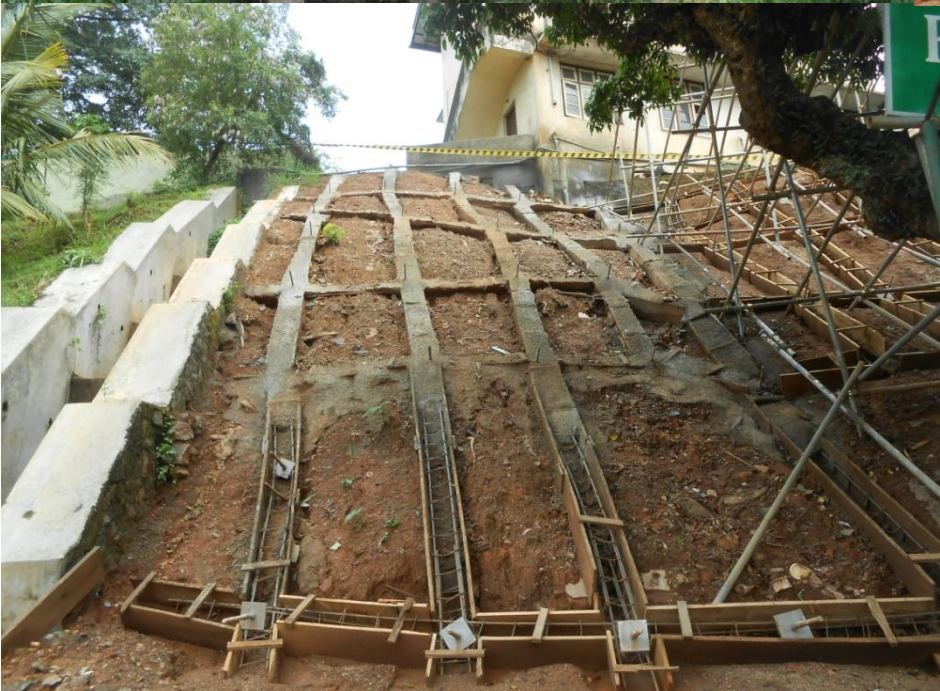
Portion of the slope covered with shotcrete as vegetation could not be established in the fractured rock with closely spaced joints.

**Soil Nailing with beams connecting nail heads and vegetation
Mahamaya College - Kandy**

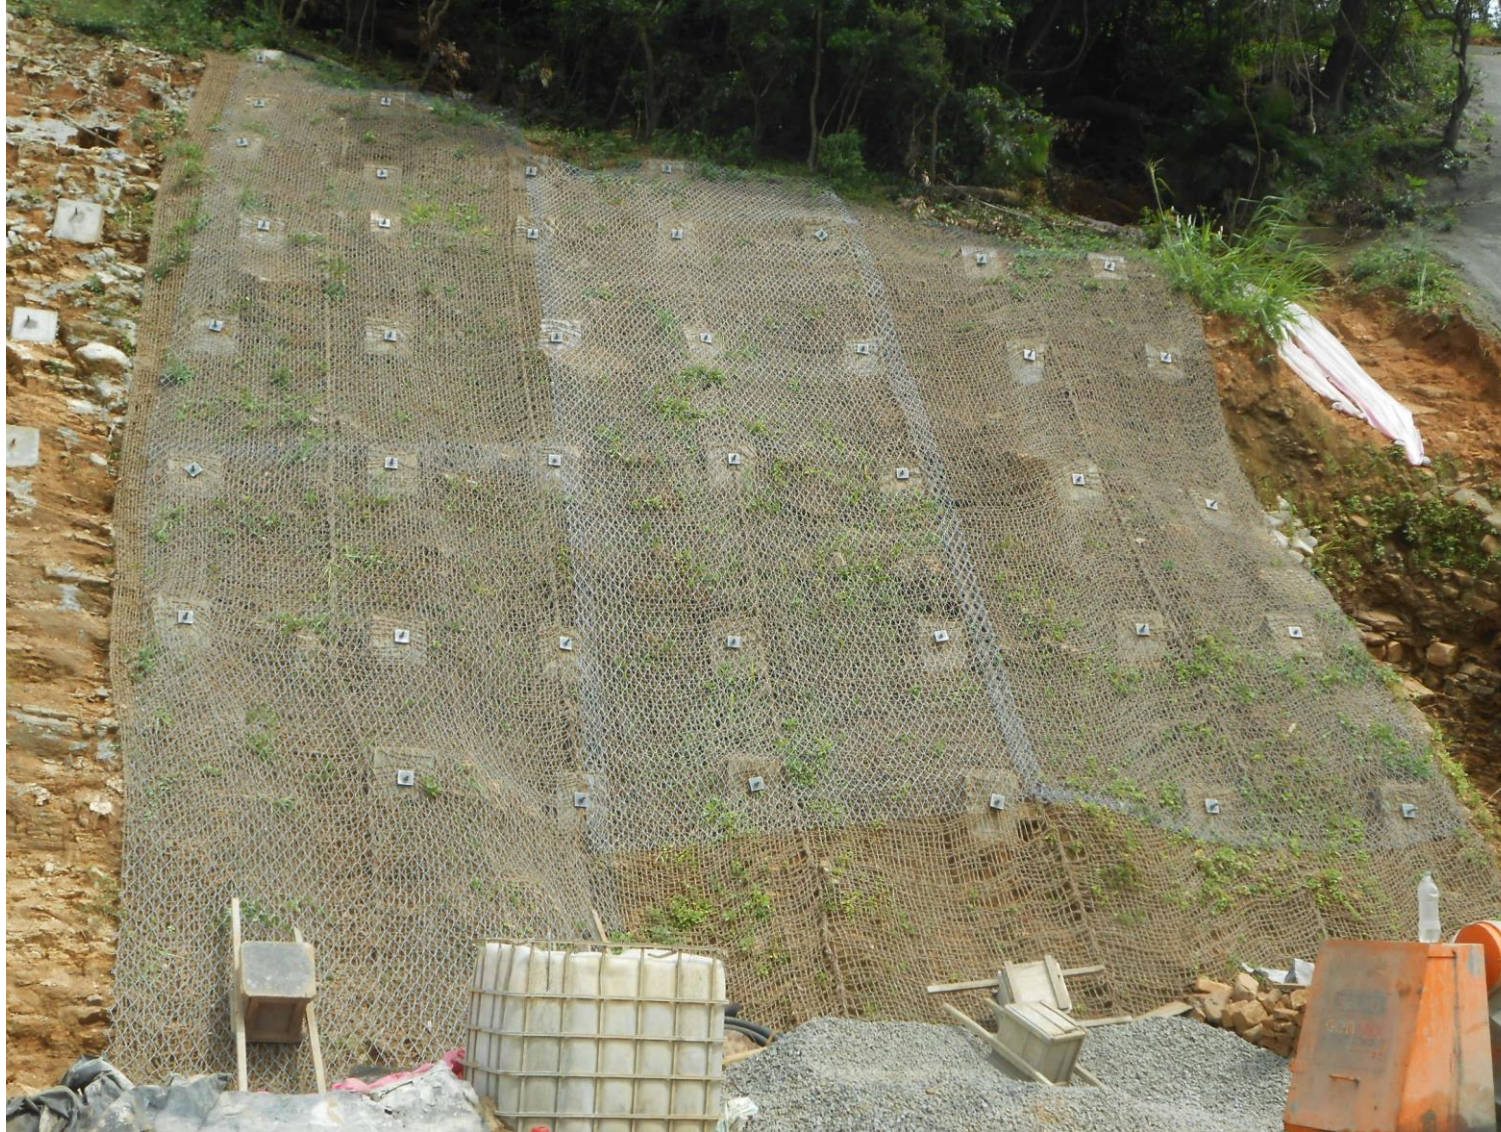
Protective net and coir mat introduced to provide surface cover by hydro seeding
Location 10 Kandy Mahiyangana Road

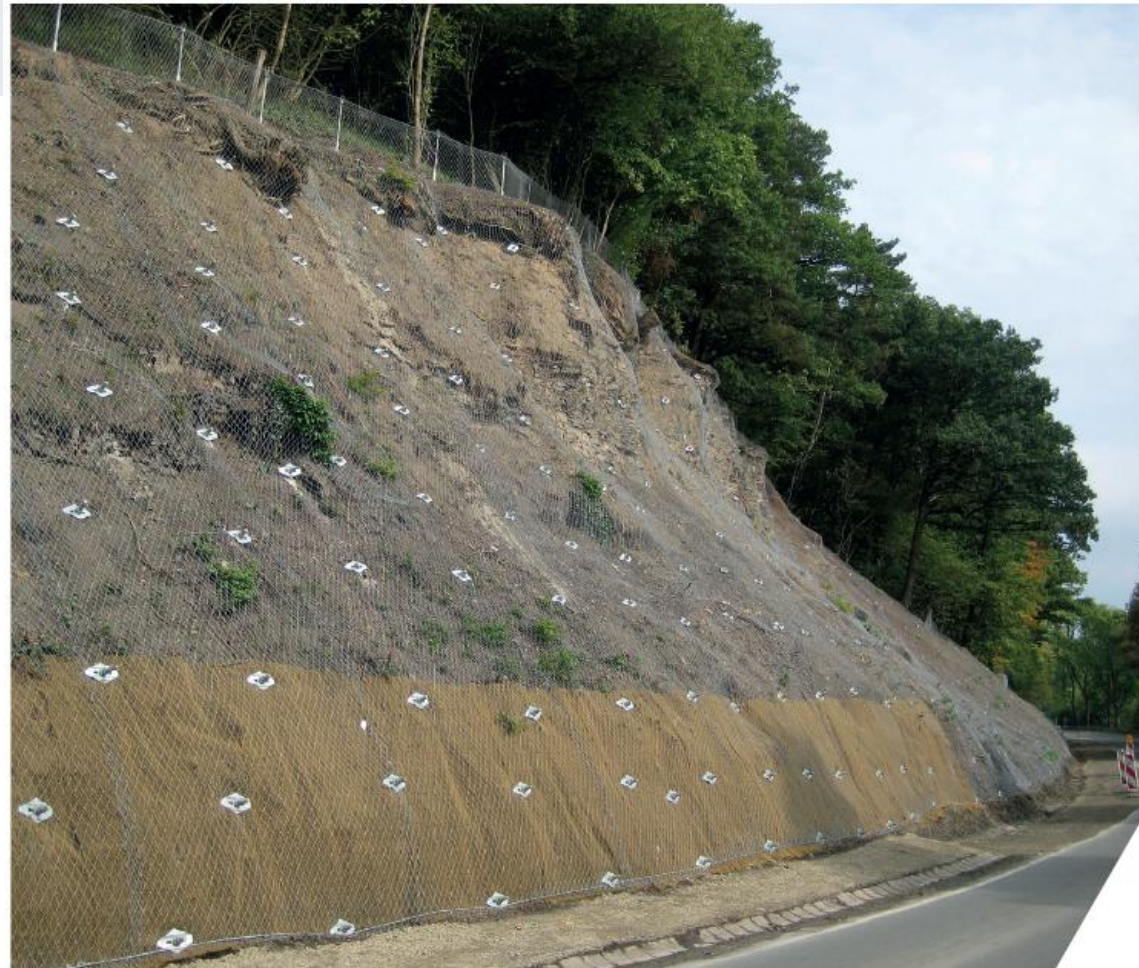
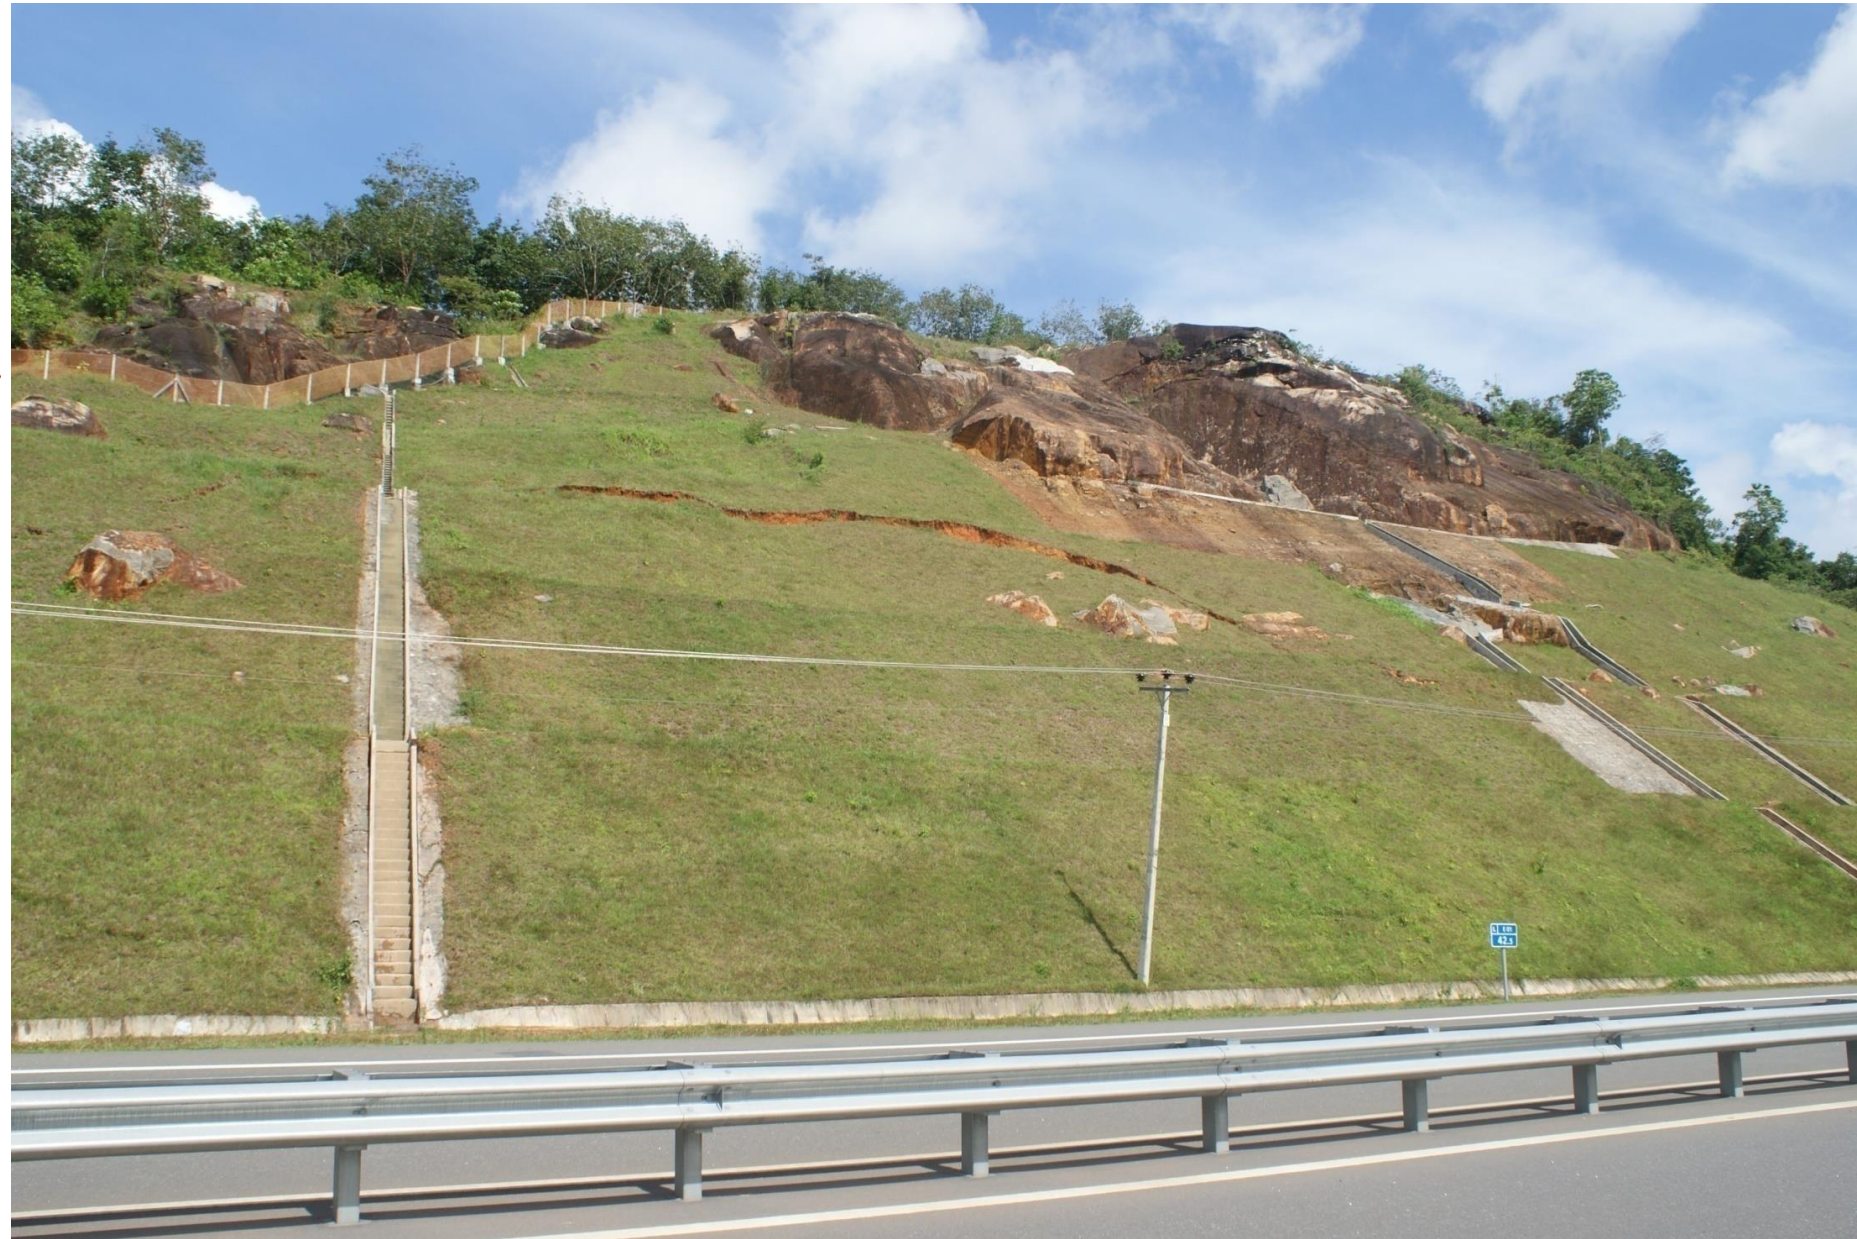
Initial tension cracks at 9AM

Landslide at Welipenna
- Failure after
adopting all drainage
measures due to faulty
surface drains- lack of
maintenance
