Reduction of Landslide Risk in Sri Lanka

Part 4 - Mitigation of Landslide Risk by Multiple Measures- Case Histories from; Southern Expressway, Ginigathhena and Kahagolla

Time Capsule project of ISSMGE
Sri Lankan Geotechnical Society

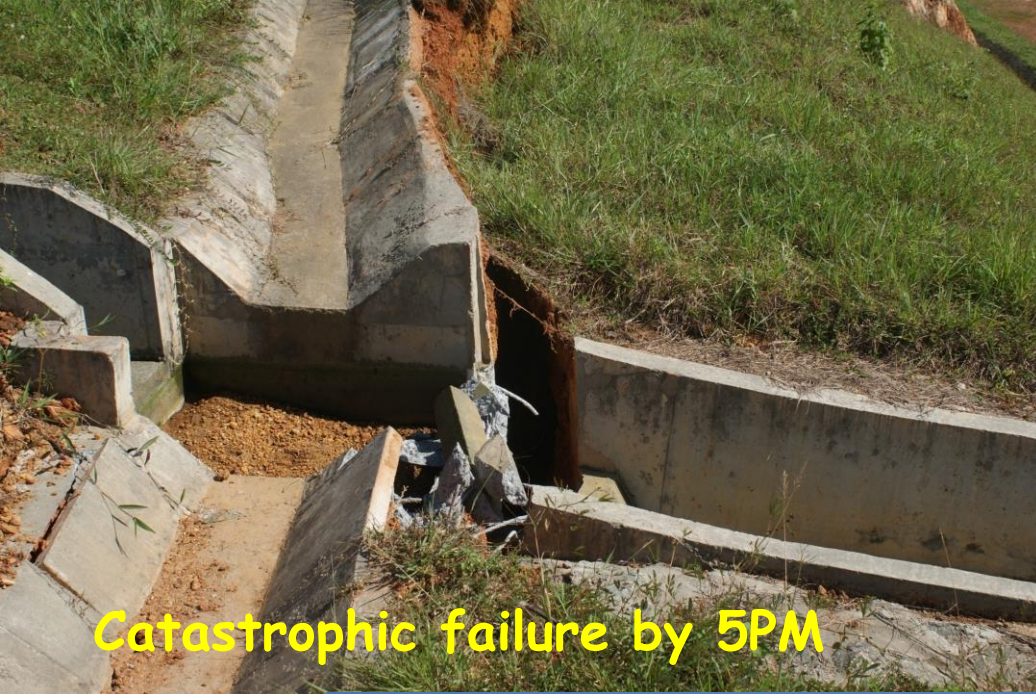
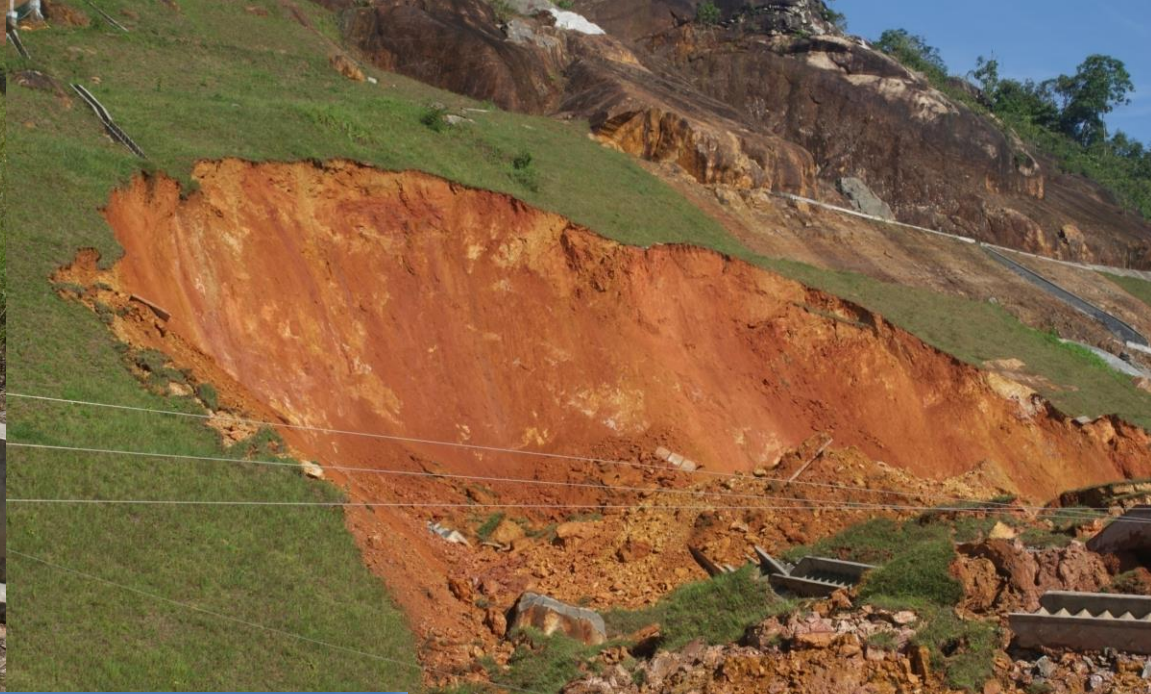
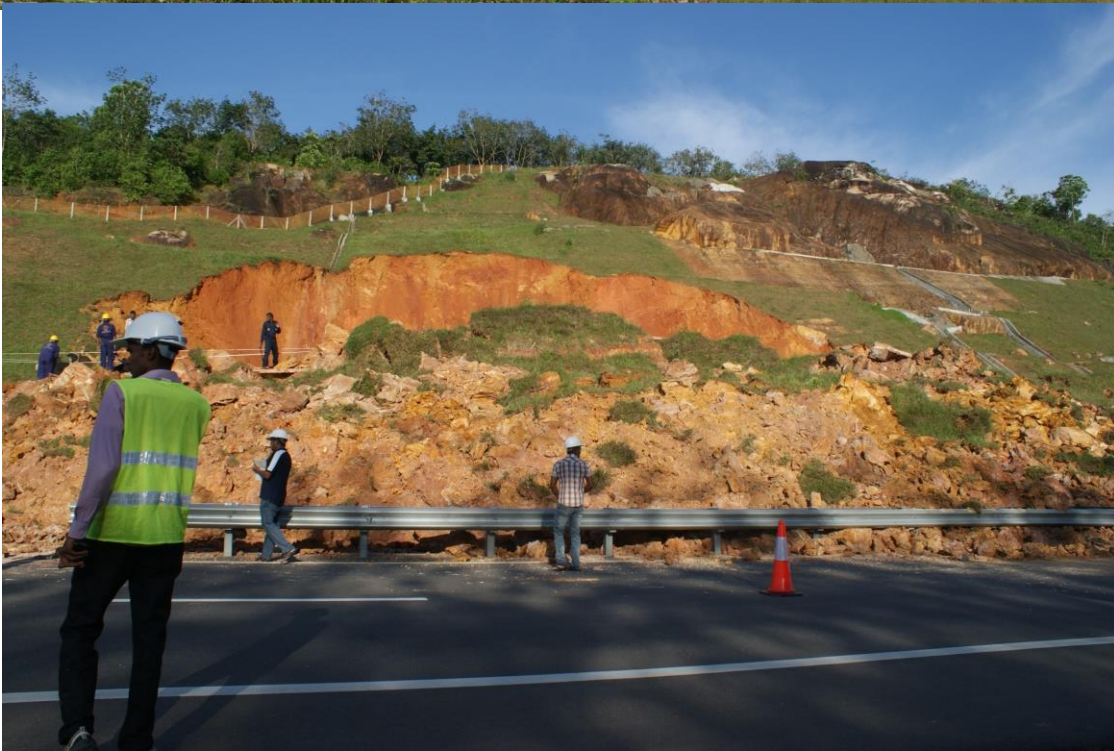
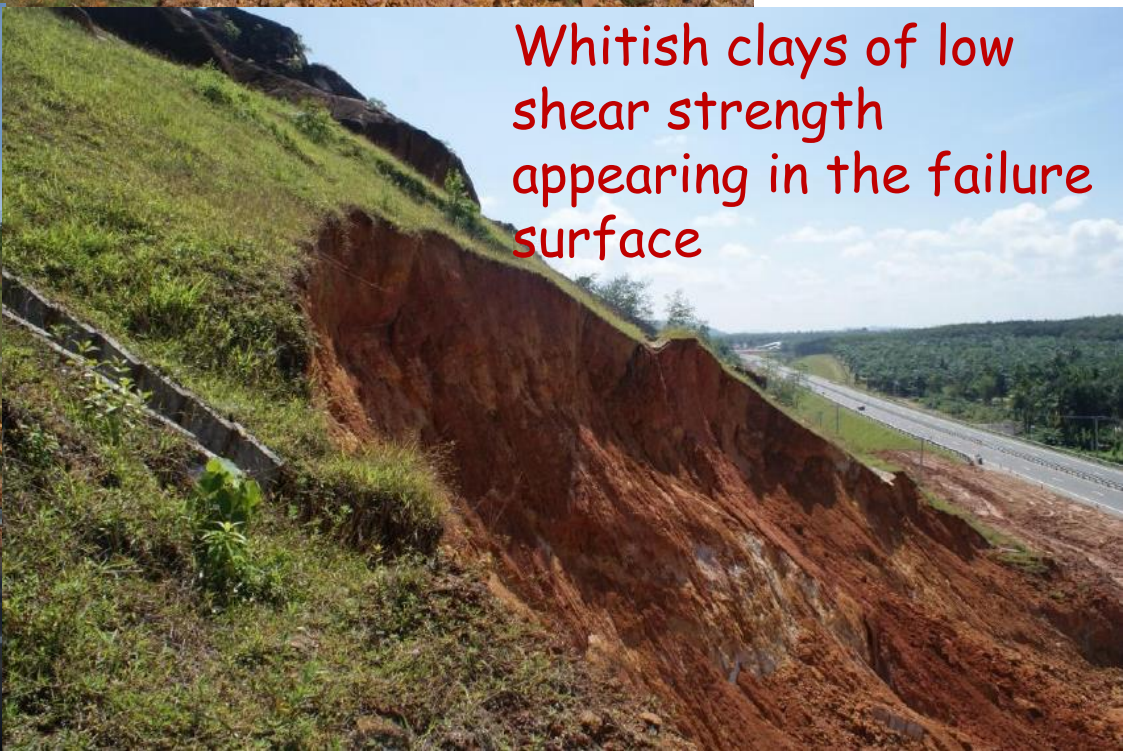
Catastrophic failure by 5PM

Whitish clays of low shear strength appearing in the failure surface

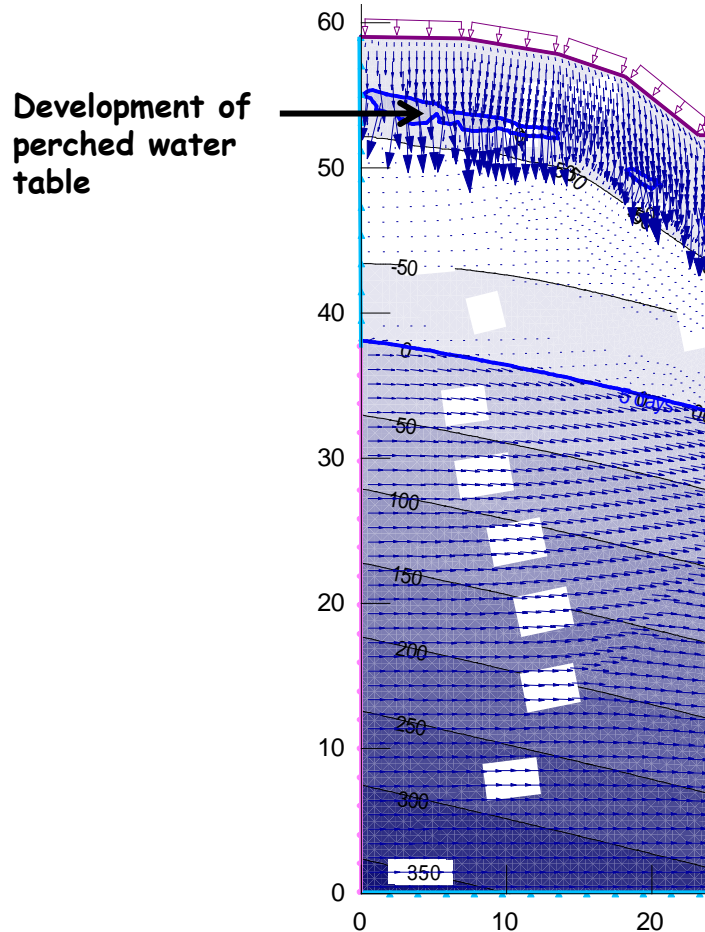
Without relict joints

Infiltration through relict joints is much higher than the infiltration through soil slope. (Idirimanna and Kulathilaka 2020)

It reveals with following diagrams. (The arrow size represents the intensity of the infiltration)

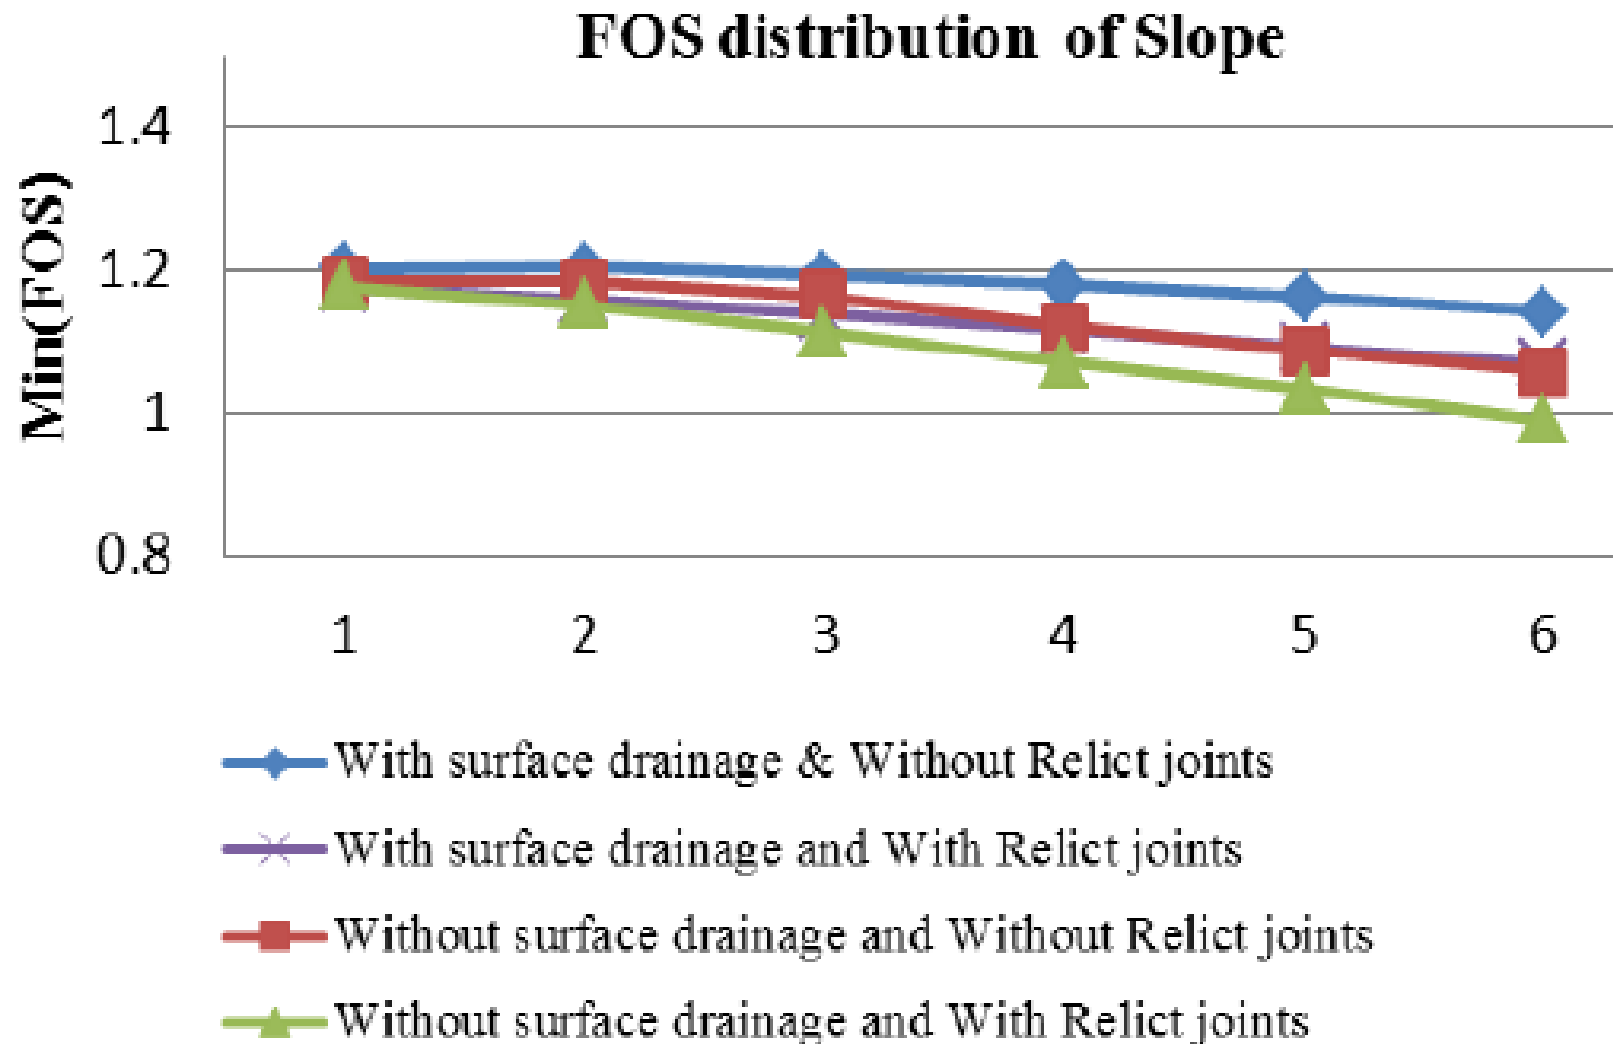
Reduction of FOS of the Slope with rainfall under different conditions

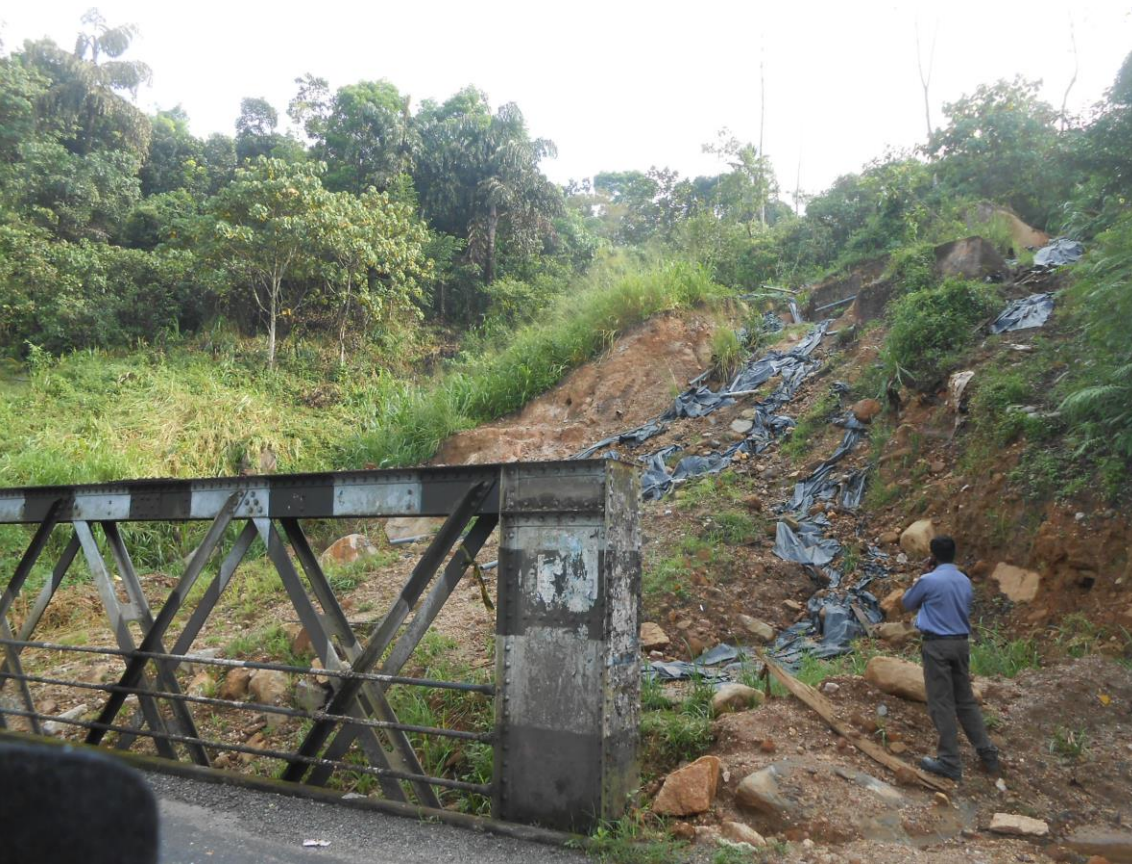
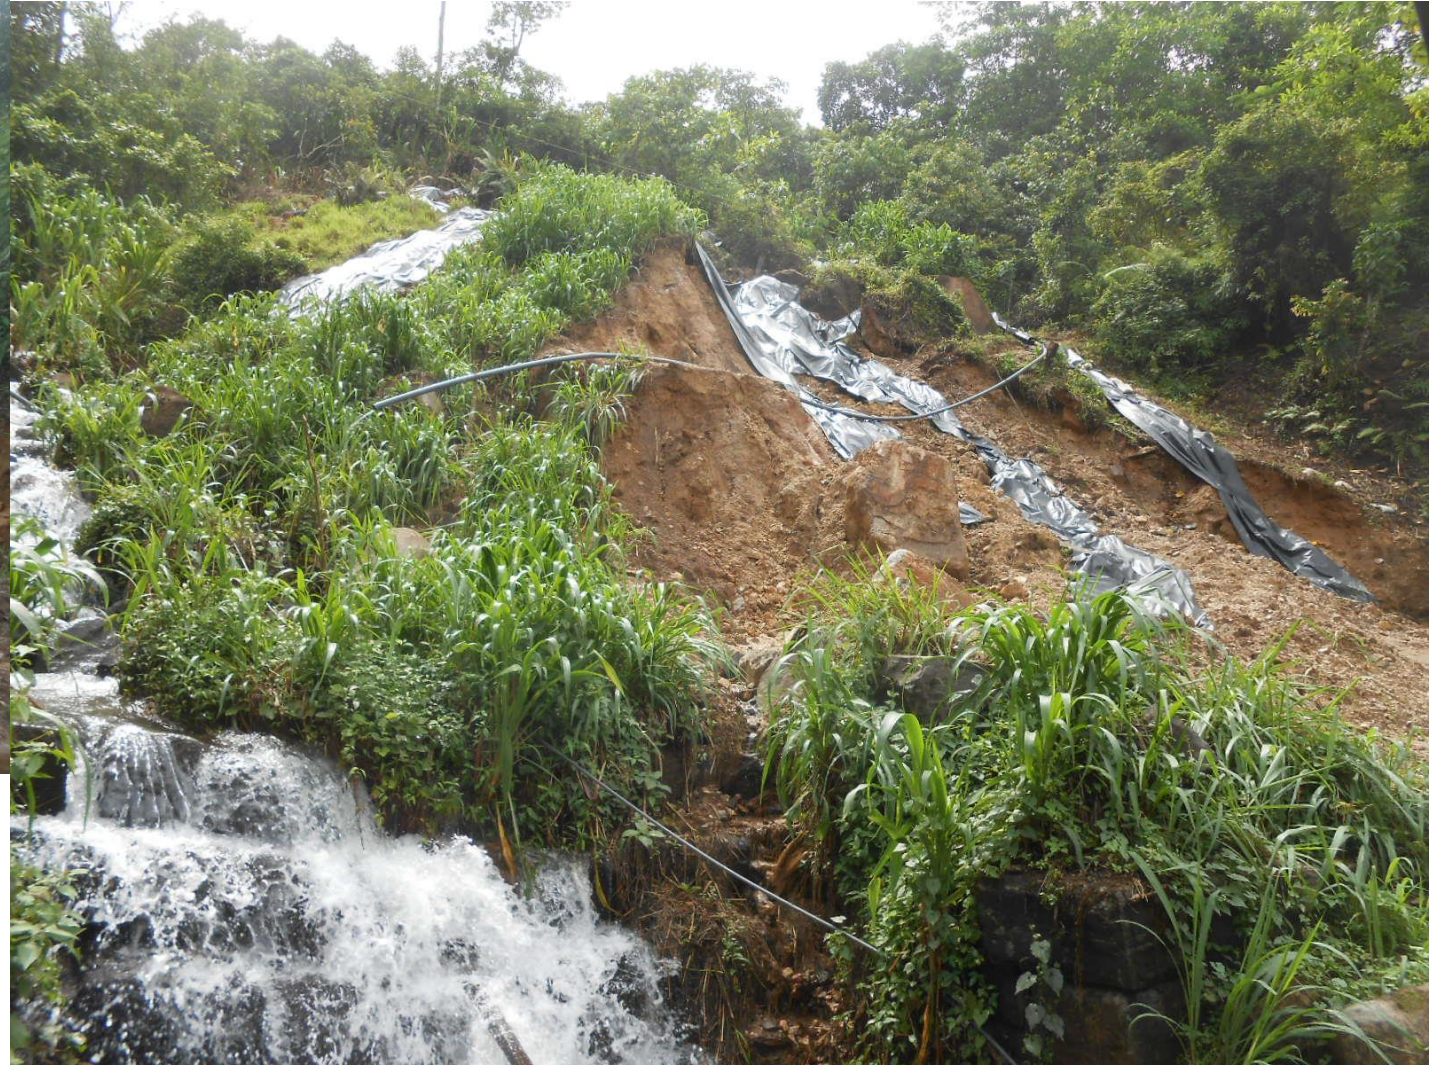
Excavation at the toe to widen the road reactivated the landslide Propagated further with the subsequent rainfall

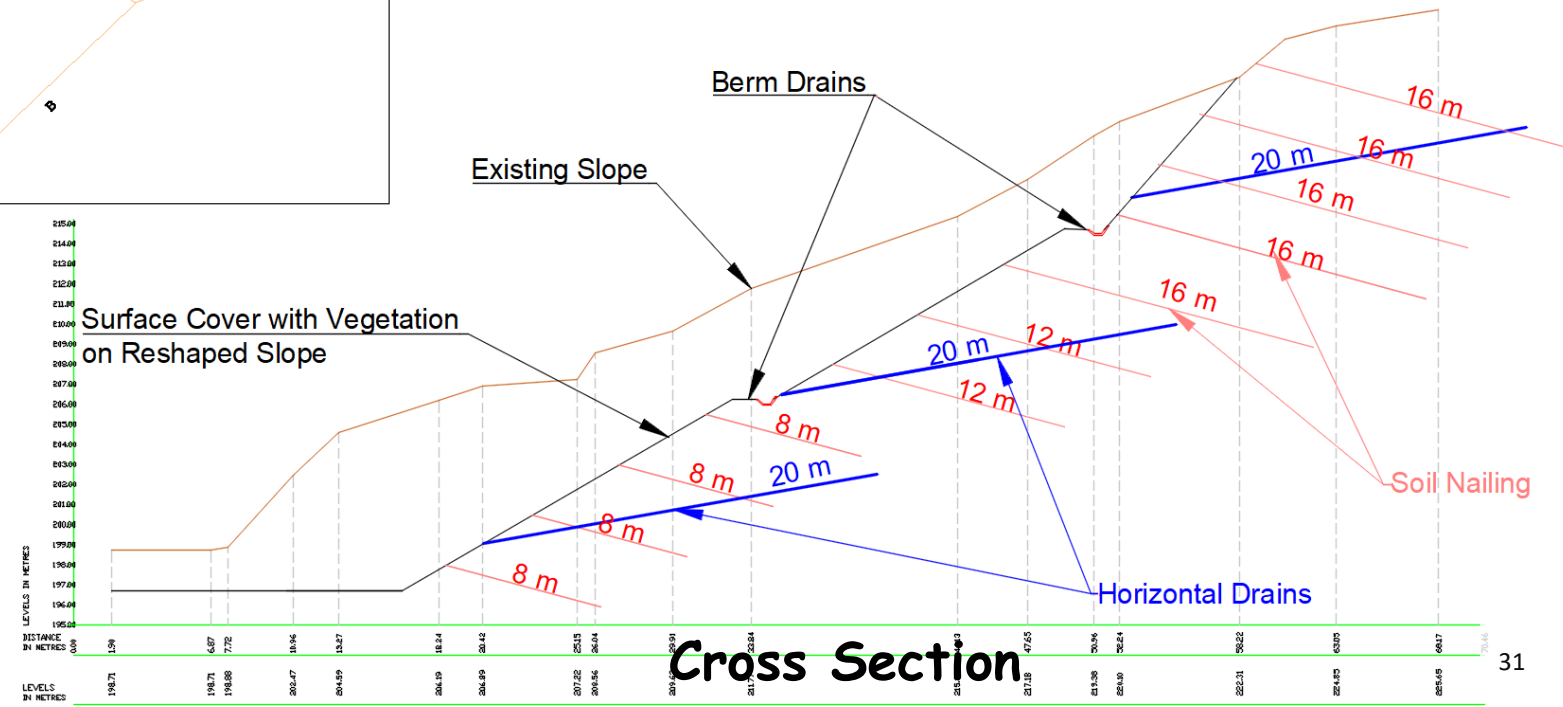
Construction Stages

- Slope excavation was done in three construction stages
- Stability of each stage was evaluated for different combinations of mitigation measures

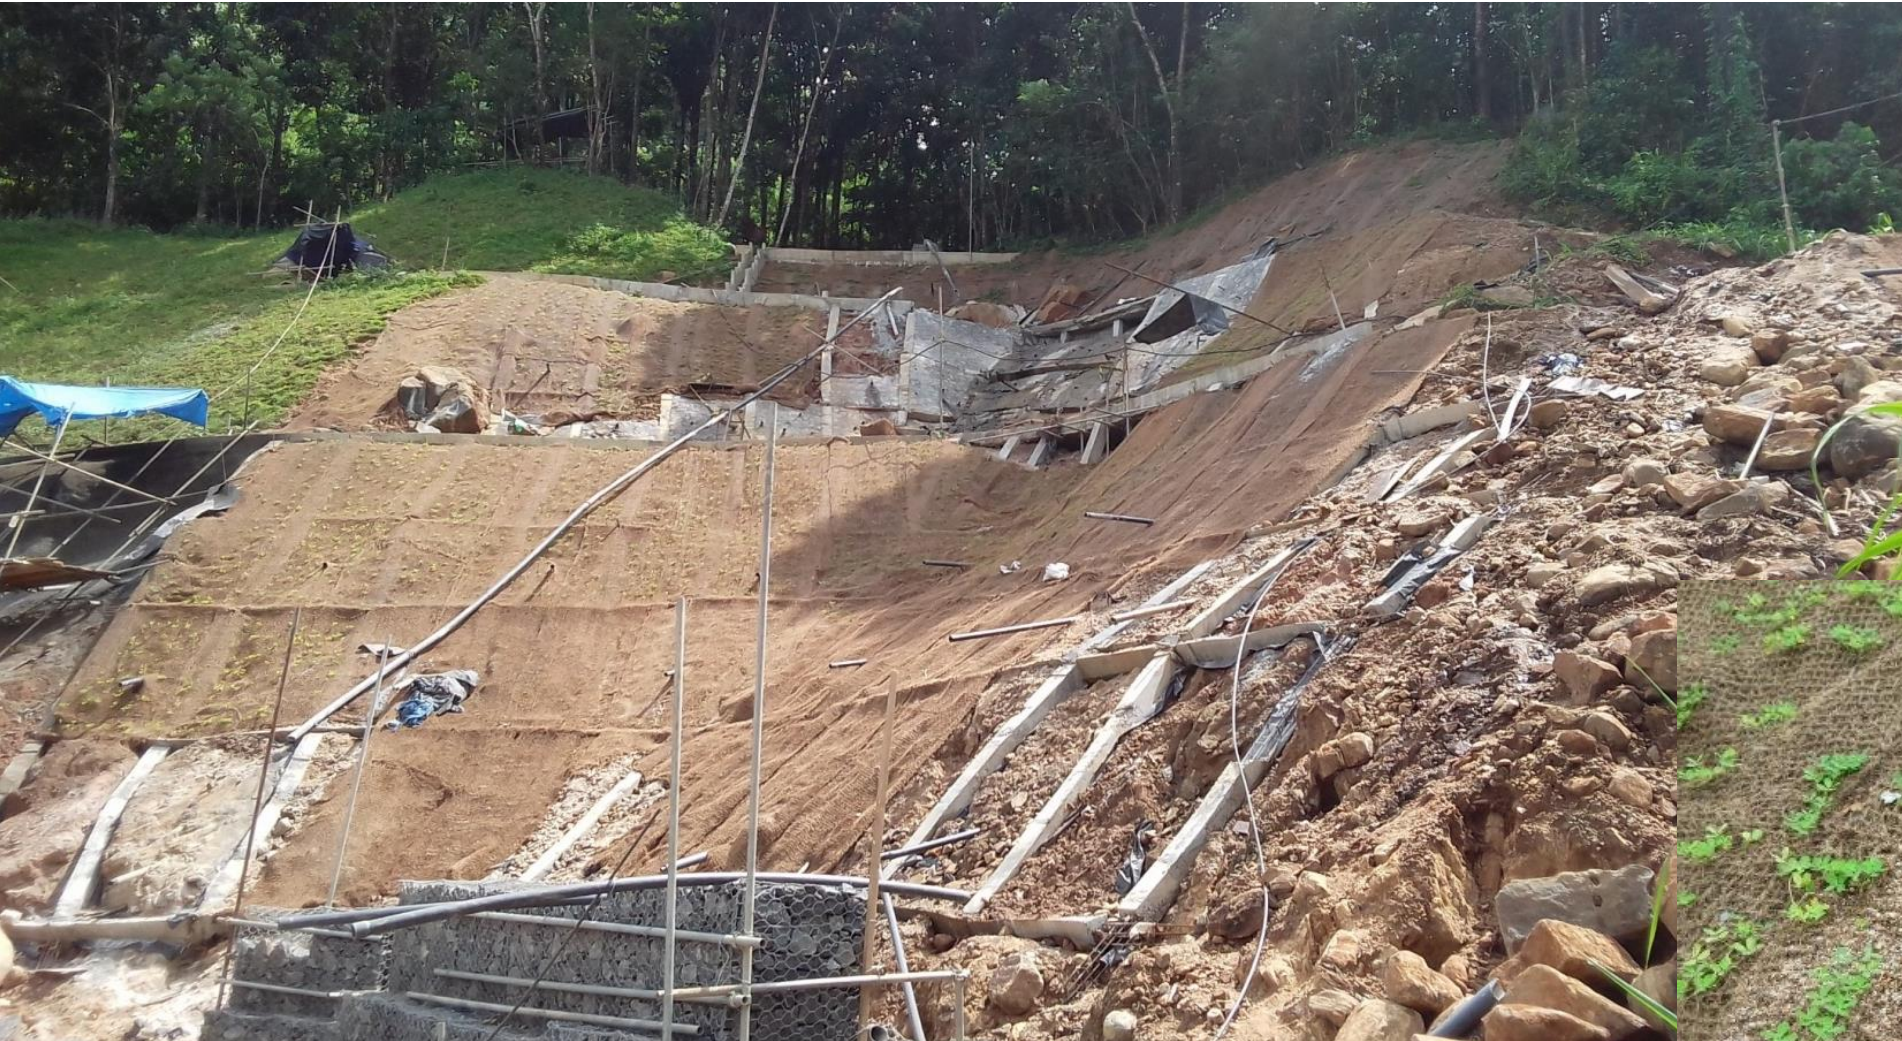
Nail heads connected by beams and vegetation introduced in between with the by hydroseeding protected by coir geotextiles. (at Ginigathhena)

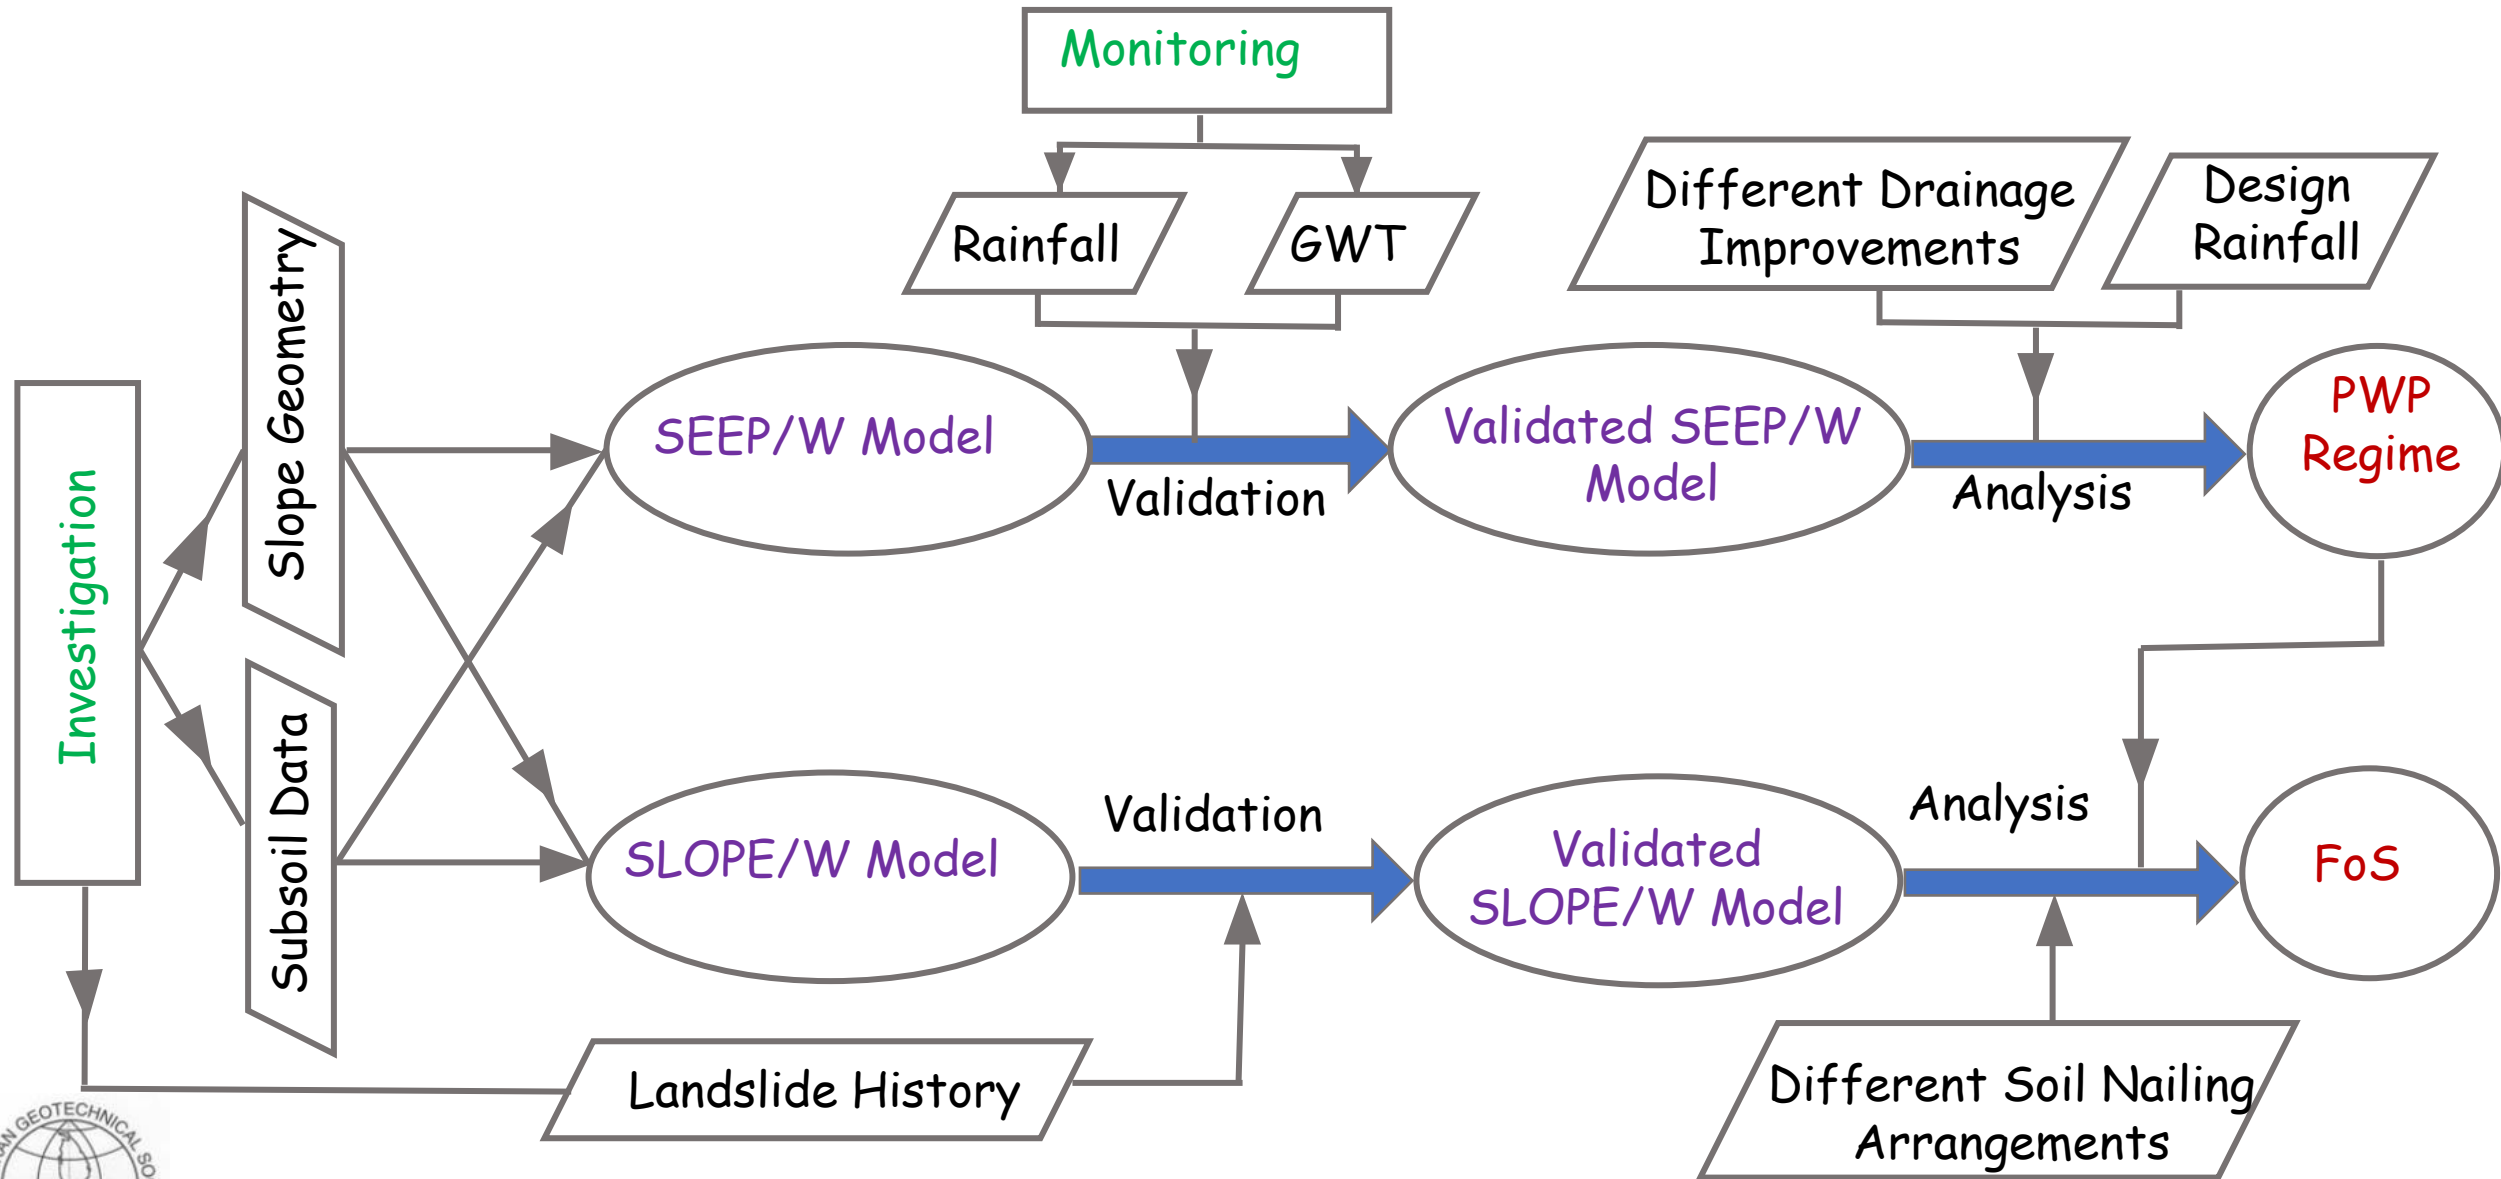
Methodology Adopted

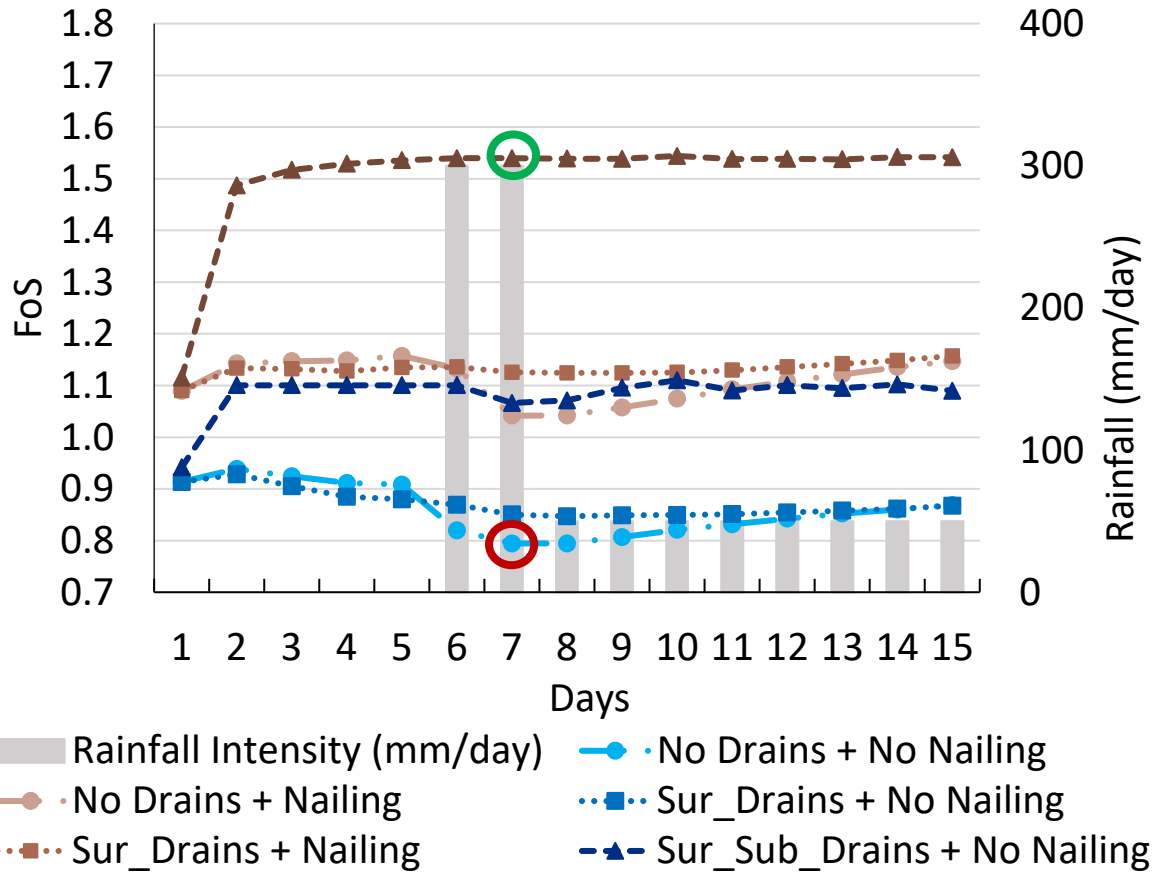
FoS of Construction Stage 3

Daily FoS Variation of Stage 3

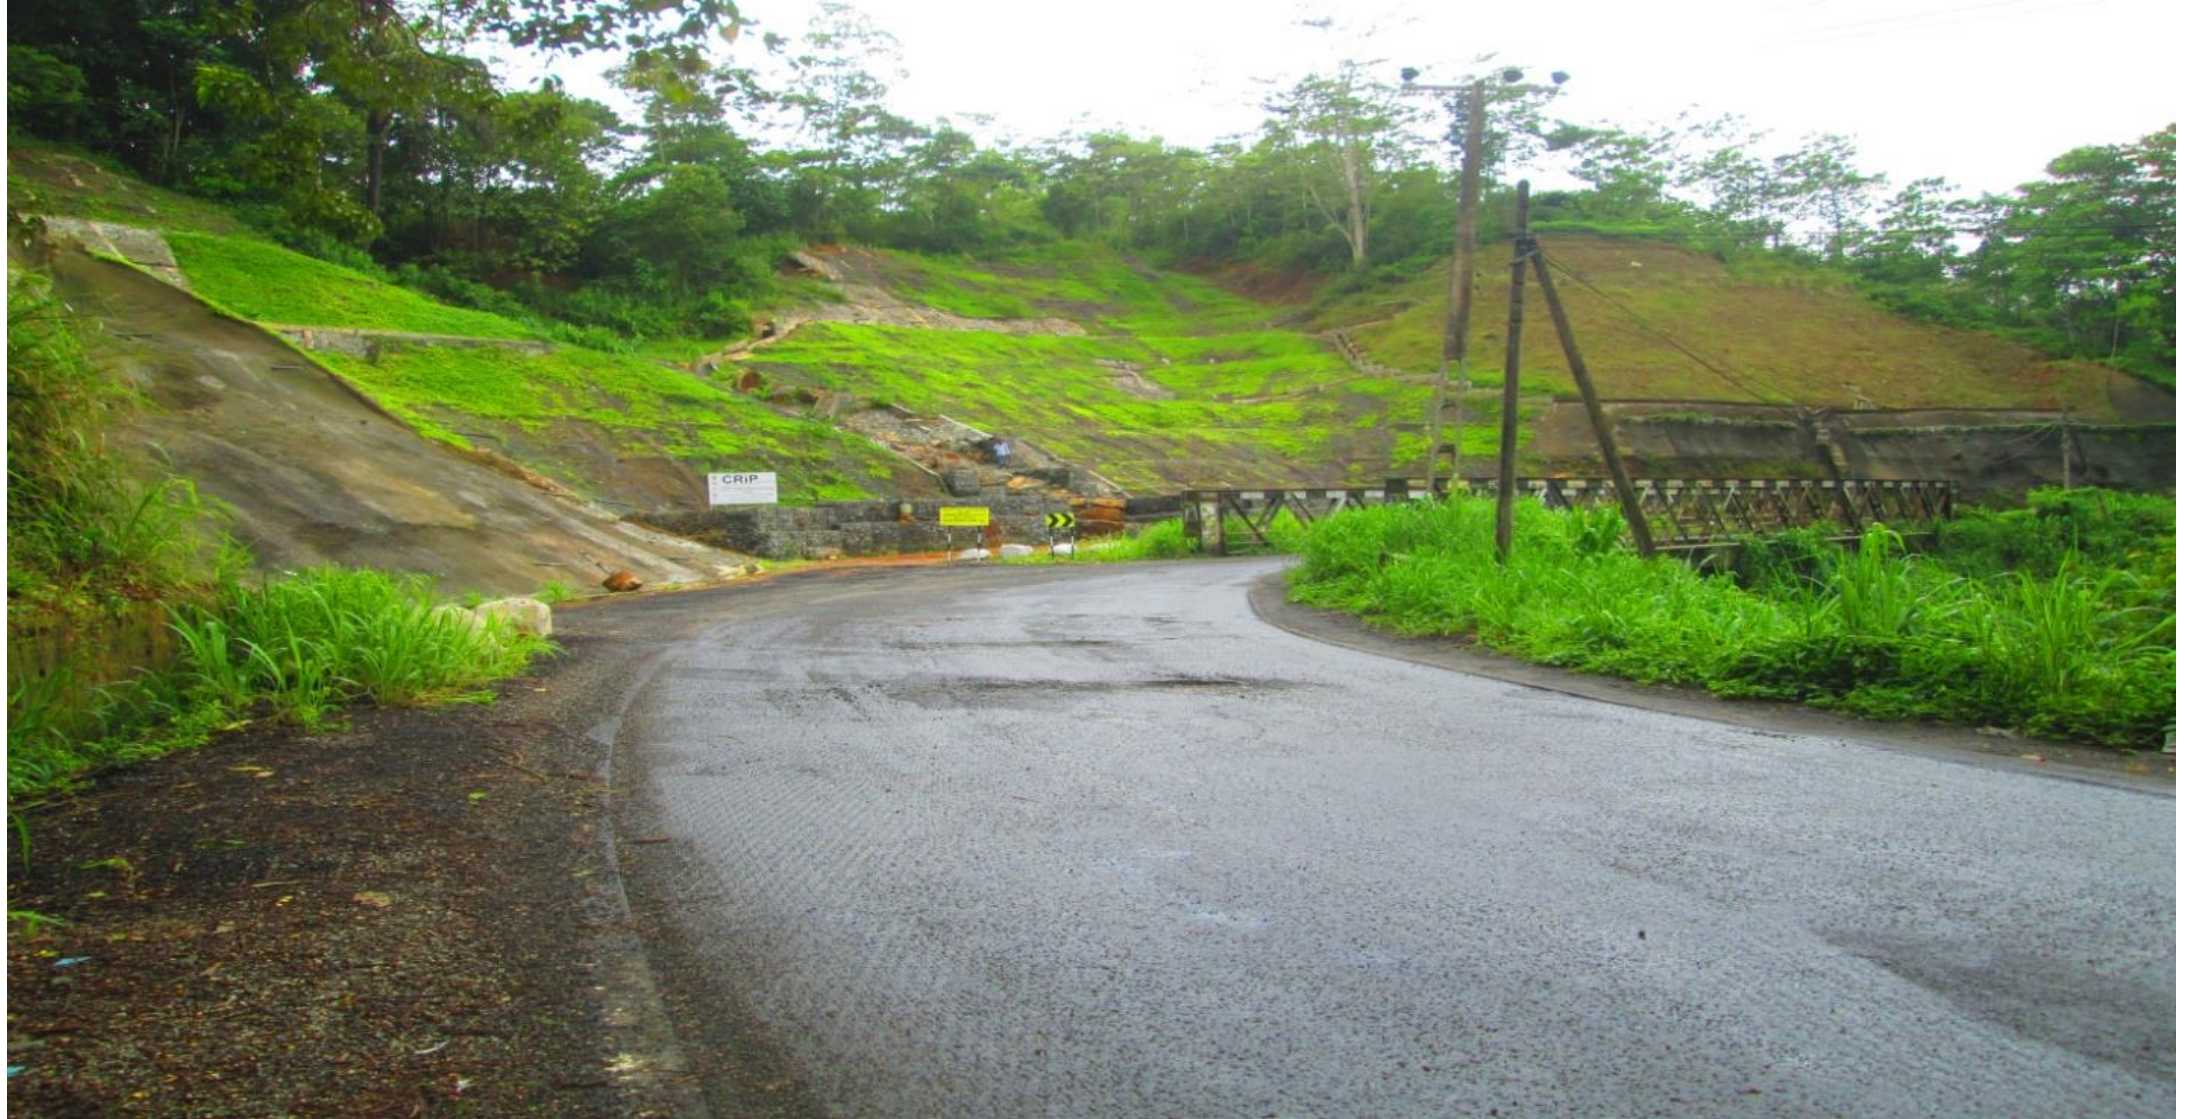
Slope After Completion of all Rectification

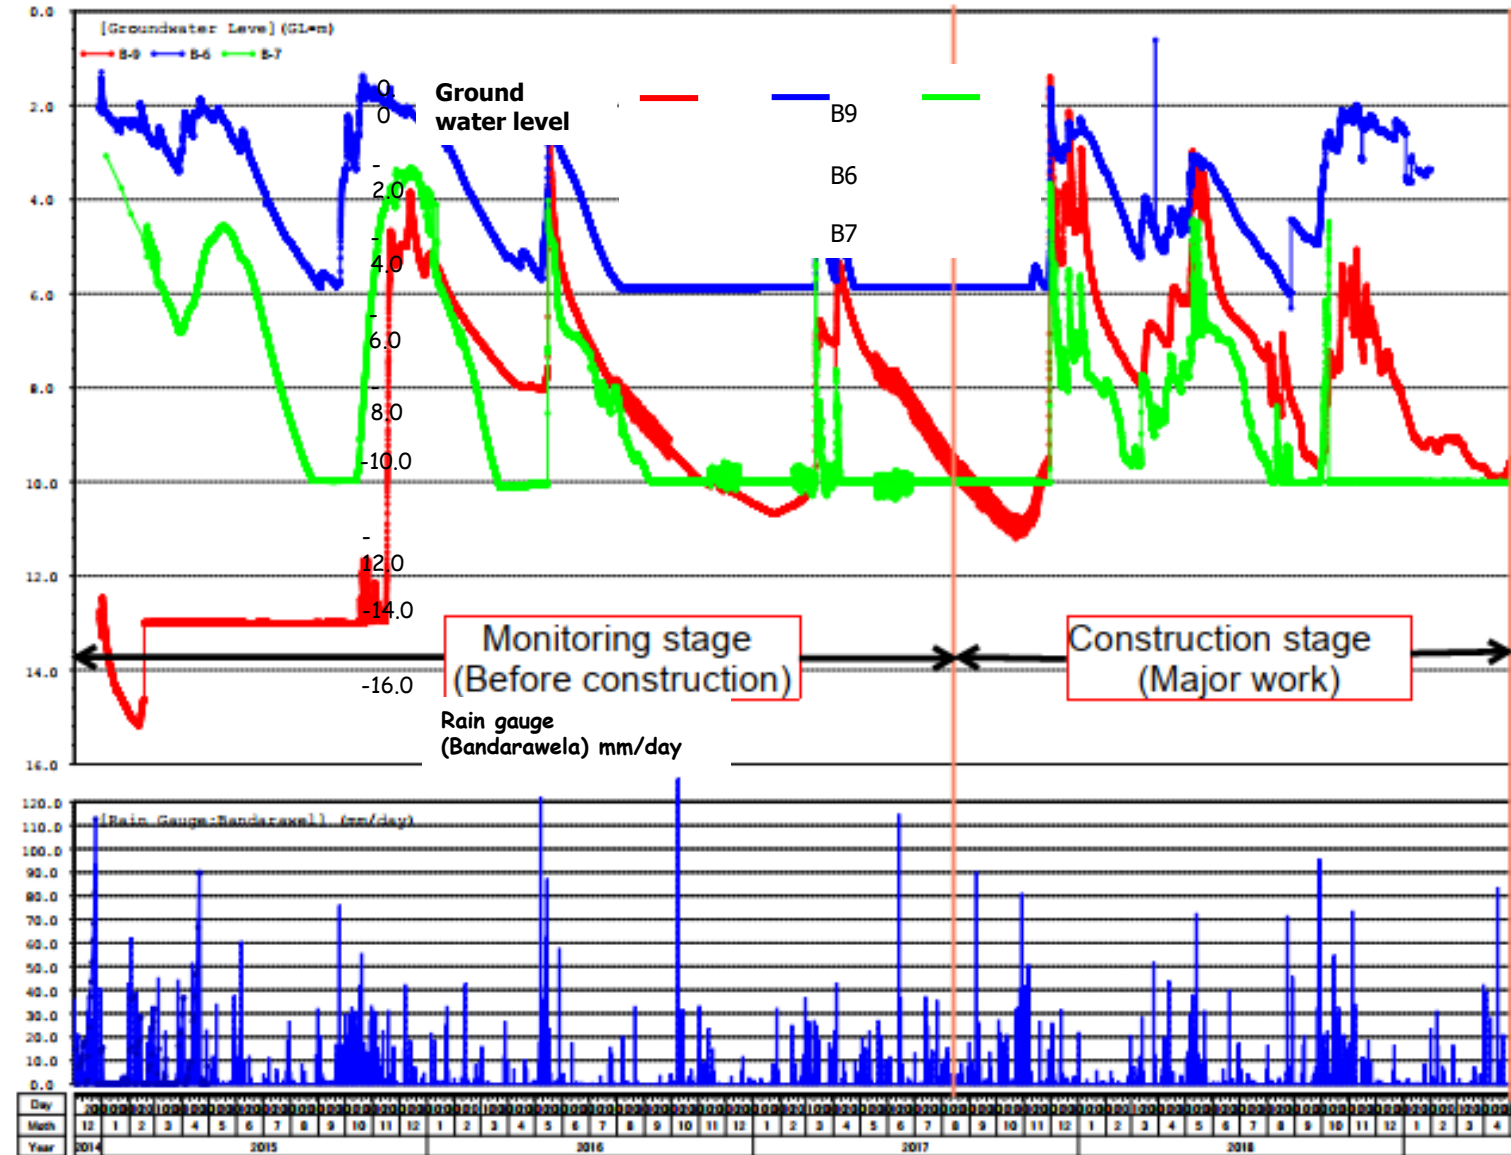
Response of the measured GWL to rainfall

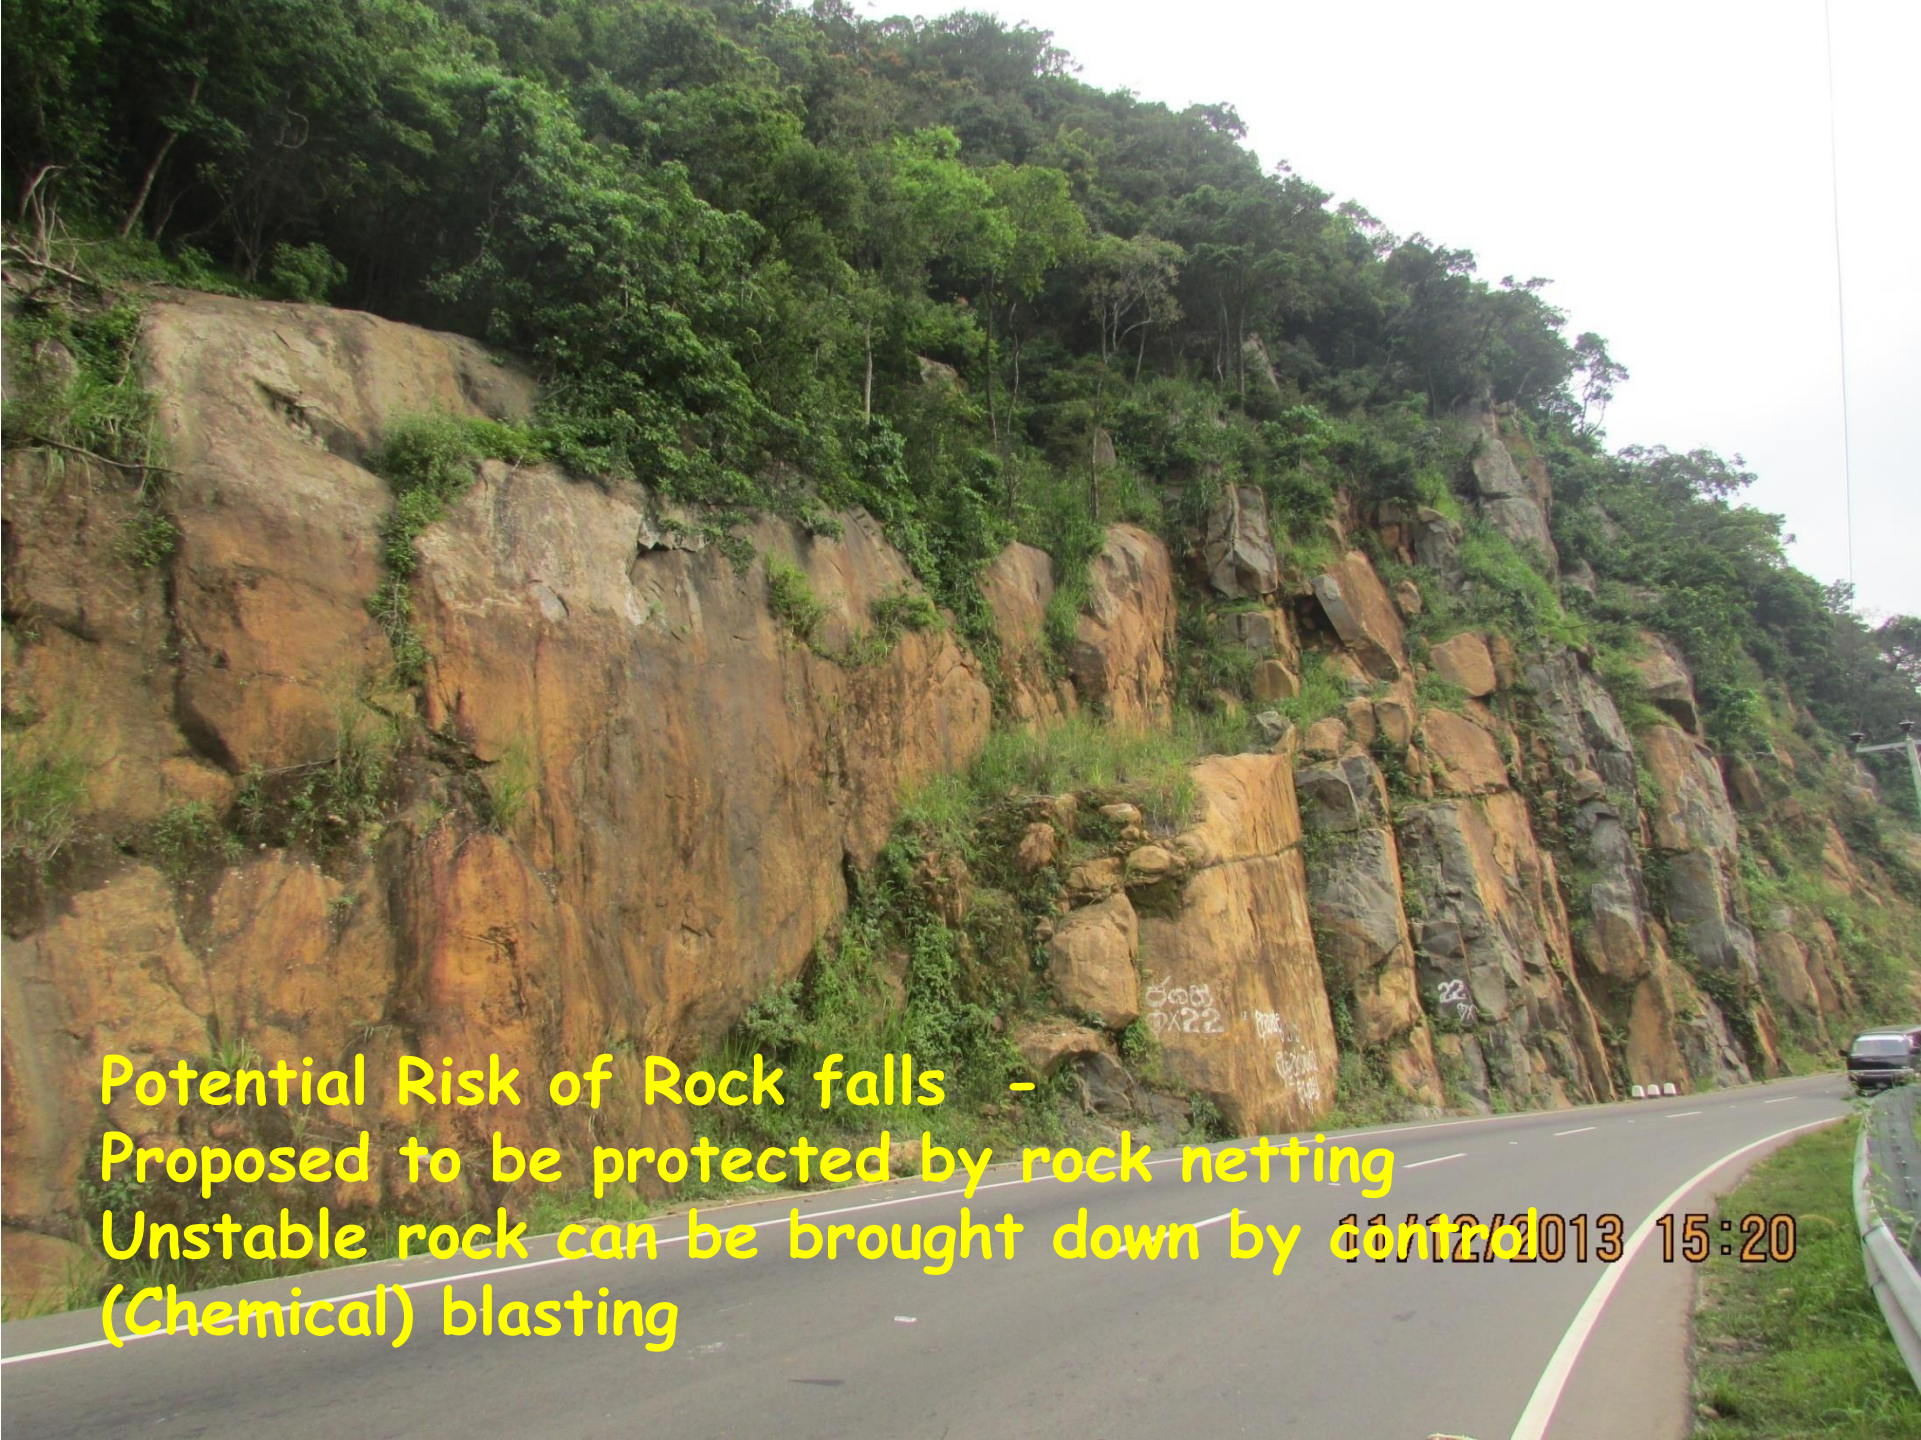
Potential Risk of Rock falls -
Proposed to be protected by rock netting
Unstable rock can be brought down by control
(Chemical) blasting
