Reduction of Landslide Risk in Sri Lanka

Part 4 - Mitigation of Landslide Risk by Multiple Measures- Case Histories from; Southern Expressway, Ginigathhena and Kahagolla

Time Capsule project of ISSMGE
Sri Lankan Geotechnical Society

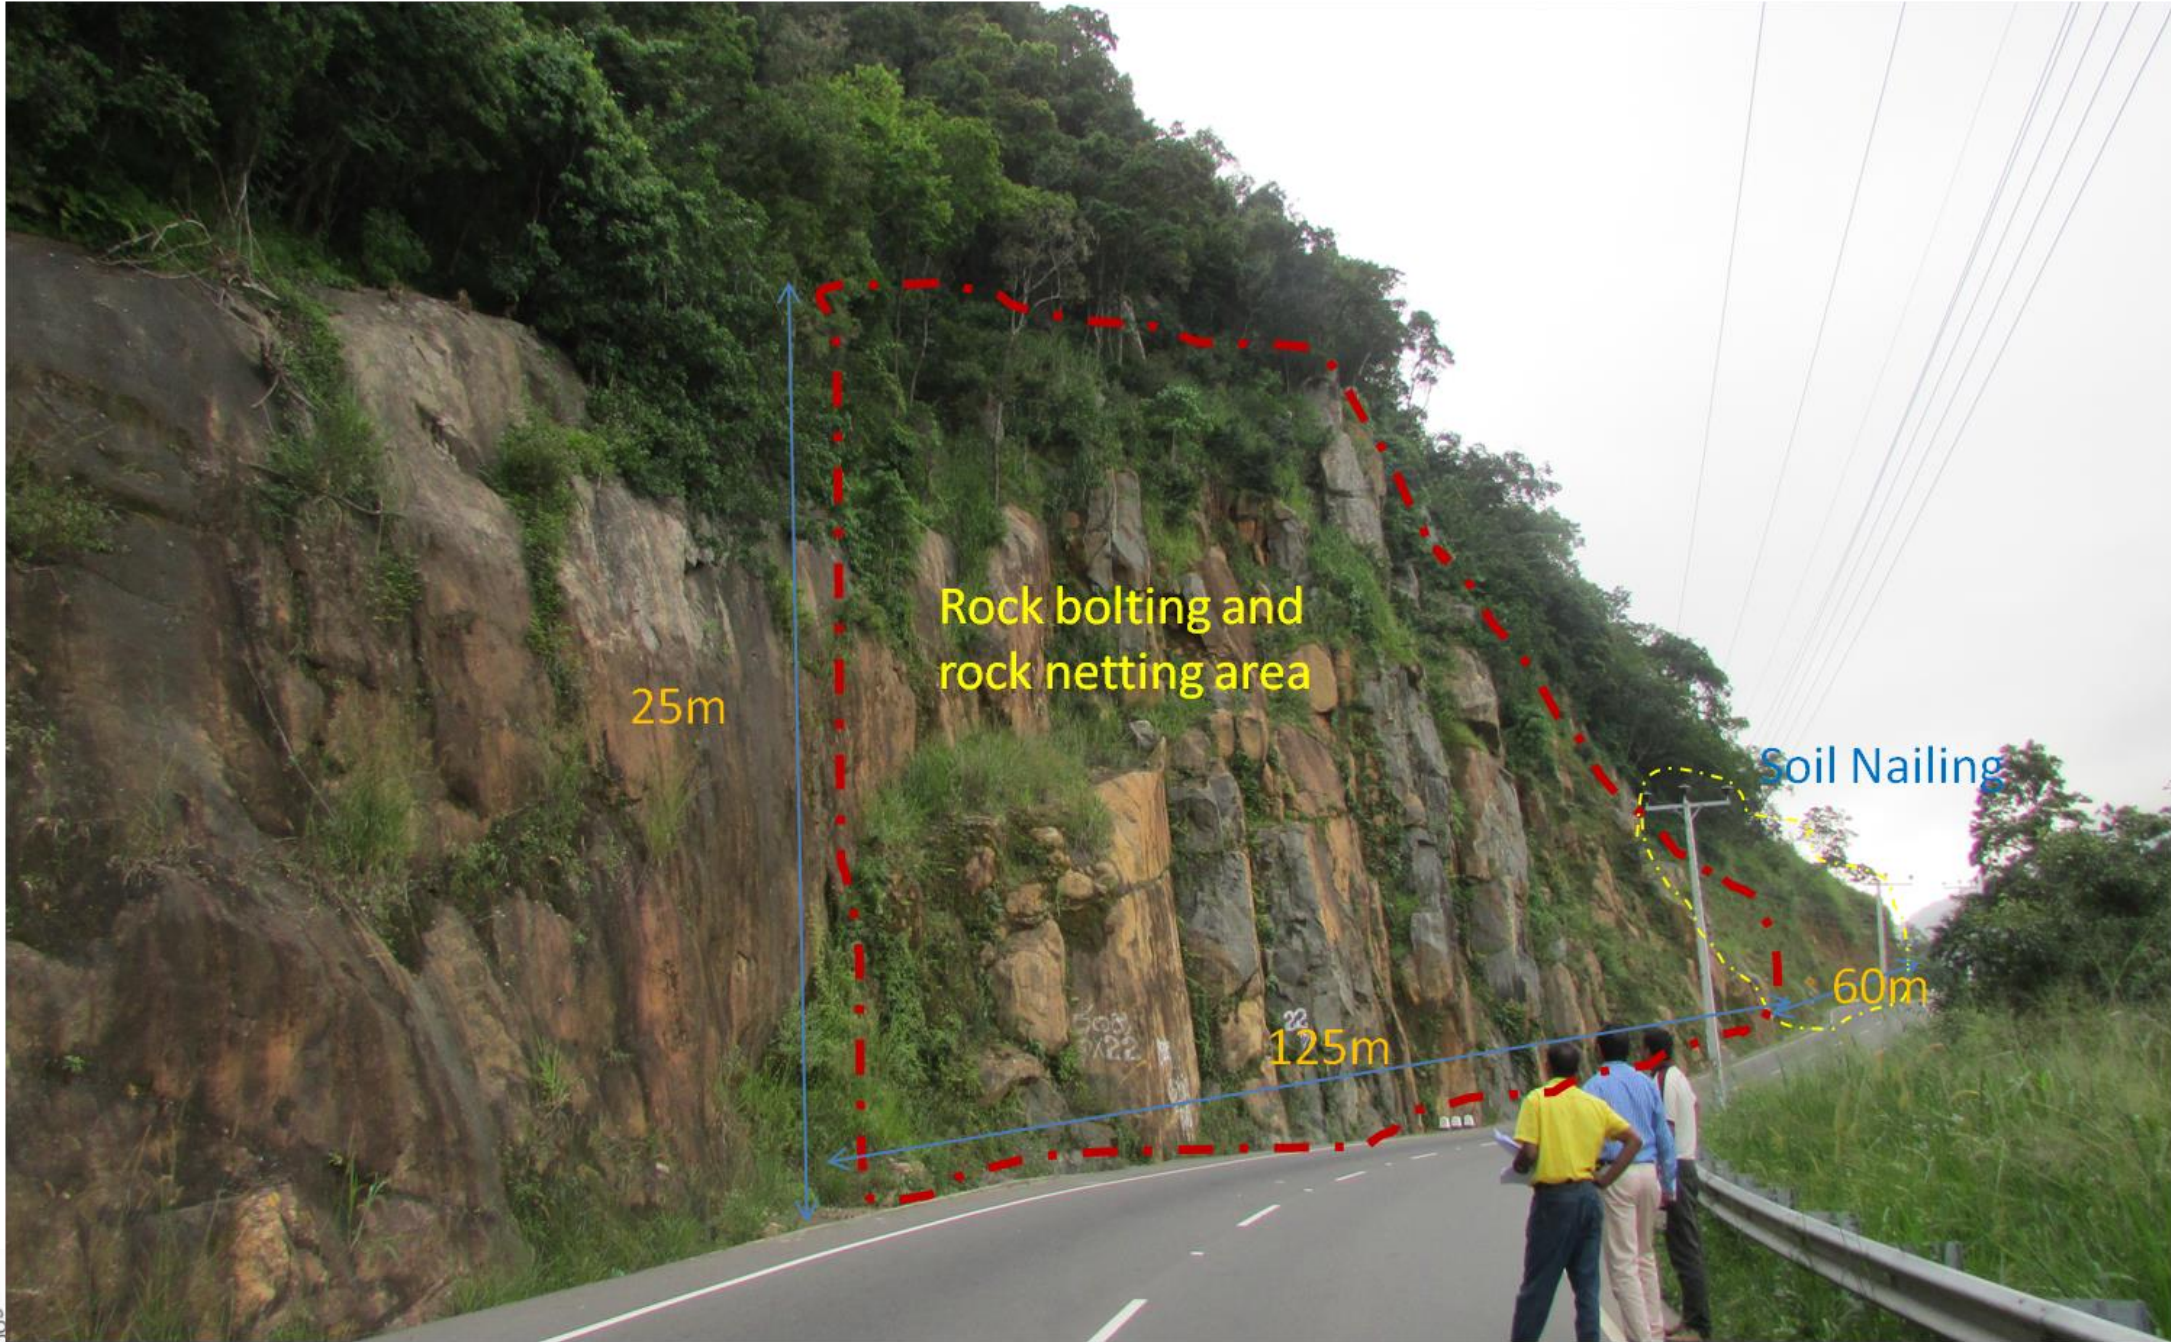
Rock bolting and
rock netting area

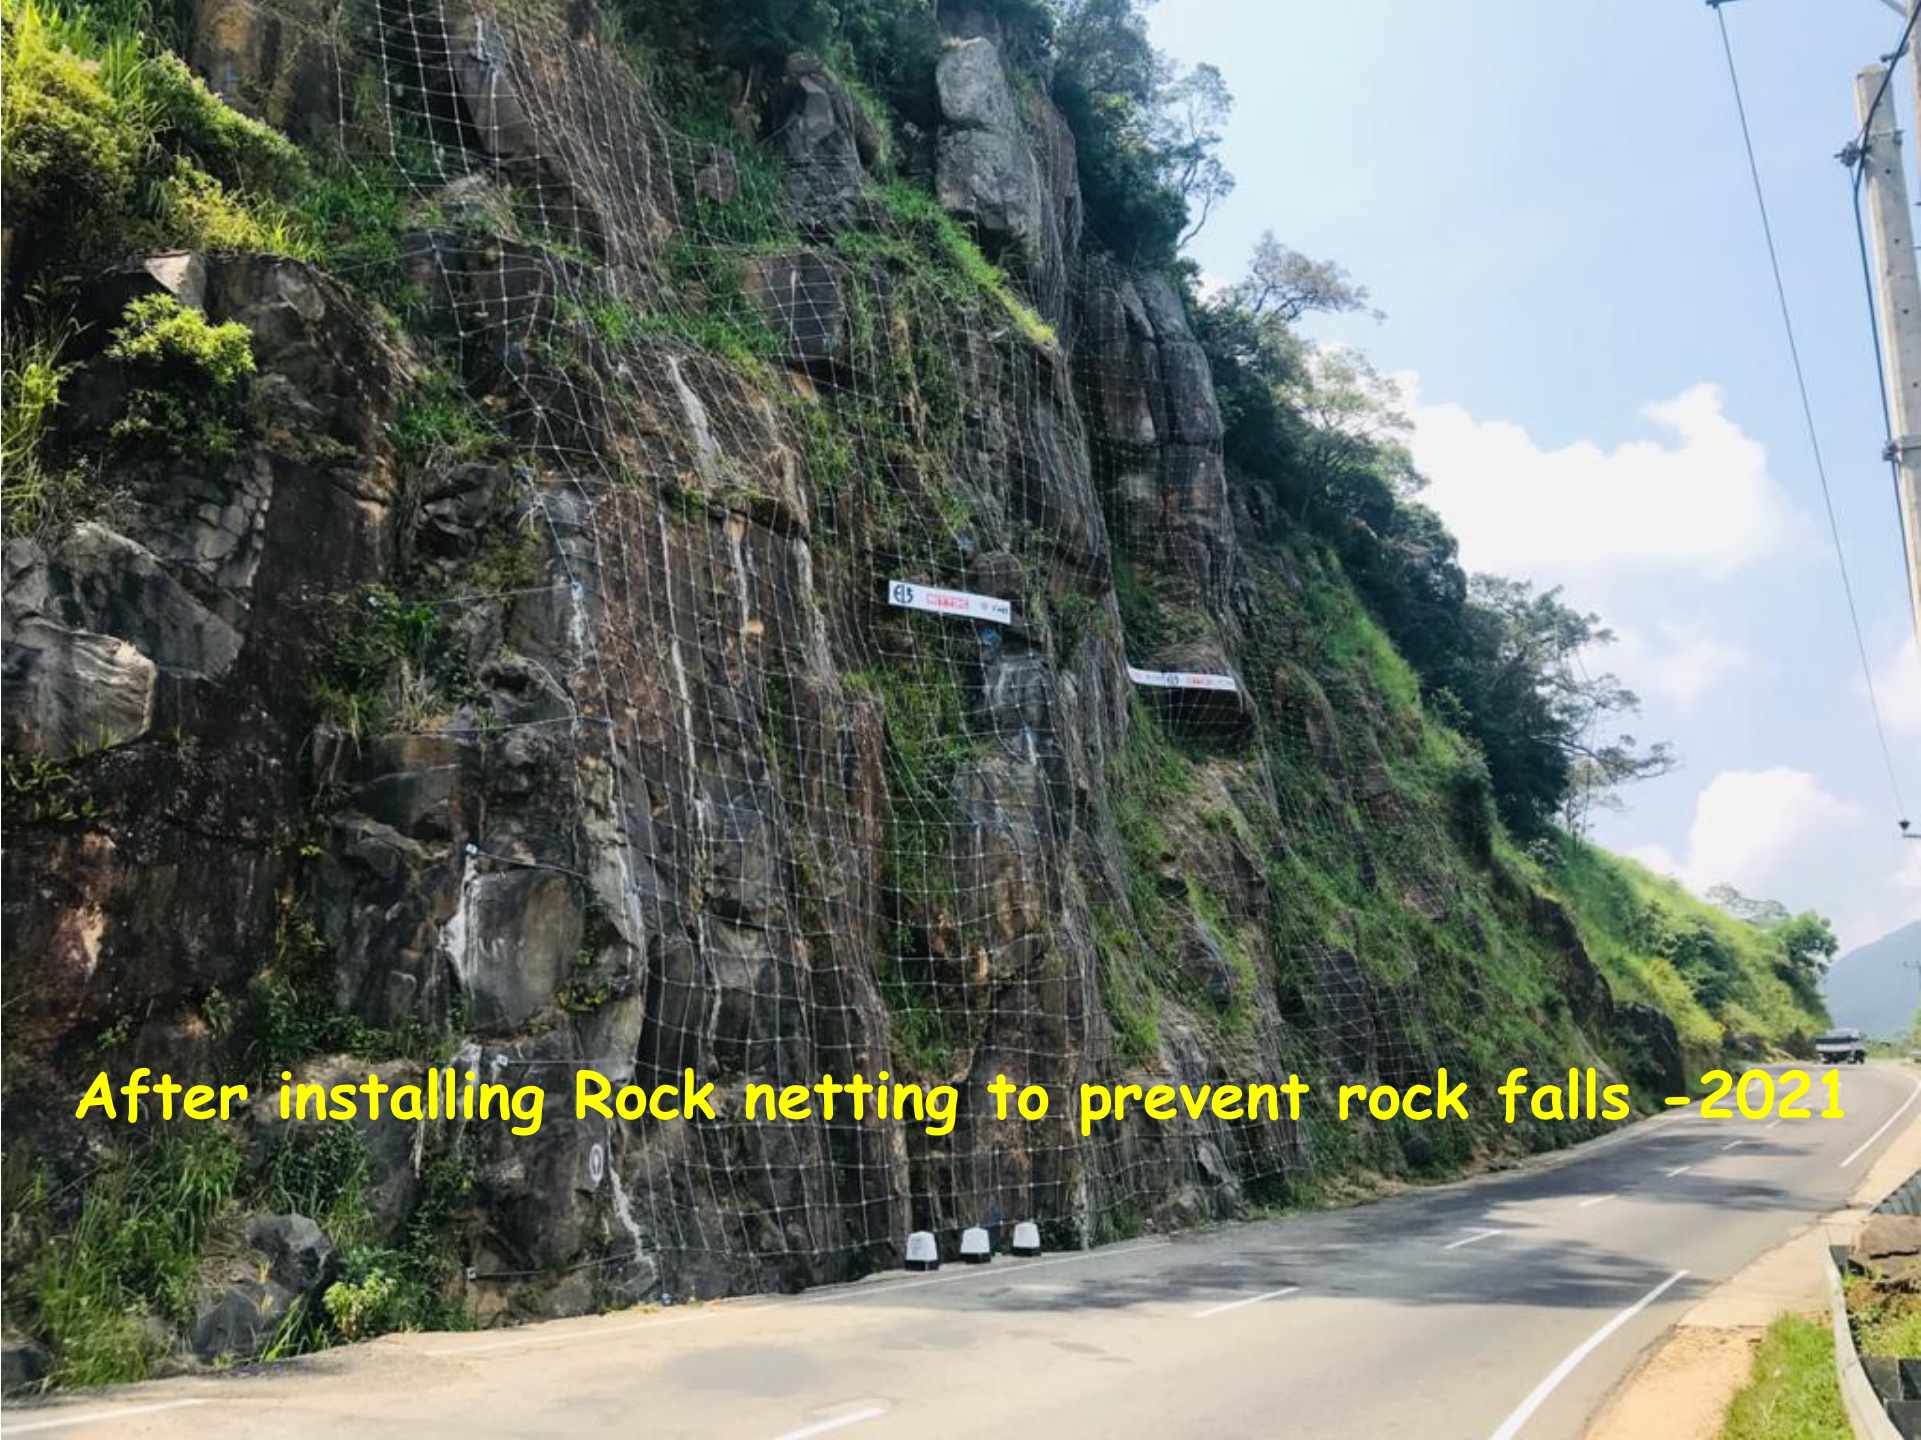
After installing Rock netting to prevent rock falls -2021

Rock Netting to prevent Rockfalls

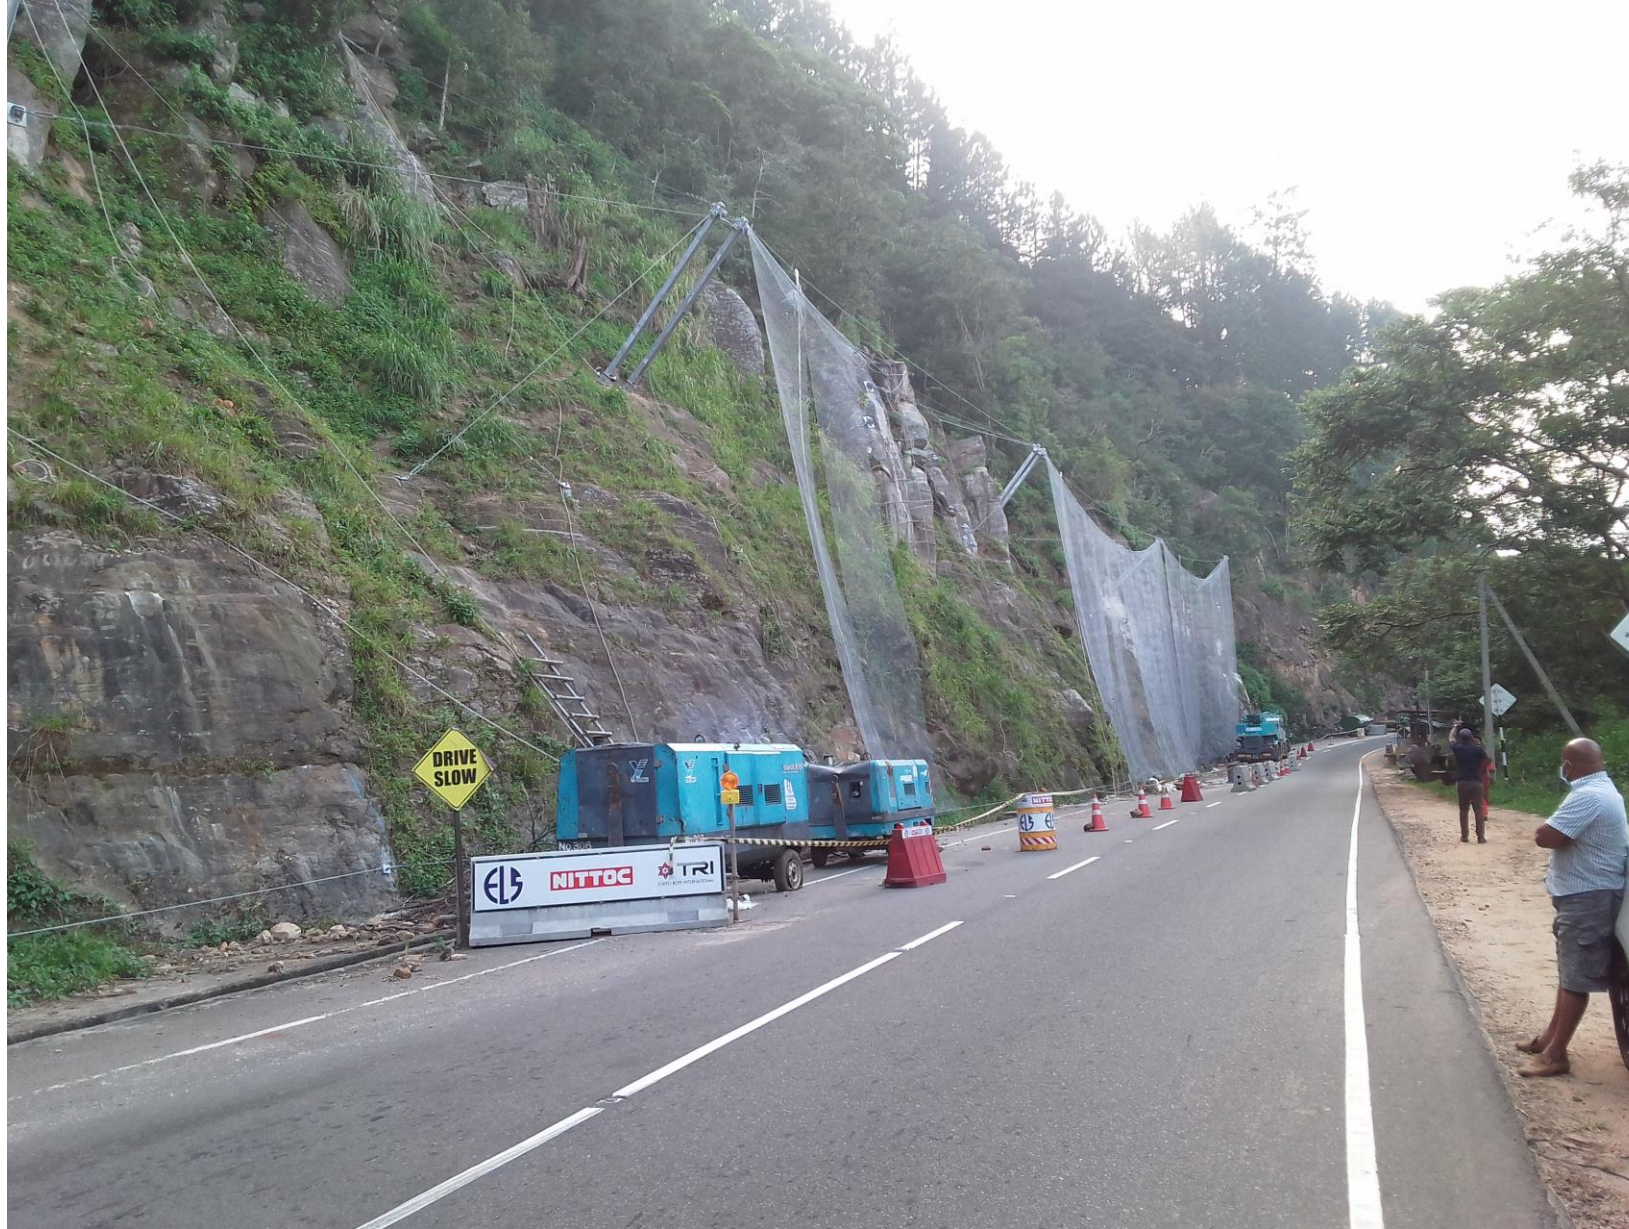
**Curtain Netting to retain falling rock pieces
Kandy - Mahiyangana Road**

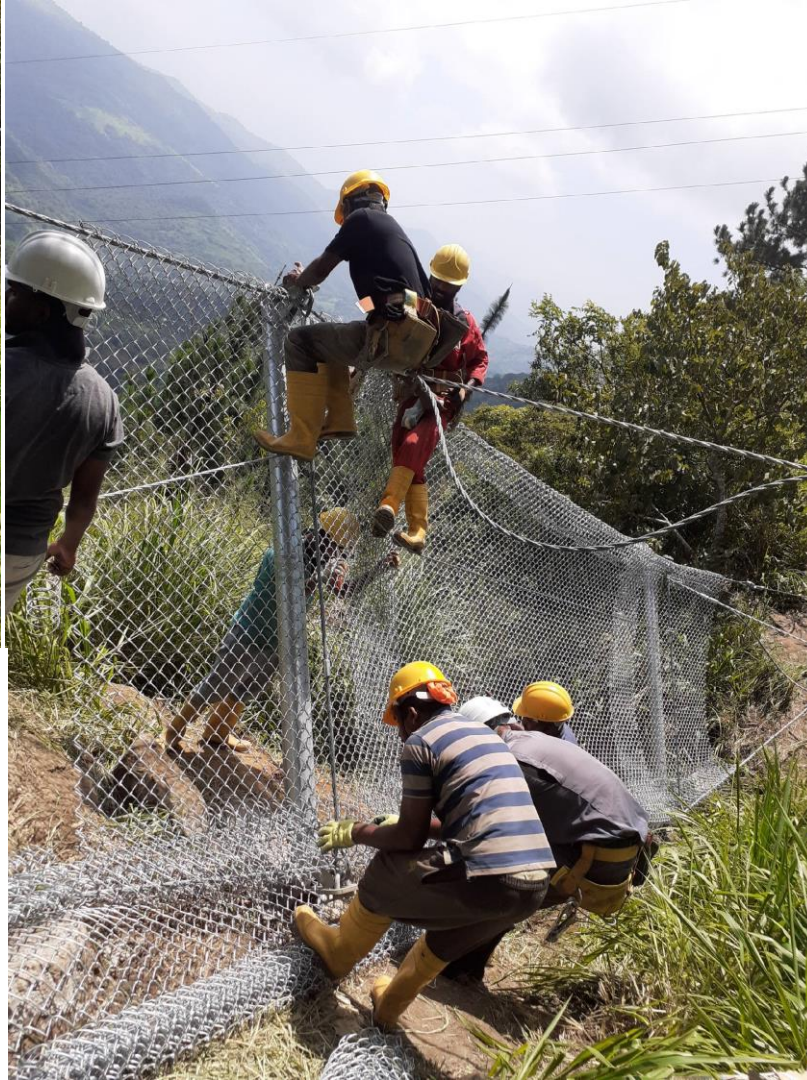
After completion

Rock Fence to catch Falling rockfalls- Kandy - Mahiyangana Road
