**ANNUAL CONFERENCE 2024**

**GEOTECHNICAL ENGINEERING  
CHALLENGES IN EXPRESSWAY  
CONSTRUCTION**

**RISK INVESTIGATION AND DAMAGE TREATMENT OF  
HIGH SLOPES ON EXPRESSWAYS**

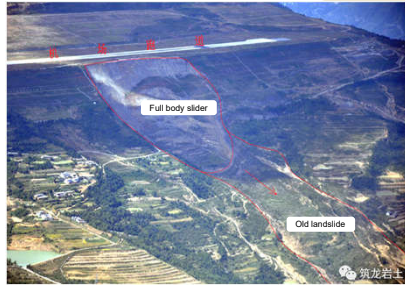
b. Landslide

The accident occurred below the airport runway in Panzhihua airport.  
The designer made a mistake in project site selection because there has been a landslide below occurred 30 years ago.

**Landslide** -The deformation of the slope is mainly horizontal sliding downward along the fixed sliding curve in the slope under the action of natural or human behaviors. The main differences between landslides and other slope deformations are the fixed sliding curve, overall sliding, and the rich groundwater.

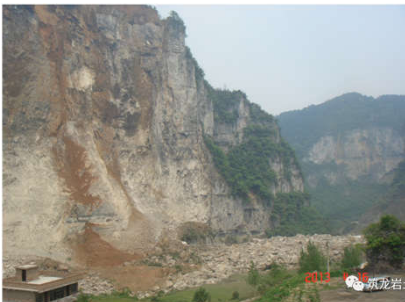
c. Foliation

Rock foliation occurred at outlet of tunnel in Kaiji, Guizhou Province. The foliation rock blocked the outlet of tunnel.

**Rock Foliation** -The weathered and broken rock mass on the steep slope collapsed or slipped due to natural and human behaviors. The foliation rock completely destroying the original structure.

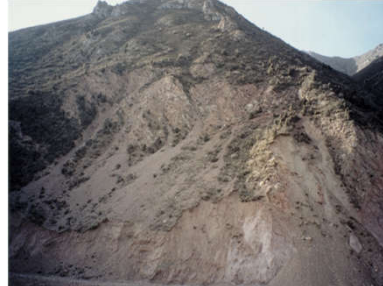
d. Scattered

Scattered occurred on the G346 highway in Shanxi Province. Reducing the weight of the upper part of the slope is the main measure to prevent scattered.

**Scattered** -For the relatively steep (35°~45°) slopes, the joint interface separates the outer weathered rock mass from the inner intact rock mass. After the river scouring or artificial excavation, the underlying soft layer cannot withstand the upper pressure and deforms, causing the upper rock mass to deform.

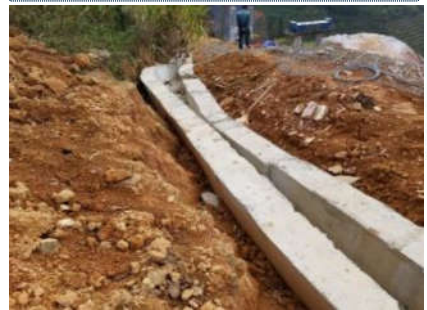
**Top of slope :** Water accumulation, Natural ditches and drainage ditches

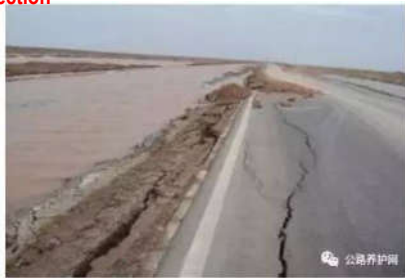
**Road pavement :** Water accumulation ; focus on longitudinal cracks, whether the cracks are arc-shaped at both ends ; whether the cracks reopen after sealing; whether the cracks continue to extend ; Verify if the cracks are offset.

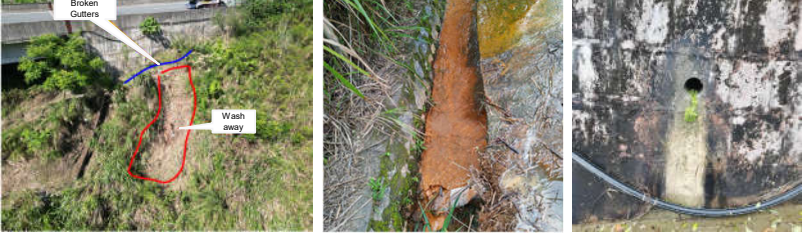
**Slope surface:** Water seepage from slope face ; Protection structures deformation; Slope toe deformation; Ditch wall deformation; Local failures on the slope; Drainage system, Berm cracks; Retaining wall deformation and cracks, Drainage holes.

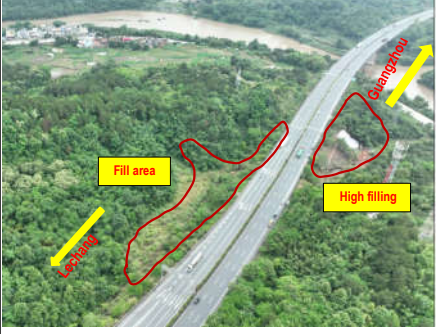
**Cause analysis**

The left side of the road is a filling area where surface water seeps into the embankment.

The drainage system is insufficient to handle rainwater runoff from the pavement surface during rainstorms, leading to severe erosion of the earth shoulders and slopes, and accelerating the infiltration of rainwater into the embankment.

The high-fill embankment is composed of muddy siltstone and soil. Prolonged heavy rainfall and rainwater infiltration have reduced the embankment's bearing capacity.

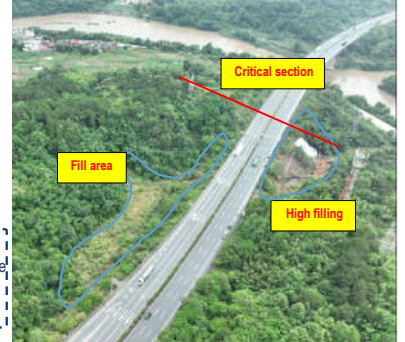
**Stability analysis method**

The simplified Bishop method is used to analyze the stability of the embankment body and the overall stability of the section.

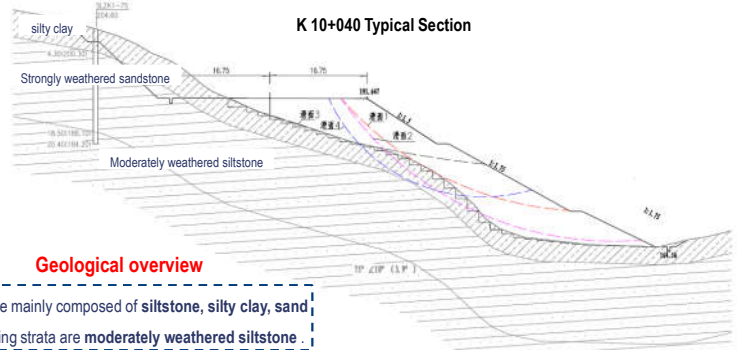
According to the site inspection, taking the last longitudinal crack on the pavement surface as the rear edge of the potential sliding curve, the sliding curve of the section are shown in the figure below.

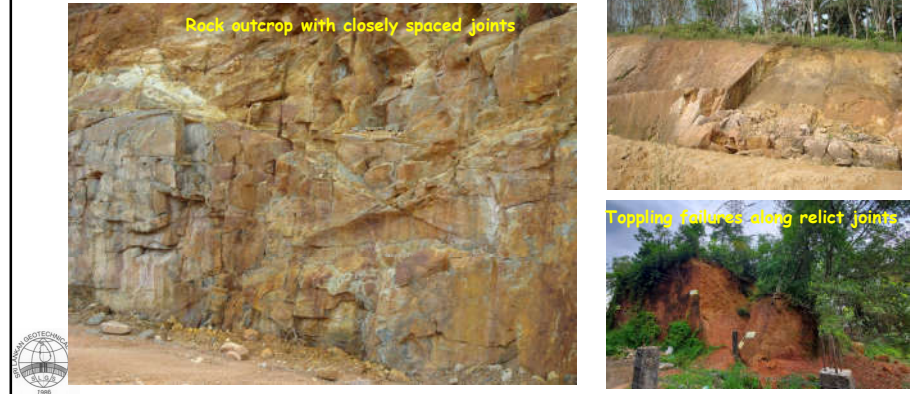
- Rocks could have banded structures with one or more joint planes. Joint planes will remain as relict joints in the residual soils. Relict joints remain as weak zones in the sloping ground. Sliding and toppling failure modes will occur when relict joints are adversely oriented.

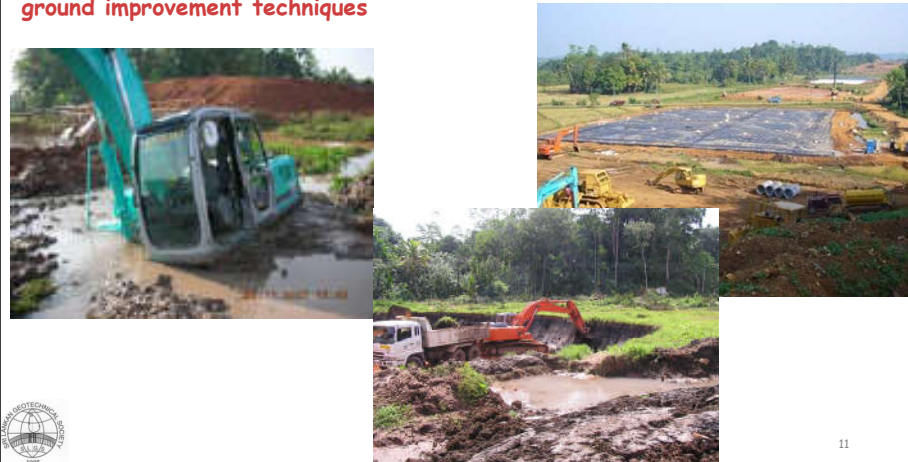
Extremely soft ground conditions encountered were overcome with different ground improvement techniques

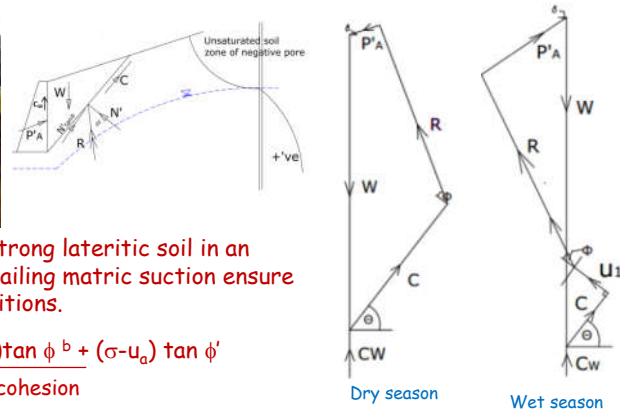
**Construction of A Mass Concrete wall to support a cutting in the CKE - Approach to the underpass at A3**

The soil in the cut is a strong lateritic soil in an unsaturated state. Prevailing matric suction ensure stability under dry conditions.

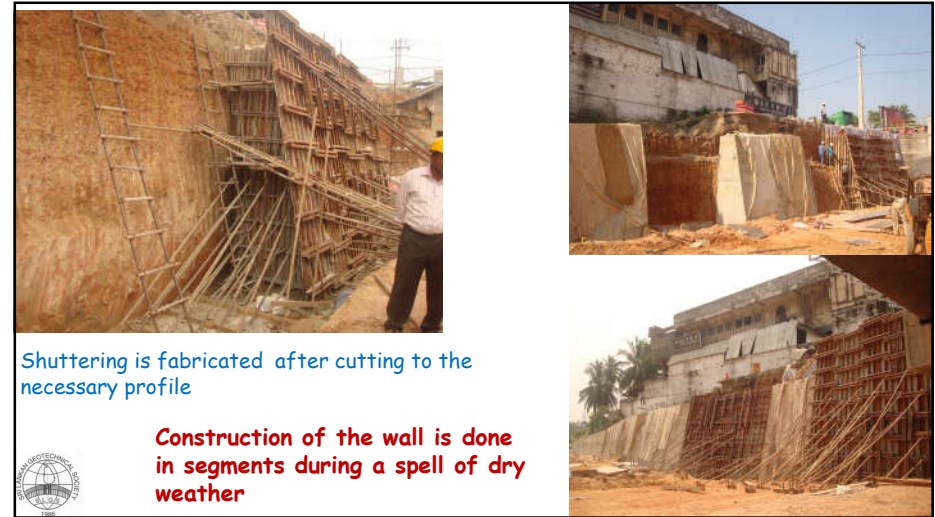
Shuttering is fabricated after cutting to the necessary profile

Construction of the wall is done in segments during a spell of dry weather

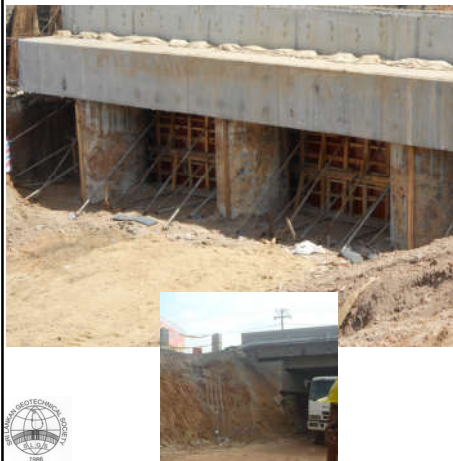
**Underpass at A3 - Bridge (two spans) supported on piles. Done in two halves.**

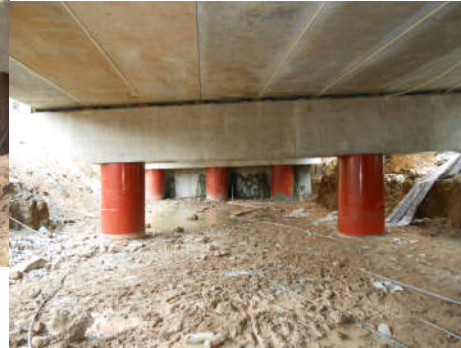
Ground was excavated vertically to find space for CKE. Vertical excavation was supported by soil nailing

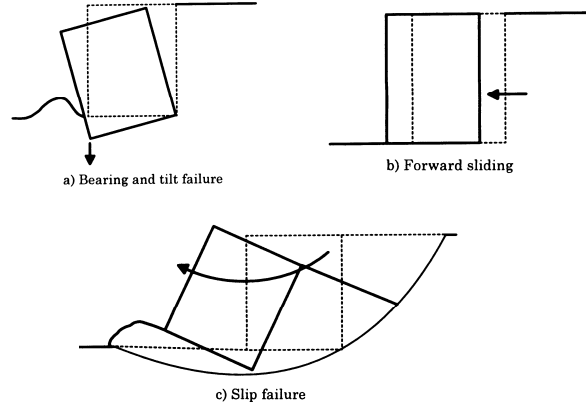
a) Bearing and tilt failure

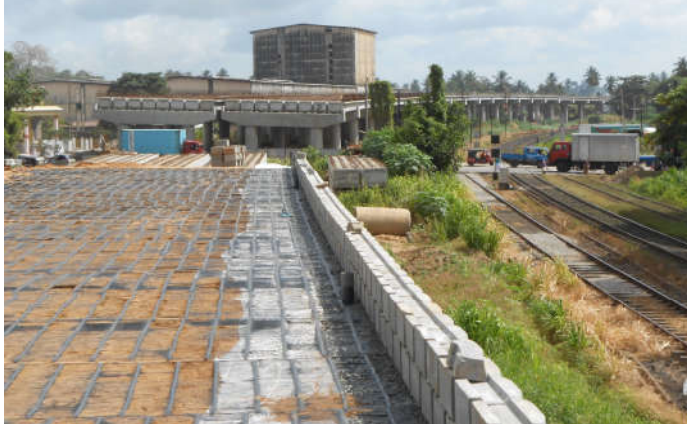
Reinforced Earth Retaining wall to provide approach to Viaduct at Hunupitiya -CKE

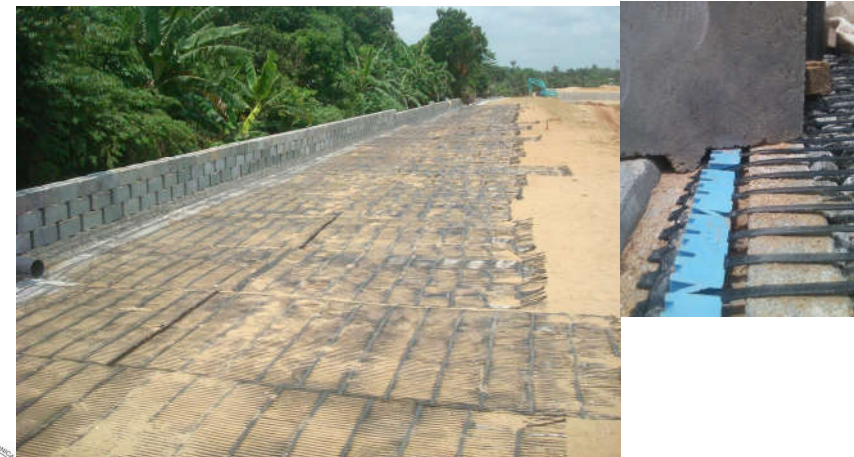
Facing blocks and Geogrid Reinforcements Placed

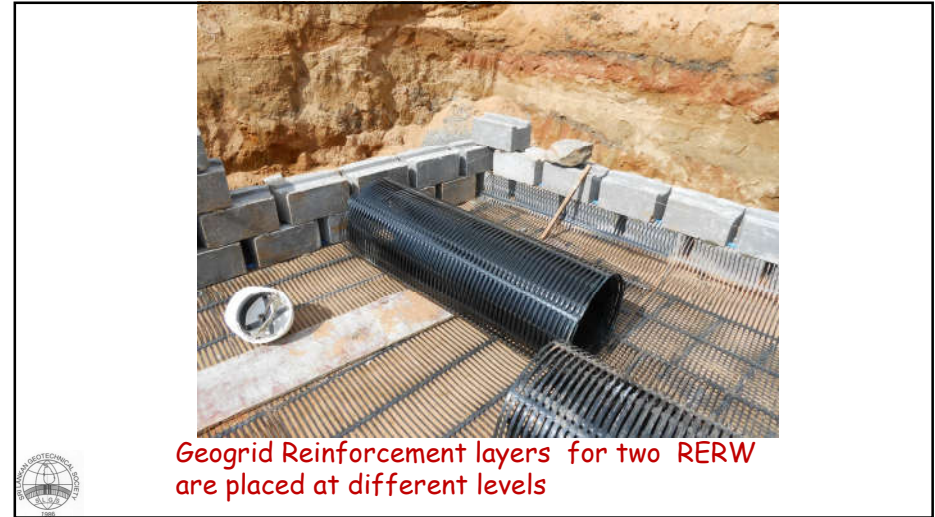
Two RERW Perpendicular to each other -approach to fly over bridge at Thelangapatha Road - 2+485 CKE

Geogrid Reinforcement layers for two RERW are placed at different levels

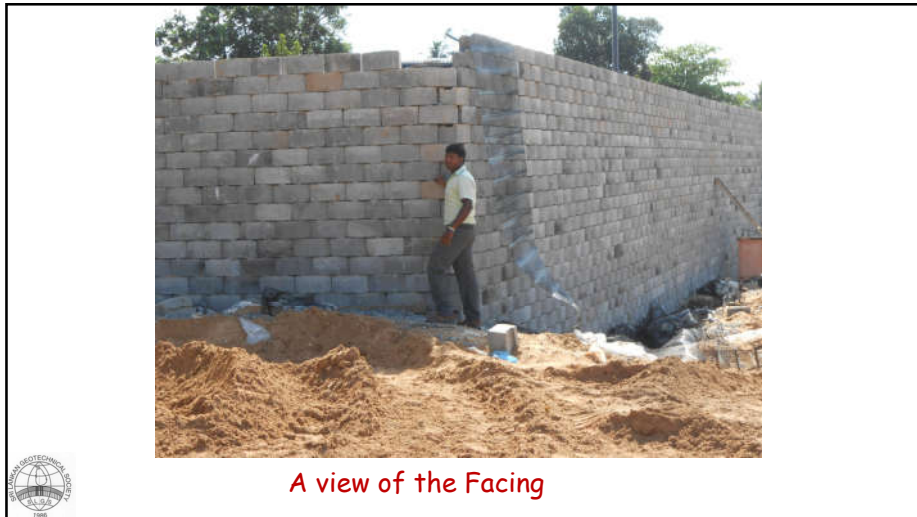
A view of the Facing

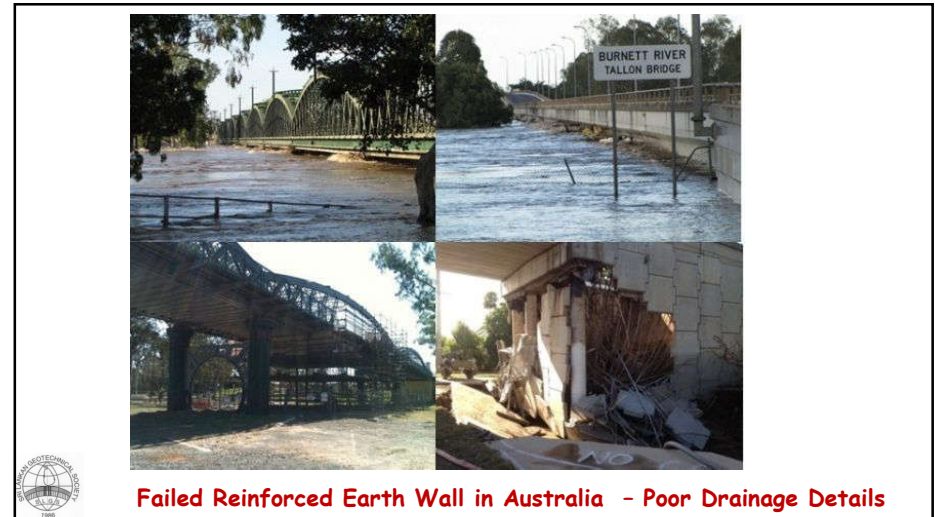
Failed Reinforced Earth Wall in Australia - Poor Drainage Details

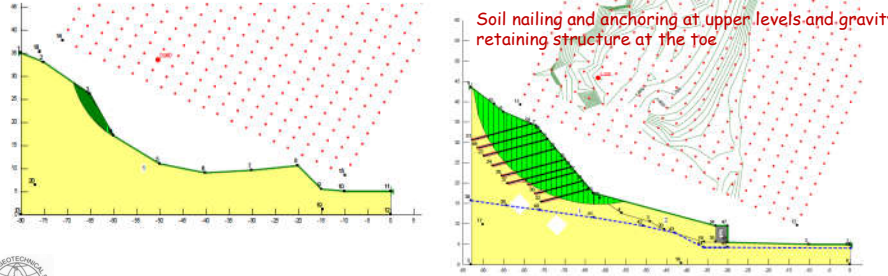
- Soil nailing and anchoring at upper level
- Gravity retaining structure at the toe
- Surface drainage -berm drains and cascade drains
- Sub surface drains at lower levels

Soil nailing and anchoring at upper levels and gravity retaining structure at the toe

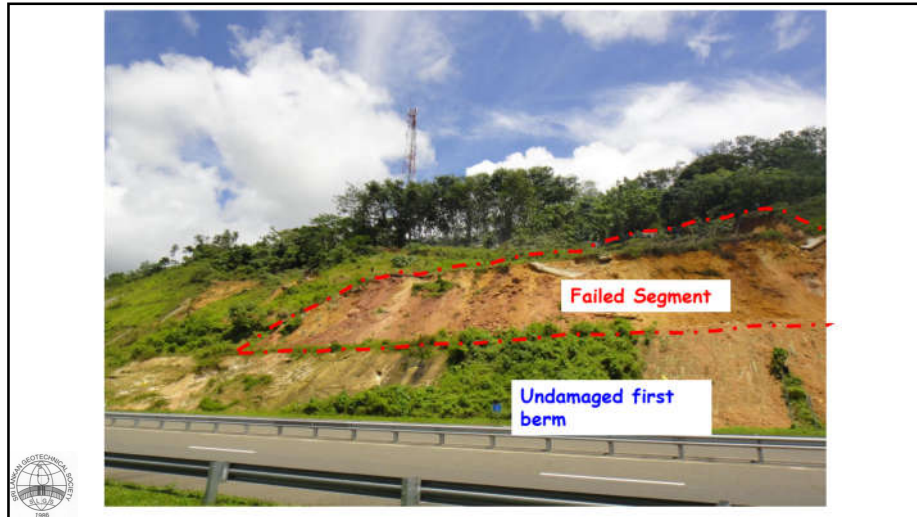
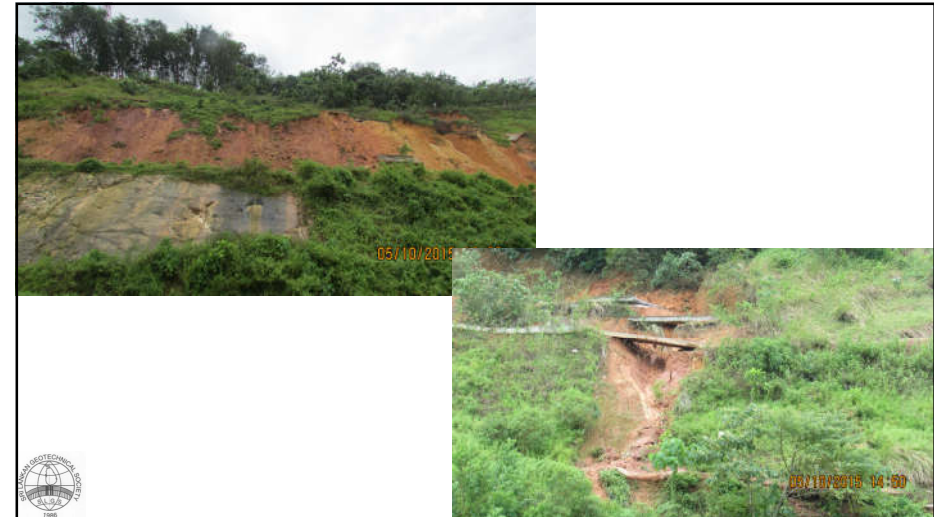
**Rectification of Failure at Kokmaduwa**

- Berms (3) were provided with berm drains and are connected to cascade drains.
- Part of the middle berm has been reinforced with soil nailing.
- The major tension cracks developed at the crest area were observed with lateral displacement of 50 to 200mm and vertical displacement of 1 m to 2m.
- Berms have been severely damaged by the movements of the cut slope.

**Tension Crack at the crest of the road cut**

**Initial failure with damages in soil nailing segment also**

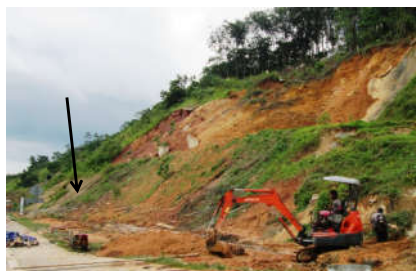
- Forty five numbers (45 Nos.) of horizontal drains into angle of 15° were installed at the first berm level get the infiltrated water trapped inside.

Installed Horizontal drains

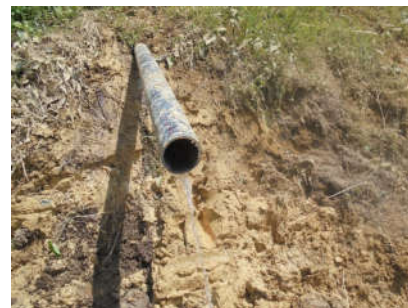
**Immediate mitigation measures**

Water discharge from horizontal gravity drains

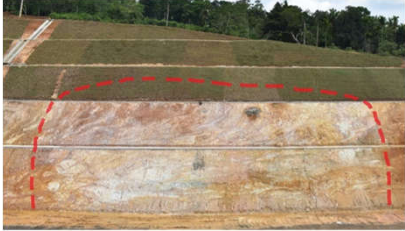
Plane failure condition

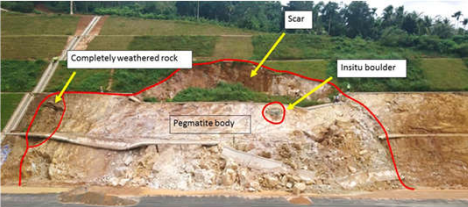
Soft infillings

Observations at collapsed location

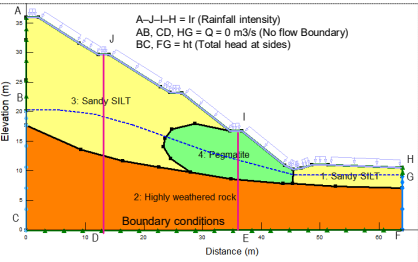
A-J-L-H = Ir (Rainfall intensity)  
 AB, CD, HG = Q = 0 m<sup>3</sup>/s (No flow Boundary)  
 BC, FG = ht (Total head at sides)

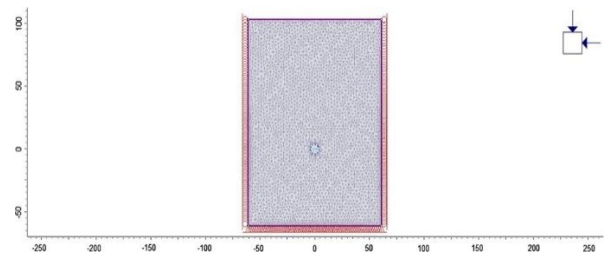
Fig. 1 Phase 2 model of the 6 m diameter circular tunnel

Pseudo-static finite element analyses were performed to assess the impact of rock joint deformation on the seismic response of circular tunnels. Figure 1 illustrates the computational domain and boundary conditions. The lower boundary was constrained in both vertical and horizontal directions, while the lateral boundaries were fixed in the vertical direction. The ground level was treated as a stress-free surface, while the bottom boundary was fixed, and both sides were considered rollers.

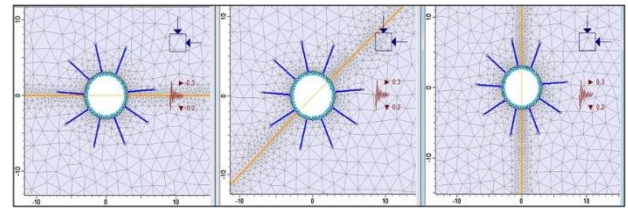
Fig. 2 Joint model for a 6-meter diameter circular tunnel with horizontal, diagonal, and vertical joints under quasi-static seismic loading conditions.

In this approach, the tunnel is modeled as an equivalent continuum, incorporating a critical joint set within the rock mass. Unlike continuum methods, this approach allows for the explicit inclusion of interfaces, enabling the modeling of anisotropic variations. Such scenarios are analyzed using the discrete element method, which examines joint interactions with the tunnel. Vardakos et al., 2007 utilized in situ blasting measurements to investigate how joint layouts affect stress wave propagation. Similarly, Li and Ma, 2010 explored the interaction between blast waves and arbitrarily positioned rock joints. For this study, joints were simulated at three orientations:  $0^{\circ}$ ,  $45^{\circ}$ , and  $90^{\circ}$ , as shown in Fig. 2.

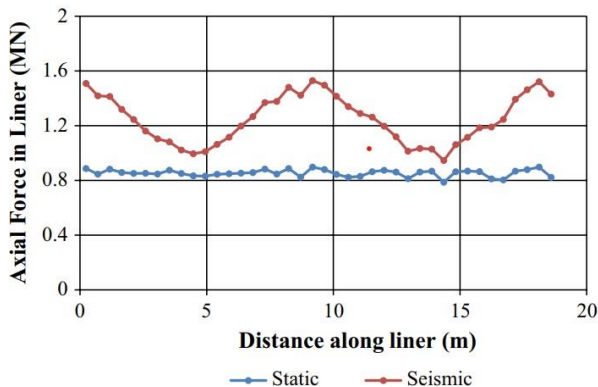
Fig. 4 Axial force on the lining for both static and seismic loading for  $Q = 1$  (6 m dia.)

Numerical modeling was conducted using Phase2 software to analyze various tunnel diameters (6, 12, 18, and 24 m) across different  $Q$  values ( $Q = 1, 10, 30$ ). Figure 4 illustrates the distribution of major principal stress ( $\sigma_1$ ) for a 6-m tunnel excavated in a rock mass with  $Q = 1$ , following the elastic-perfectly plastic model. Under static conditions, the high-stress zone is concentrated around the tunnel invert.

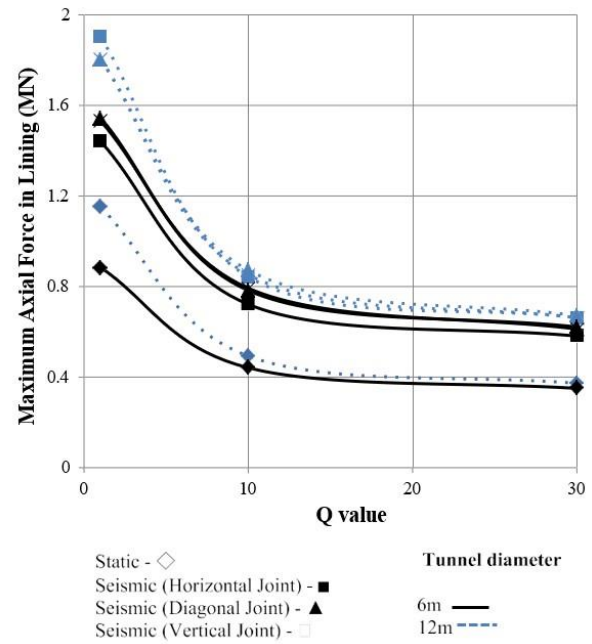
Fig. 6 Axial force in the lining for single-joint simulation at 0°, 45° and 90° for a 6-m-diameter circular tunnel in static load and after superimposing the seismic load combination in weak rock (Q = 1) and strong rock (Q = 30)

For the weak rock mass case (Q = 1), the effects of joint weakening do not manifest in the same manner as observed in stronger rock conditions. Figure 6 displays the seismic axial force distribution along the liner for rock classes (Q = 1, 10, and 30) and diameters (6 m and 12 m) across different joint orientations.

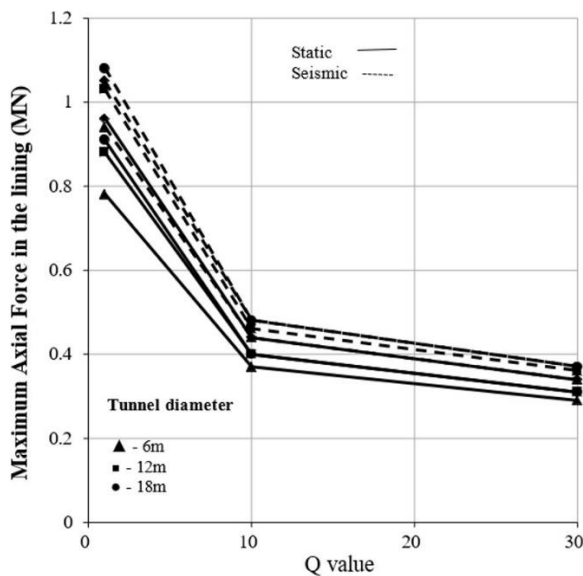
Fig. 7 Variation of the axial force in static and seismic conditions with the rock quality for different tunnel diameter

Meanwhile, Figure 7 illustrates the variation in axial force around the tunnel for rock classes ( $Q = 1, 10,$  and  $30$ ) across diameters of 6 m, 12 m, 18 m, and 24 m under both static and seismic loading conditions.

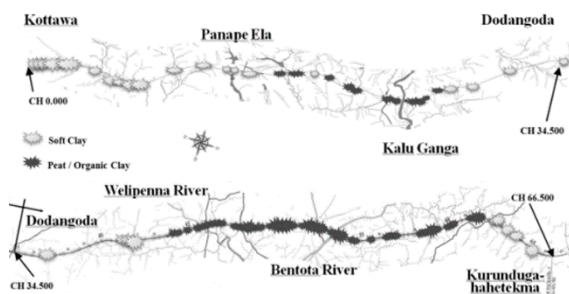
Fig. 1 Distribution of soft ground areas

The investigation identified that the soft ground area of the highway mainly consisted of peat, organic clay, alluvial clay, and loose sand deposits. The distribution of soft soil deposits along the highway trace from Kottawa to Kurundugahahetekma is shown in Fig. 1.

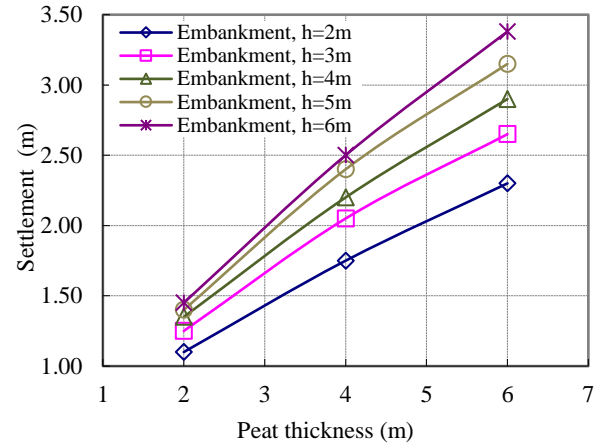
Fig. 2 Predicted settlement in peaty clay due to different embankment heights

The heavy tamping method resulted in a quick decrease in the void ratio of the peaty soil and instantaneous settlement of ground under impact. Heavy tamping method was designed to enforce the settlements that would be caused by the construction of earth embankments on soft ground by applying impact energy. Different energy levels had to be imparted by considering the anticipated settlement of the compressible layer under the respective designed embankment heights. In the estimation of settlements, all primary consolidation settlements and secondary settlements at the end of 3 years after construction were considered. The estimated settlement of peaty soil layers of different thicknesses under various embankment heights is shown in Fig. 2. In the calculation of settlement, the values of 0.428, 0.0428, 0.05, and 20 kPa were used for the parameters  $c_c/(1+e_0)$ ,  $c_r/(1+e_0)$ ,  $c_\alpha$ , and  $P_c$  respectively where  $c_c$  is the compression index,  $e_0$  is the initial void ratio,  $c_r$  is the recompression index,  $c_\alpha$  is the coefficient of secondary consolidation and  $P_c$  is the pre-consolidation pressure.

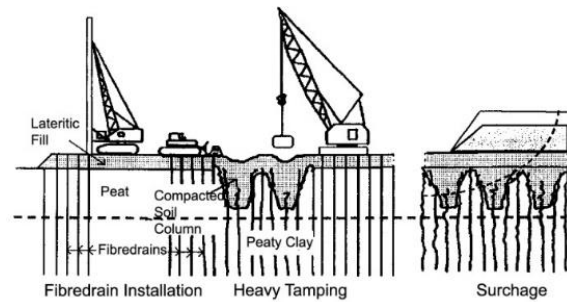
Fig. 4 Major steps in heavy tamping ground improvement.

However, according to the investigation, it was observed that the soft compressible layer thickness was higher than above in most of the locations and therefore the underneath deeper soft layers were not improved properly by heavy tamping. These underneath deeper soft layers were improved after the heavy tamping operation by keeping a surcharge load for a sufficient period of time. Fig. 4 illustrates the major steps in the heavy tamping ground improvement adopted in the project.

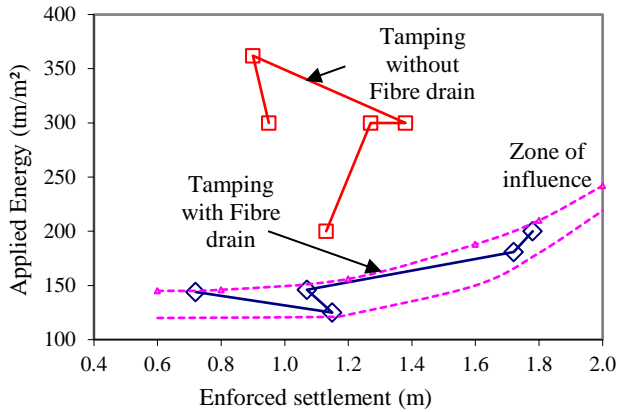
Fig. 5 Comparison of Applied energy vs. Enforced settlement with and without fiber drains

The in situ permeability of peat is relatively higher than that of ordinary clays and therefore it was assumed that quick dissipation of excess pore water pressure would occur within the peat during the tamping operation. However, it was noted that the process of pore water pressure dissipation was rather slow, and therefore no further densification can be achieved by imparting additional energy to the soils. This could have been due to the rapid reduction of permeability of the peaty soil as a result of damage to the structure of the soil, the presence of a substantial amount of clay content, and long drainage paths. Therefore, it was noted that the energy level required to achieve the designed enforced settlement was very high as the excess pore pressure was not allowed to dissipate as expected. Having experienced the above difficulty, it was decided to install special strong type fiber drains in the peaty soil prior to the tamping in order to eliminate the development of high excess pore water pressure during the heavy tamping operation. Fig. 5 shows the applied tamping energy level in order to achieve the designed enforced settlement with and without fiber drain installation in similar ground conditions. As shown in Fig. 5, the energy that was required to achieve the designed enforced settlement in fiber drain installed peaty ground was significantly lower than the energy required without fiber drains. This clearly shows that part of the applied energy was wasted in compressing the 'incompressible' water. Therefore, the provision of a strong band drain such as a fiber drain to withstand heavy tamping impact is useful in reducing the required tamping energy level as described in Karunaratne (2007).

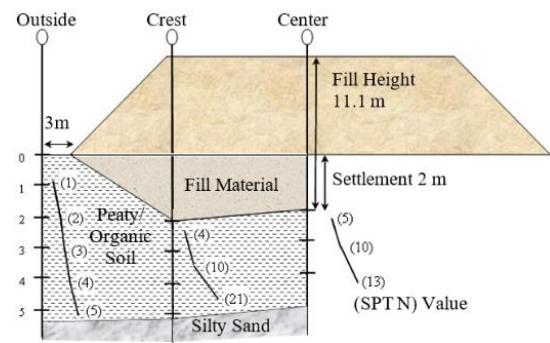
Fig. 10 Subsoil profile of improved and unimproved area

A site investigation was carried out to assess the actual ground improvement in the areas improved by the heavy tamping and vacuum consolidation method just before the removal of the surcharge. The investigation was carried out in the improved as well as the adjacent unimproved area in order to assess the ground improvement. Site investigation comprised of advancing boreholes with Standard Penetration Test (SPT), collection of undisturbed soil samples, performing of Field Vane Shear Test, Cone Penetration Test (CPT), and performing of laboratory tests. The improvement of the physical and mechanical properties of peat due to heavy tamping improvement is described in Karunawardena (2011). The observed subsoil in one of the CVC improved areas deduced from the borehole investigation is shown in Fig. 10. In the same figure recorded SPT values are also plotted along the depth.

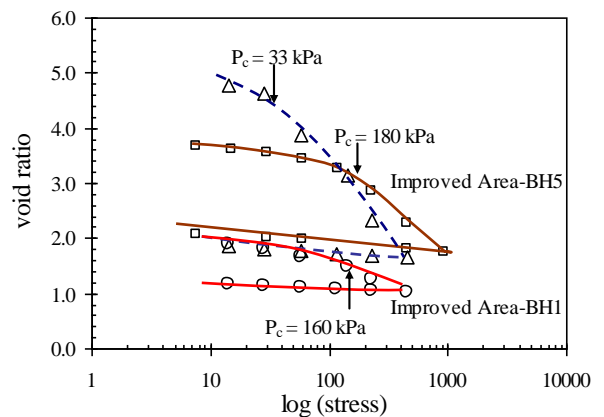
Fig. 11 Consolidation Test Results

consolidation pressure determined through the 1-D consolidation test. Consolidation tests carried out from section Ch.47+850 to Ch.47+920 indicated that the pre-consolidation pressure of the peaty soil found under the embankment has increased from 28 kPa – 38 kPa range to 160 kPa – 180 kPa range after ground improvement as shown in Fig. 11. The expected load induced on the peaty layer due to the proposed embankment is around 145 kN/m<sup>2</sup>. Therefore, the subsoil will behave under the over-consolidated state with an Over Consolidation Ratio (OCR) of 1.2 to 1.3 during the service life of the highway and hence will only give rise to very small settlements in the future.

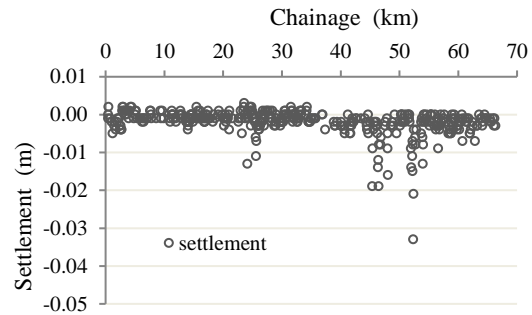
Fig. 12 Results of the surface settlement monitoring

reasons. The observed total surface settlement up to September 2012, ten months after opening to traffic, is shown in Fig. 12. The observed settlement was less than 5 mm in most of the sections, and in only two locations the settlement exceeded 20 mm. The maximum observed settlement was 35 mm and the settlement prediction using the monitoring data indicates that the estimated residual settlement is less than 15 mm at the end of 3 years after the handing over of the project.

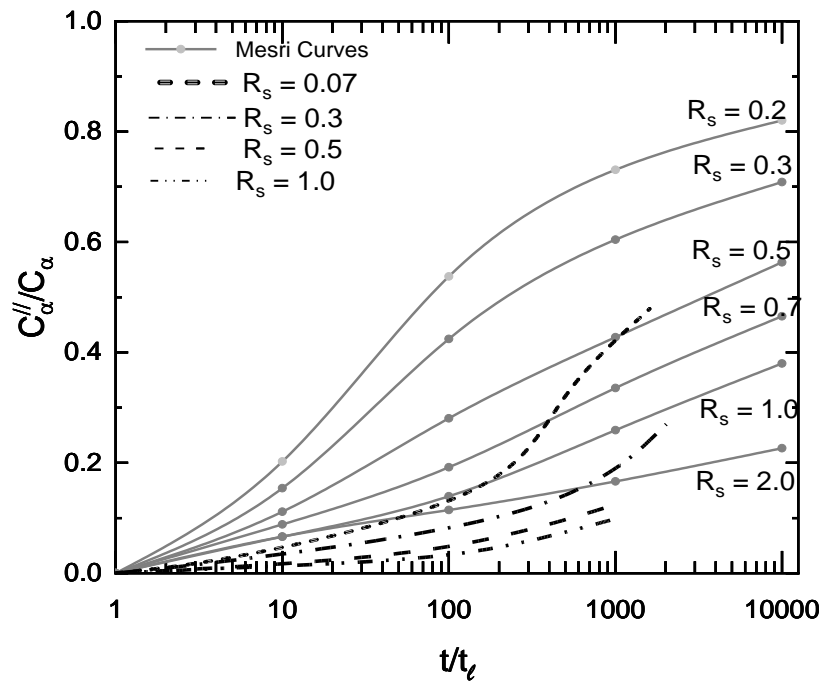
Fig 4. -  $C''/C_\alpha$  variation for Sri Lankan Peaty soil.

of the peat deposit. The low organic soils found in Sri Lanka may be different. Therefore  $C''\alpha/C\alpha$  was developed for Sri Lankan peaty soils, as shown in Figure 4.

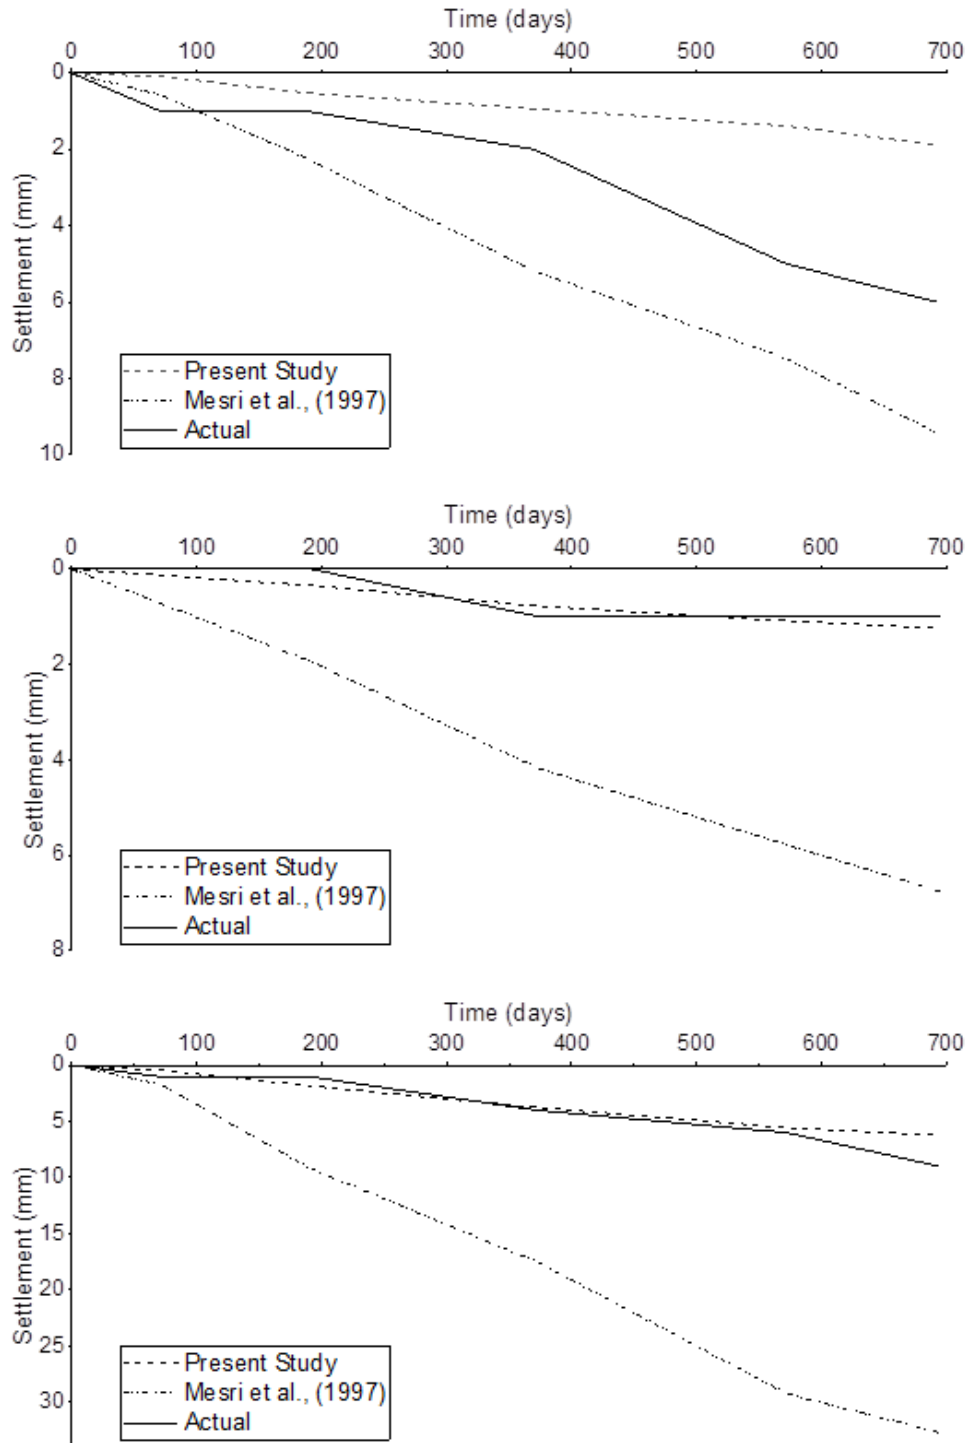
Fig. 5 – Comparisons of the actual measured settlements with the Predicted settlements.

Using the above-developed curves, the comparison study was done. The results are shown in Figure 5.
