Seminar on  
Geotechnical Engineering in  
River Basin Development

Organised by the  
Sri Lankan Geotechnical Society

in association with  
Sri Lanka National Committee  
on Large Dams

3rd December 1993

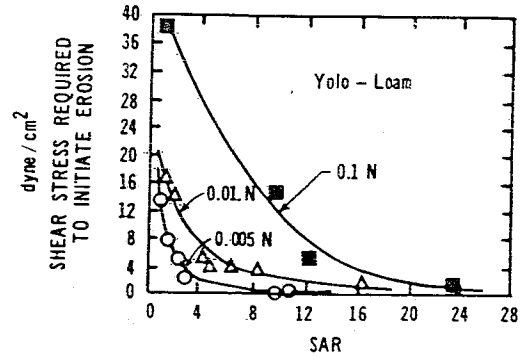
Fig.11 -Relationship Between Critical Shear Stress and SAR for different pore water electrolyte (Reproduced from Arulanandan et al (1975)).

of the sample before and after applying the shear stress. This is repeated for same sample for varying rotating speeds and the erosion rate vs shear stress graph is obtained. Arulanandan et al (1975) repeated this series of tests for same sample after increasing the SAR value by soaking in solutions of sodium salt of different concentrations and a set of test results is given in Figs. 10 (a) , (b) & (c). The intercept on the applied shear stress is called the critical shear stress. It was noted that for soils with high SAR these values were closer to zero. By combining the results from Fig 10 (a), (b) & (c) the variation of critical shear stress with SAR was obtained as in Fig.11.

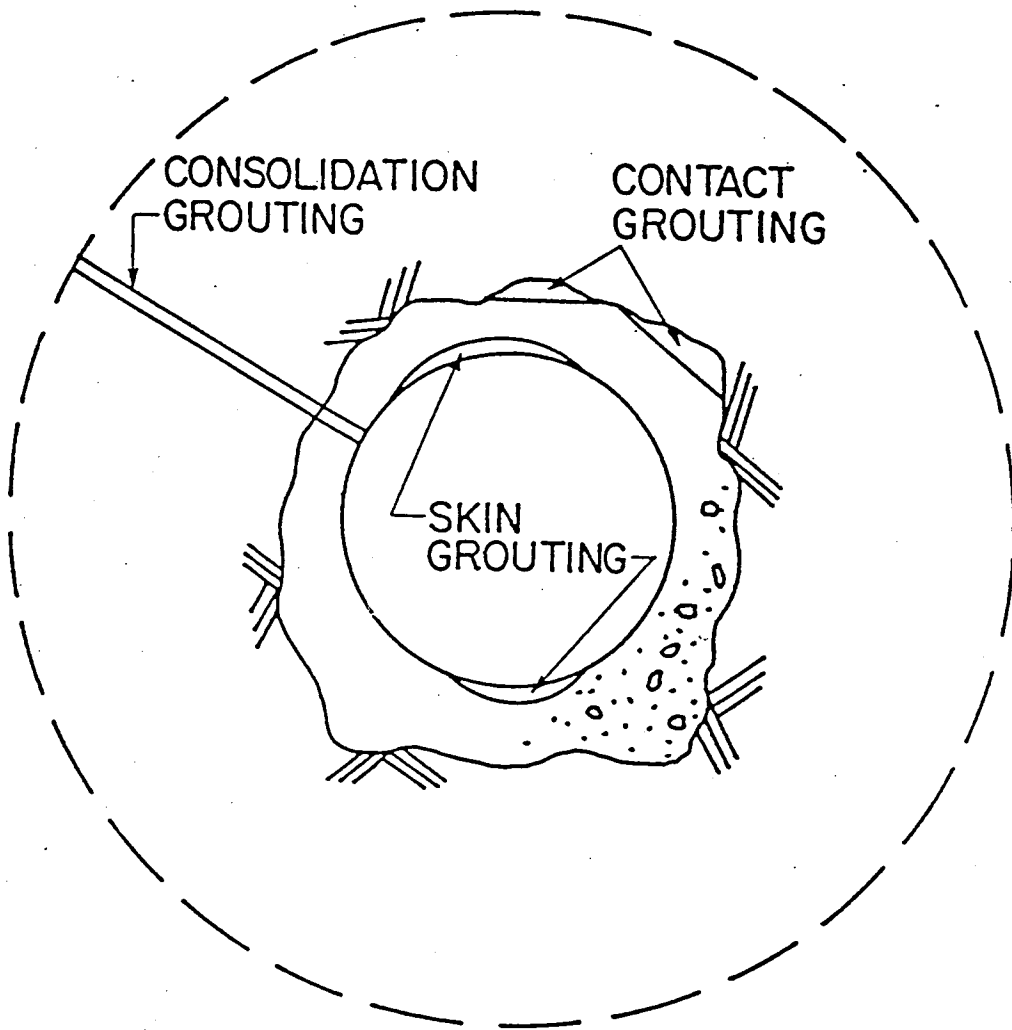
FIGURE - 7

Skin, Contact and Consolidation Grouting

- Contact grouting. to fill large voids between a placed concrete lining or concrete back packed steel lining, and the surrounding rock. Low pressures are normally used
- Skin grouting. To fill the annular gap between a steel lining and its concrete encasement which forms due to concrete shrinkage, due to plastic set in the rock during loading and unloading, due to the differential temperature between the liner and the rock.
- Consolidation grouting to consolidate blast damaged or relaxed rock and to reduce leakage. Improvement of the modulus of rock is claimed by some investigators, but it is a debatable point.(see Fig.7.)
